ATR REPORT-2021

**INDIAN FARMERS FERTILISERS CO OPERATIVE LTD.
PARADEEP UNIT**

ATR REPORT: 2021

DAP PLANT

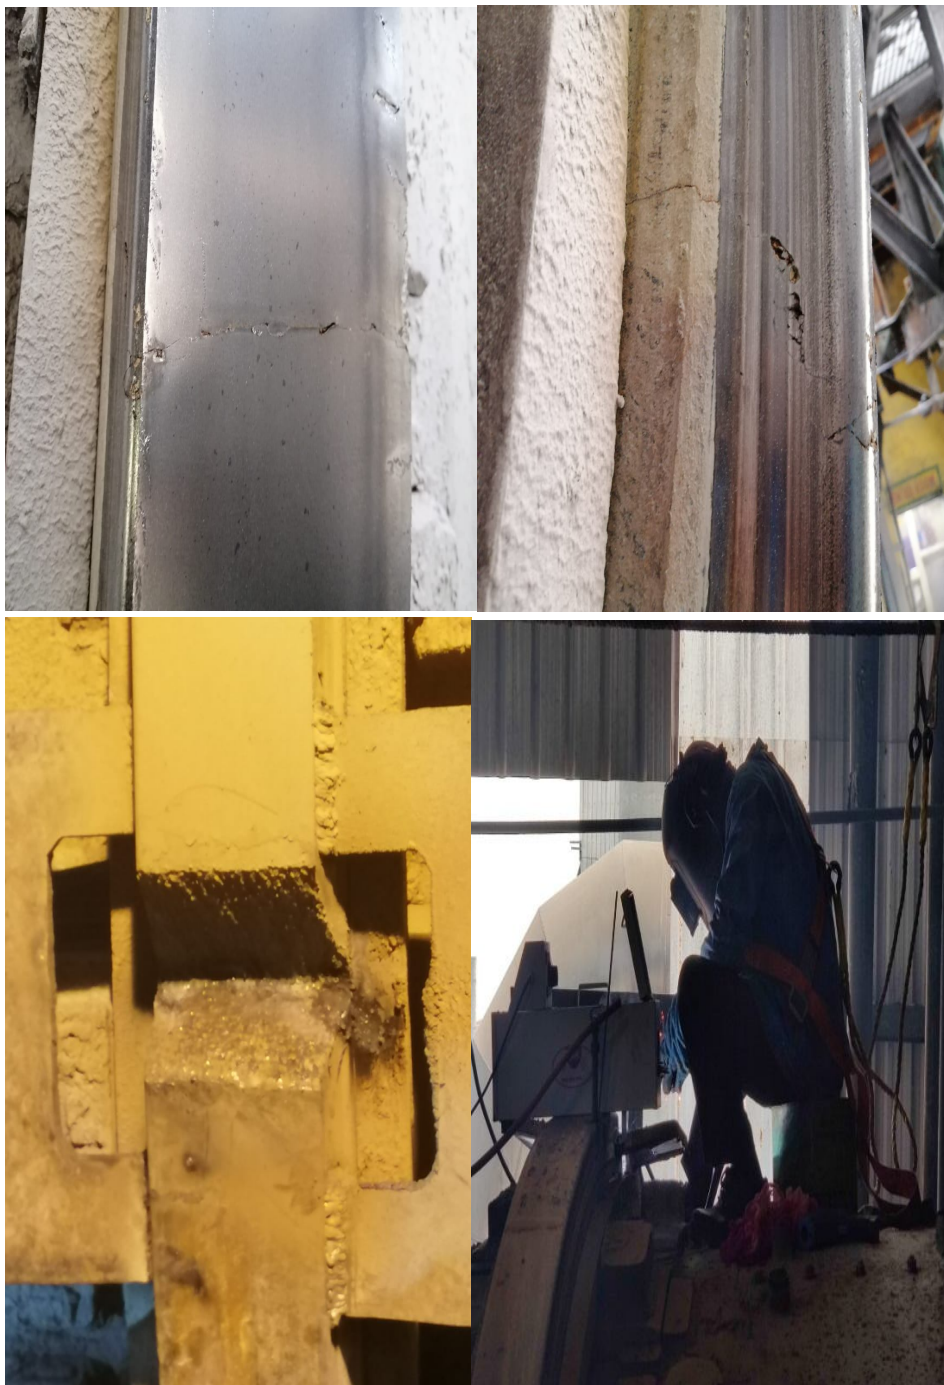
1. Thrust riding ring crack repaired by welding.

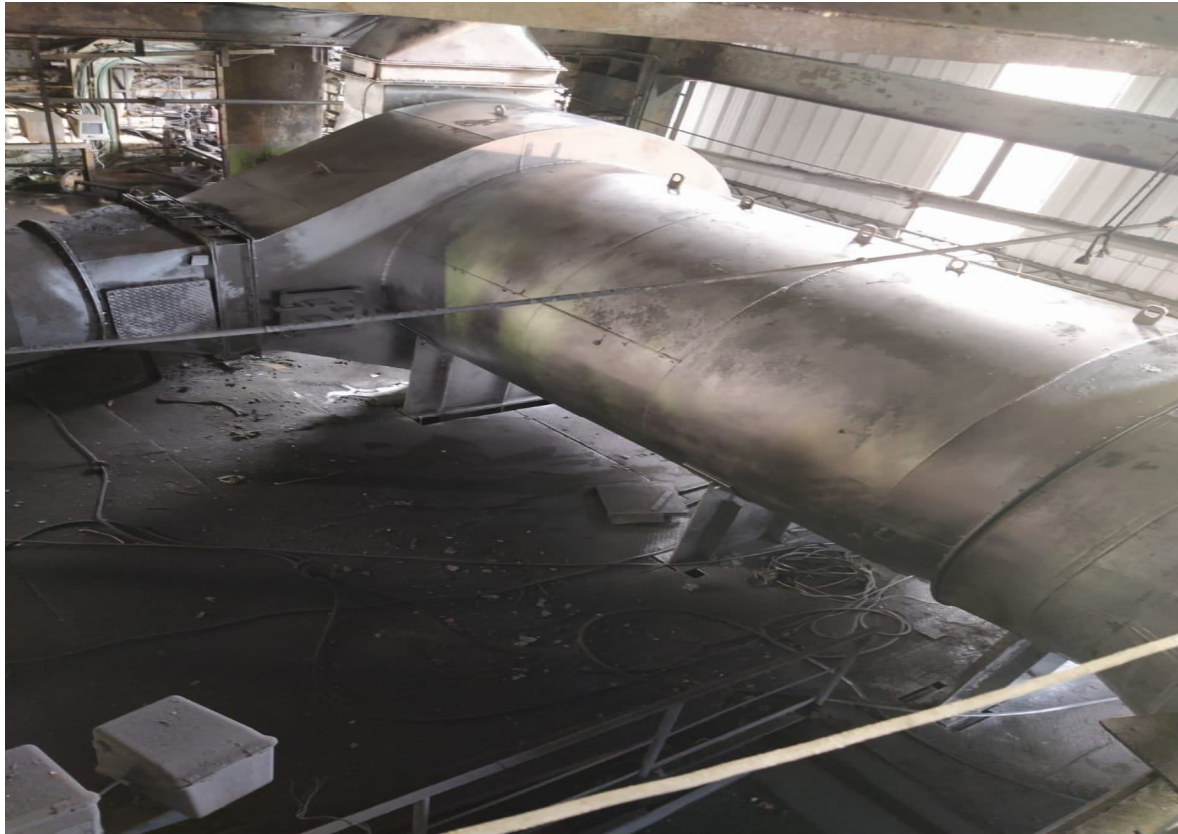
After application of heat resistant paint on outer shell of Combustion chamber

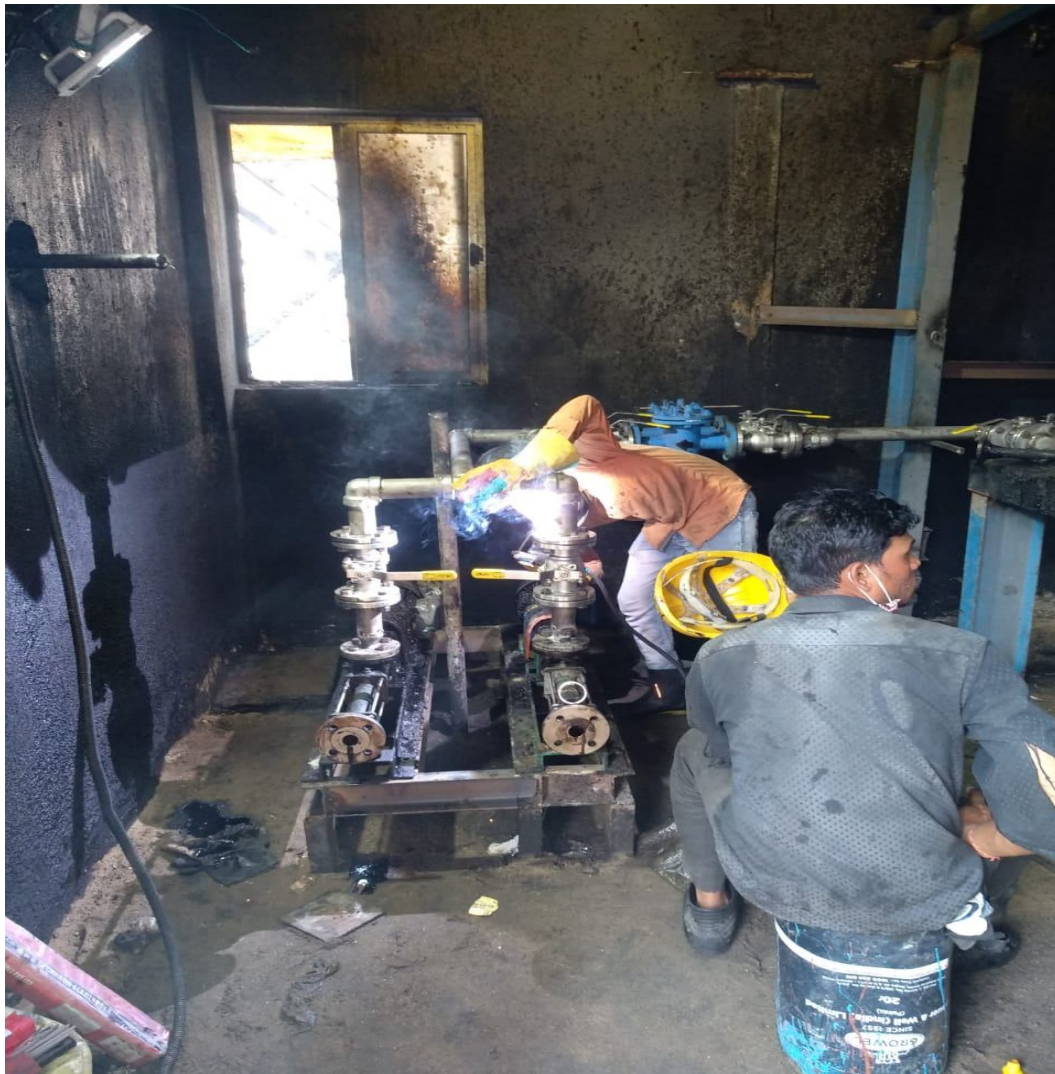
Screw type pump erection under progress

Coating pump: New screw type coating pump with 2" suction line & strainer fitted.

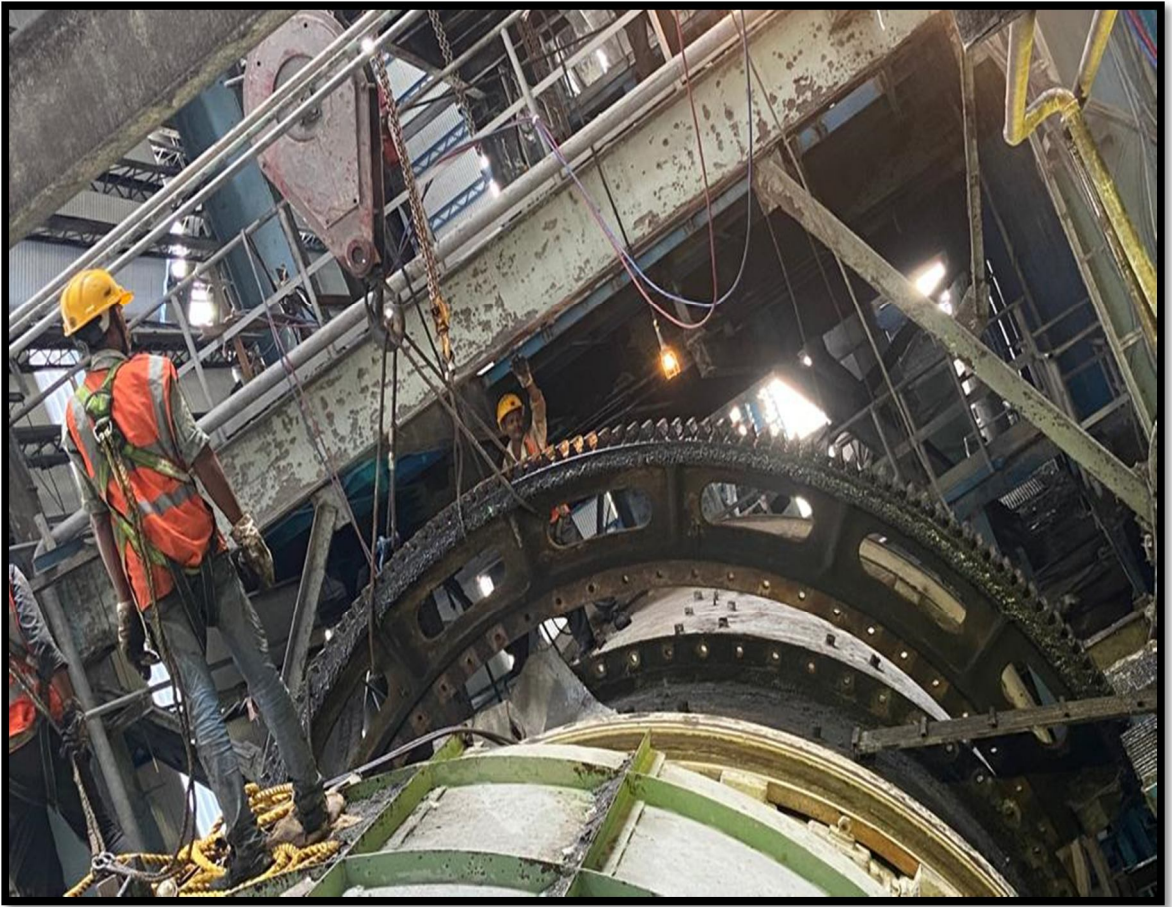
Existing girth gear dismantled.

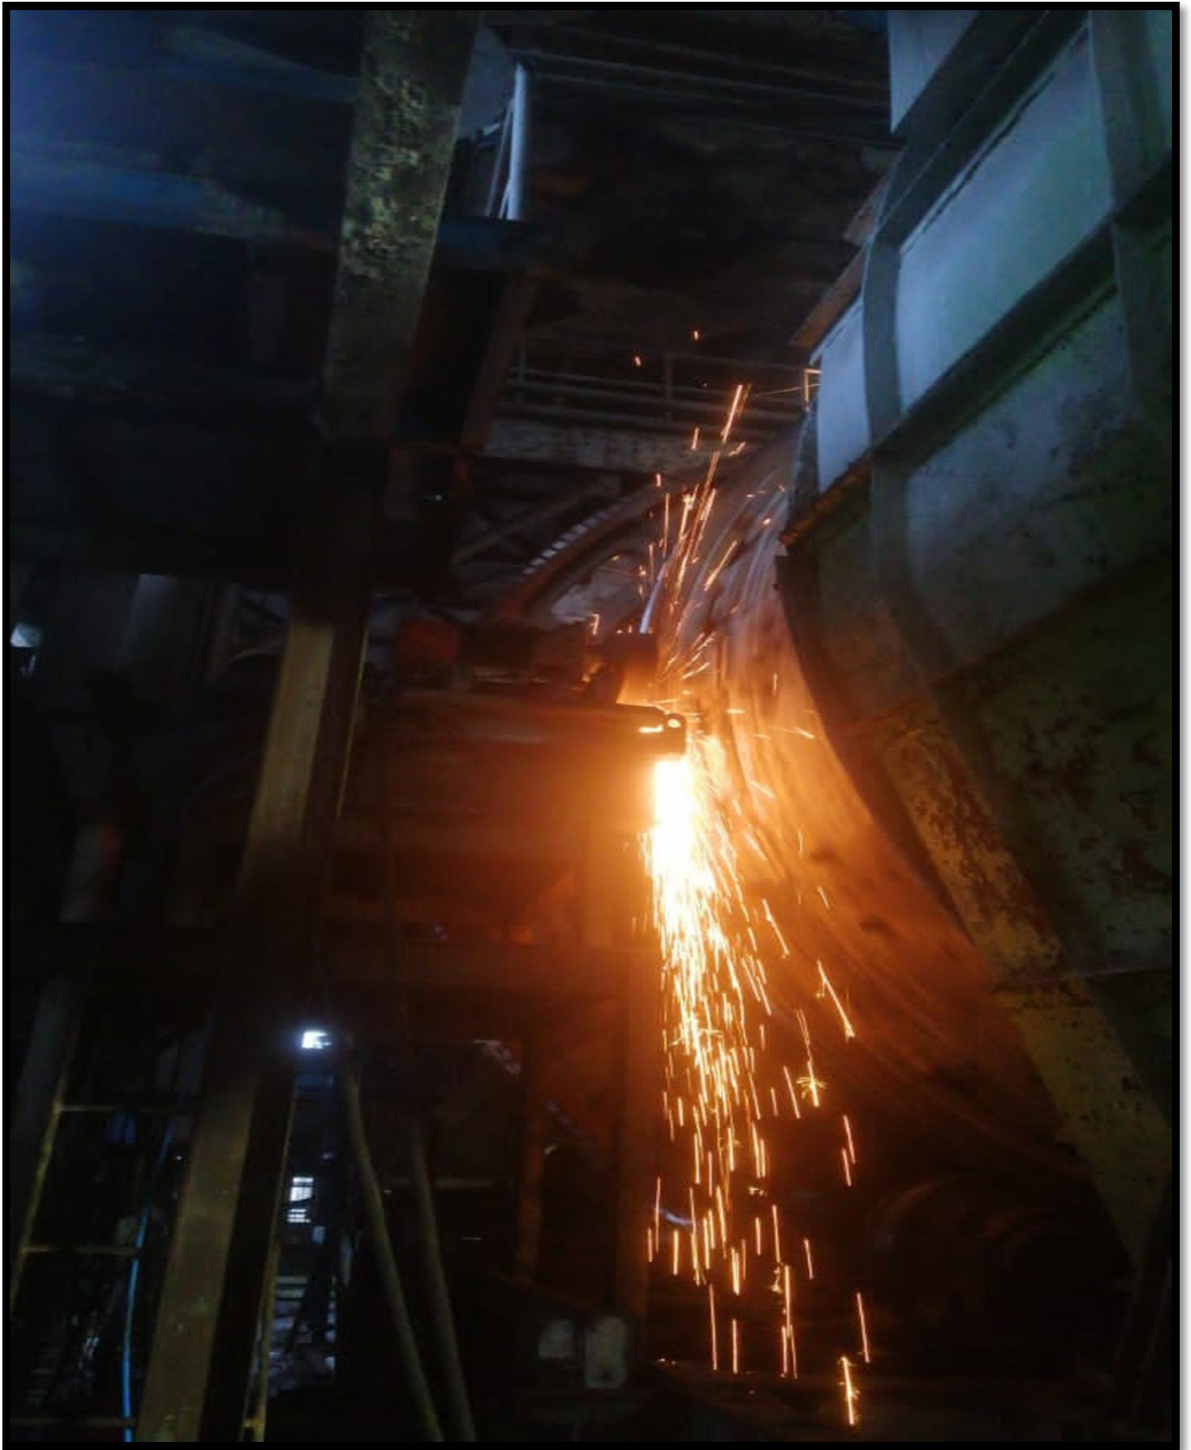
Thrust riding ring grinding work

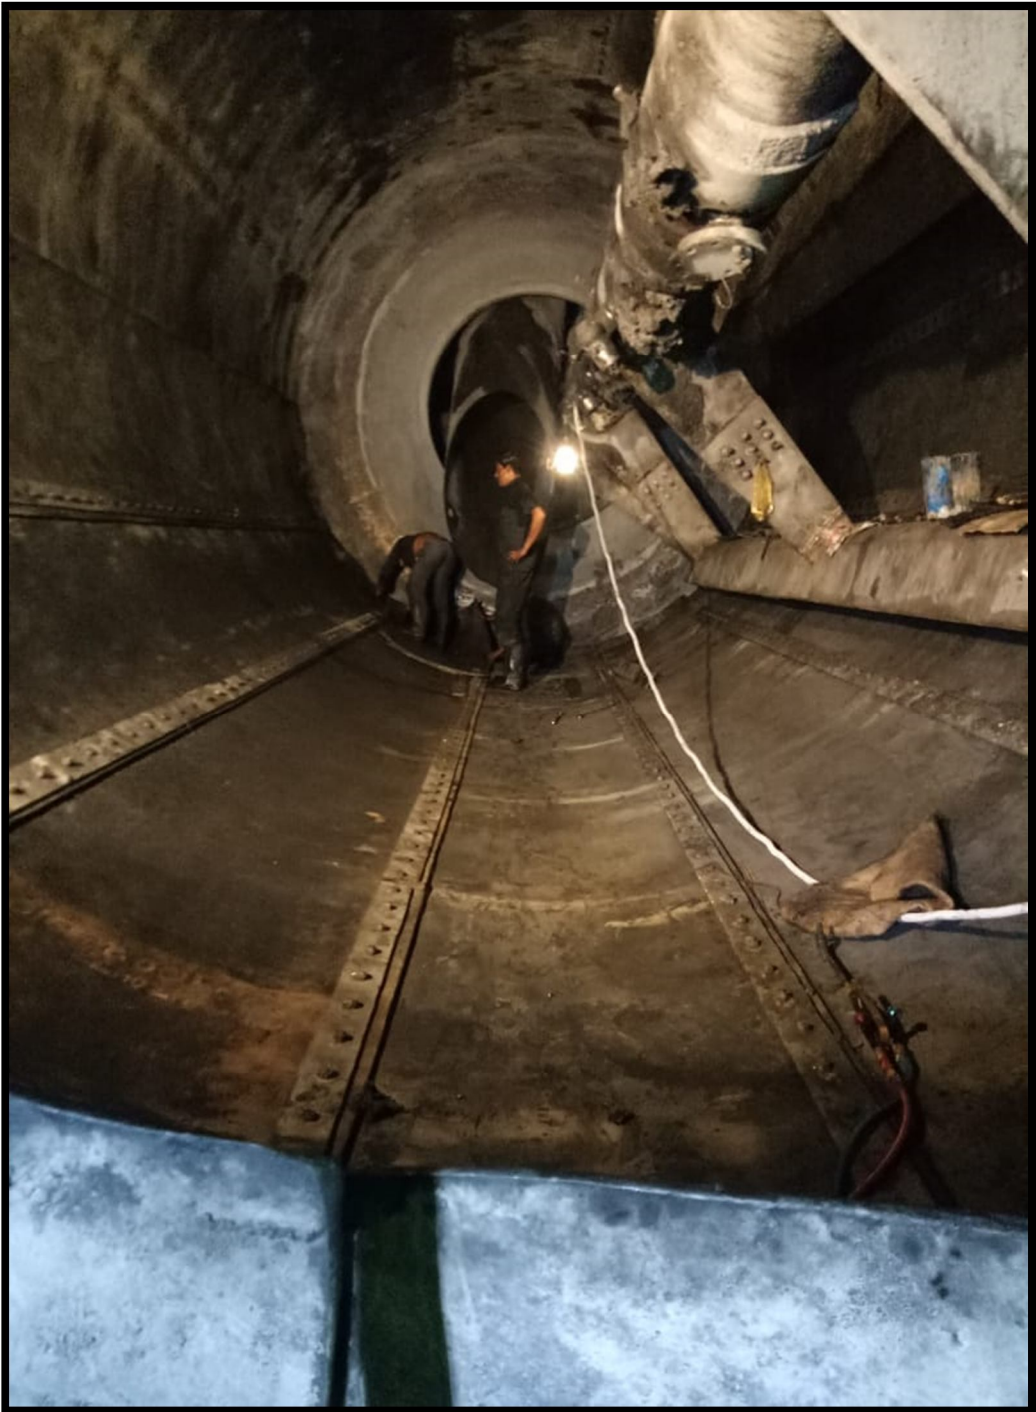
Granulator rubber panel replacement

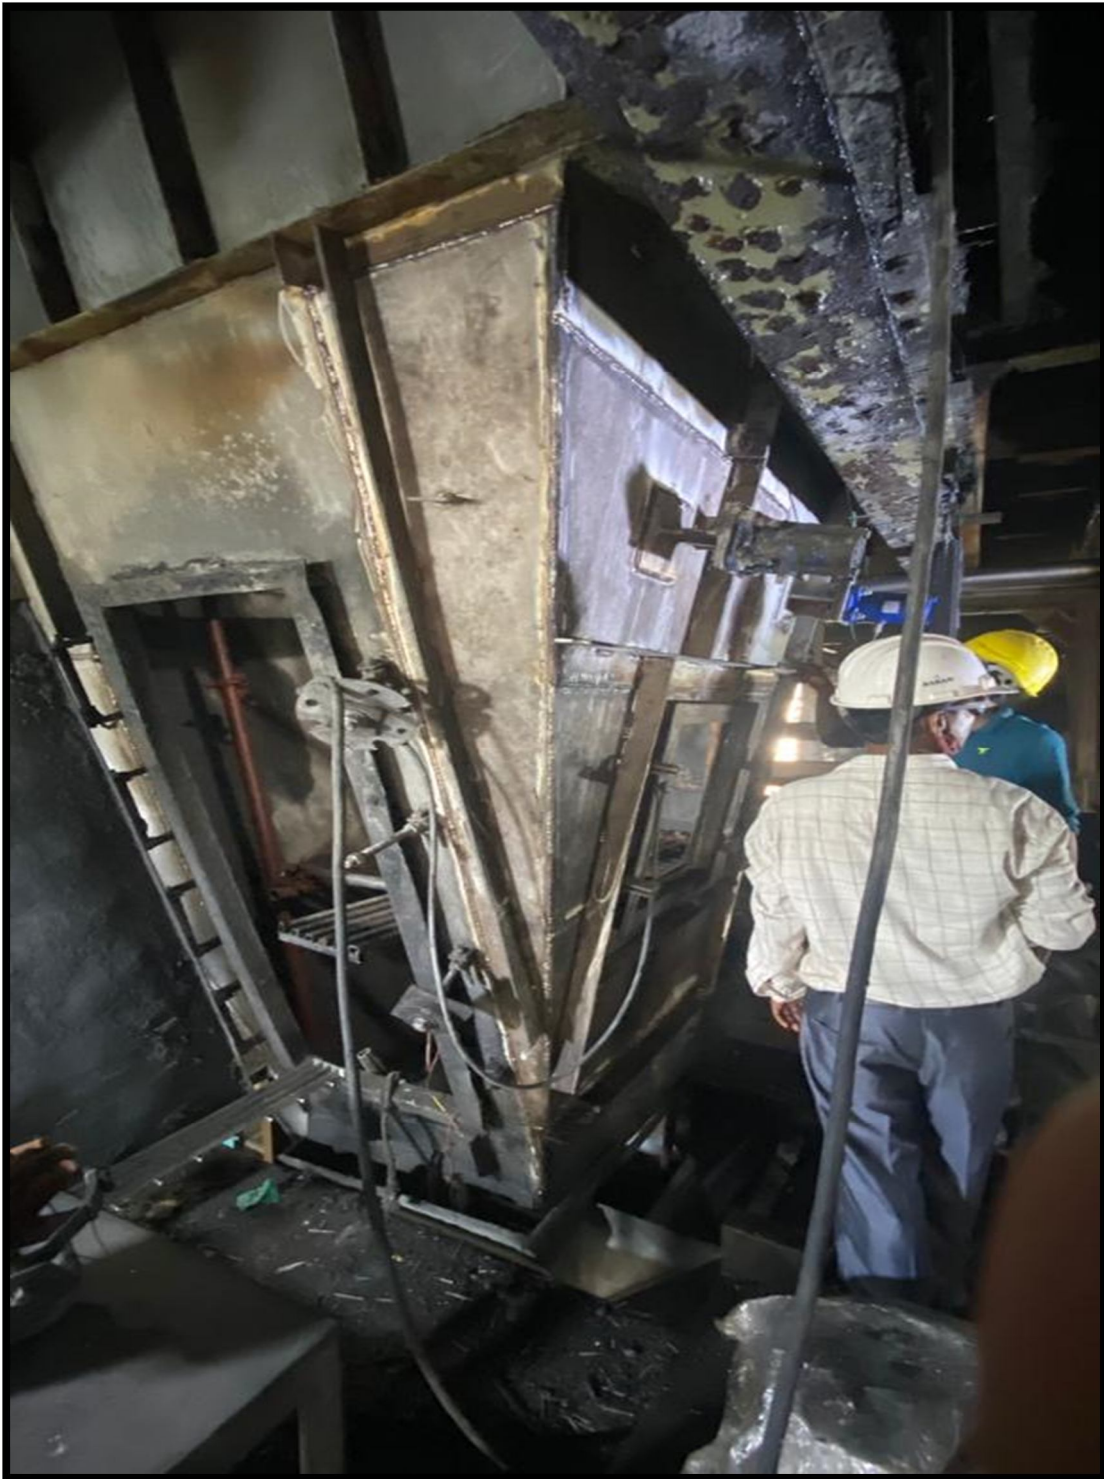
Granulator discharge hopper repair

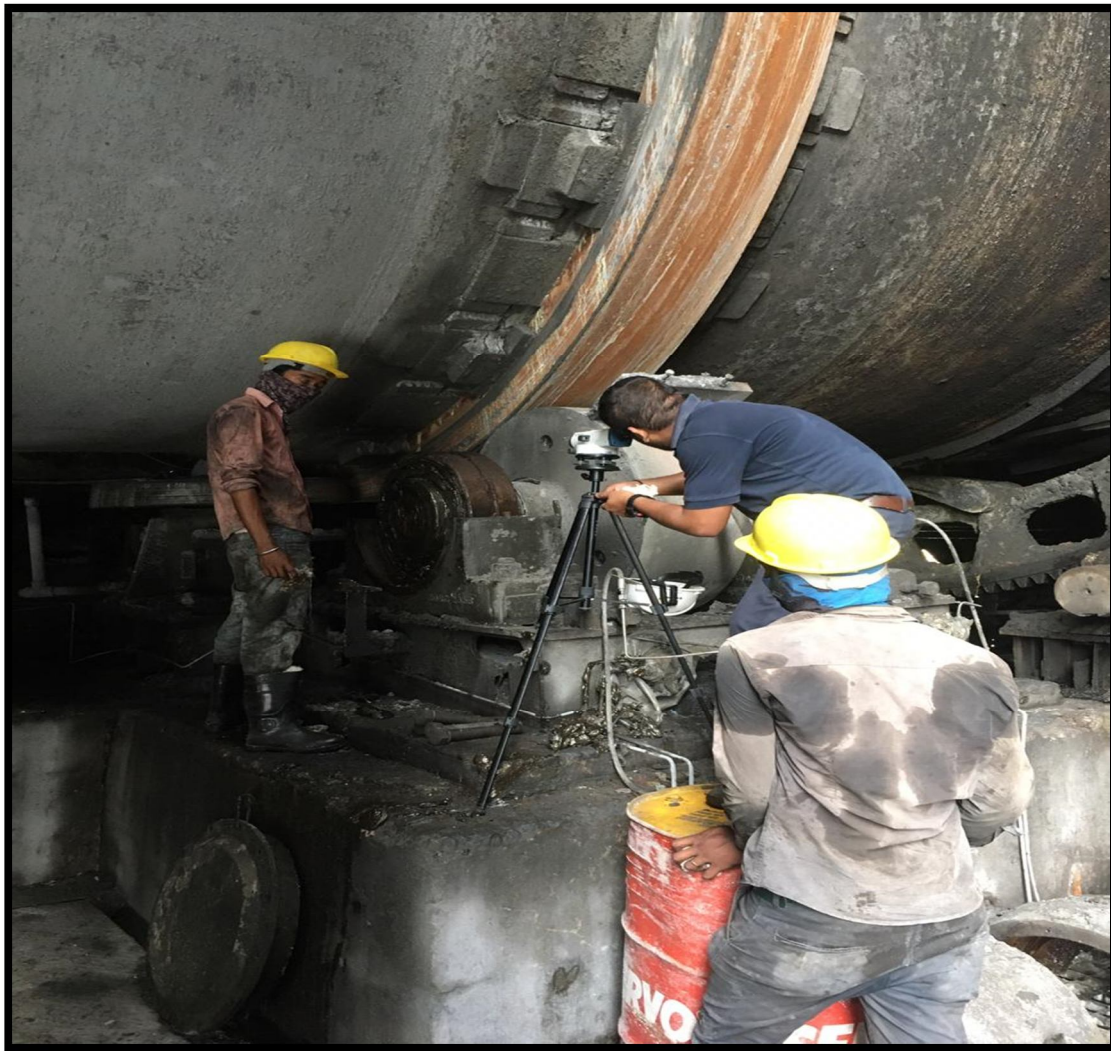
Cold alignment of dryer

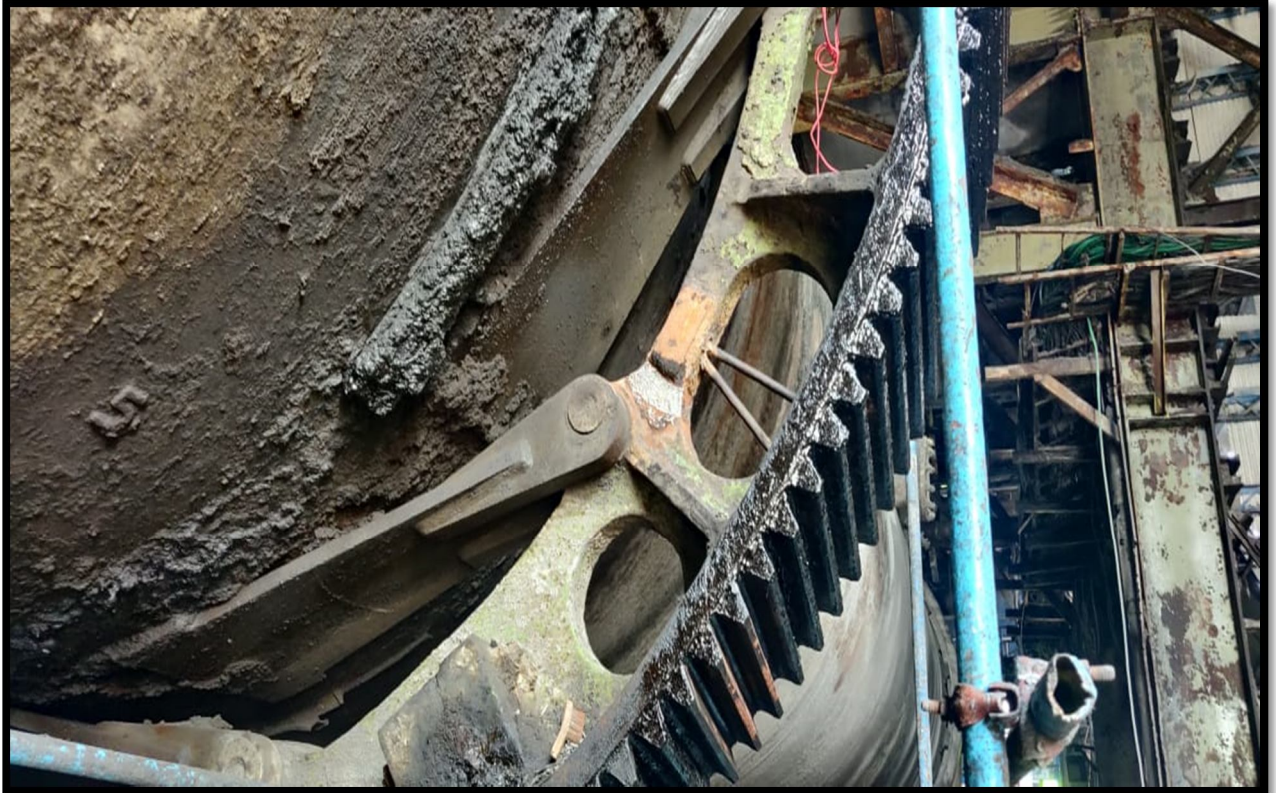
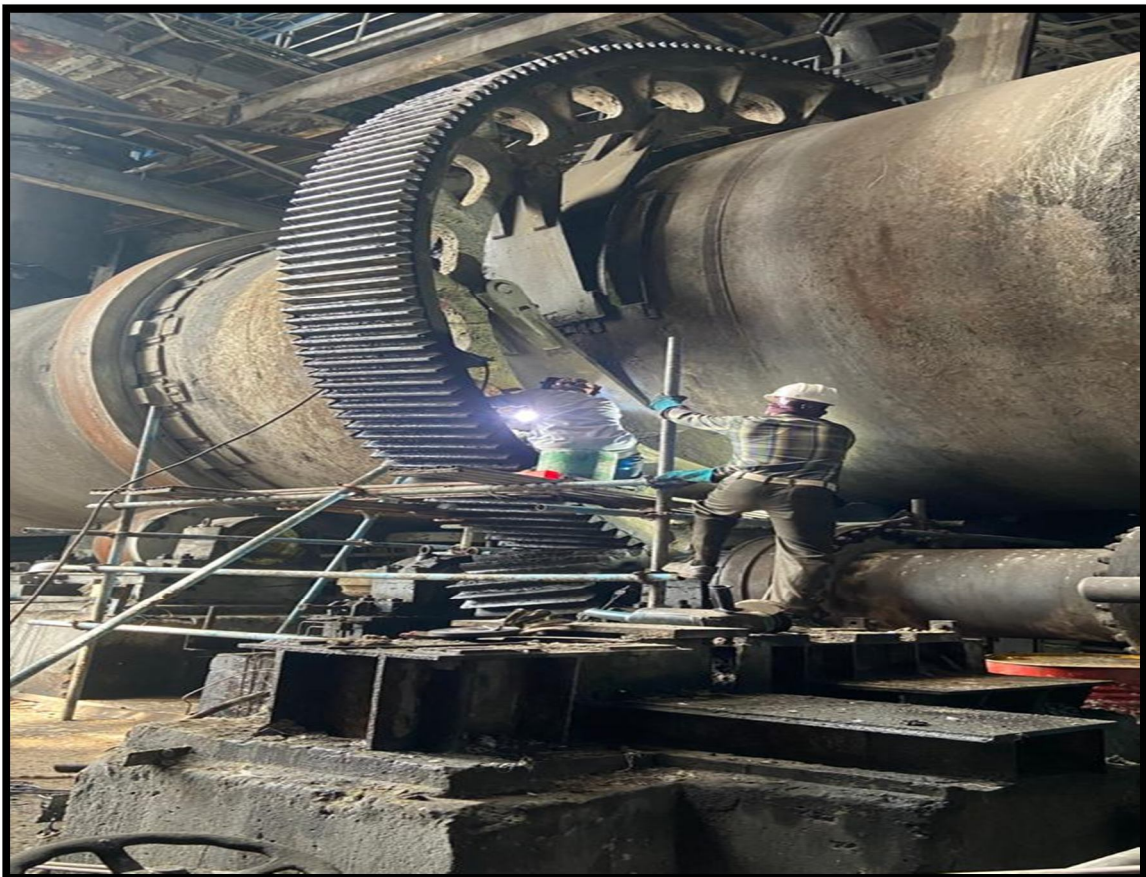
Dryer girth gear rim welding by L&T

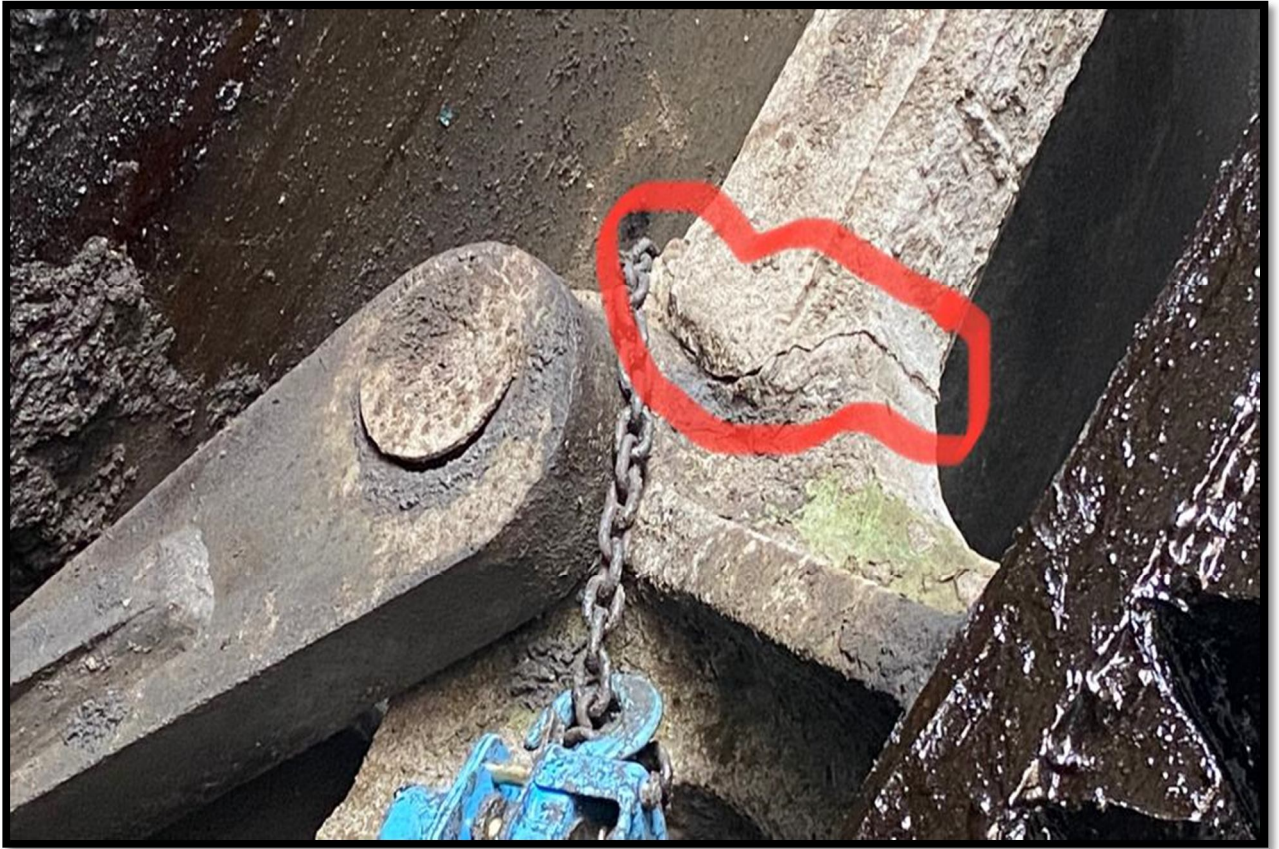
Dryer girth gear cracked portion

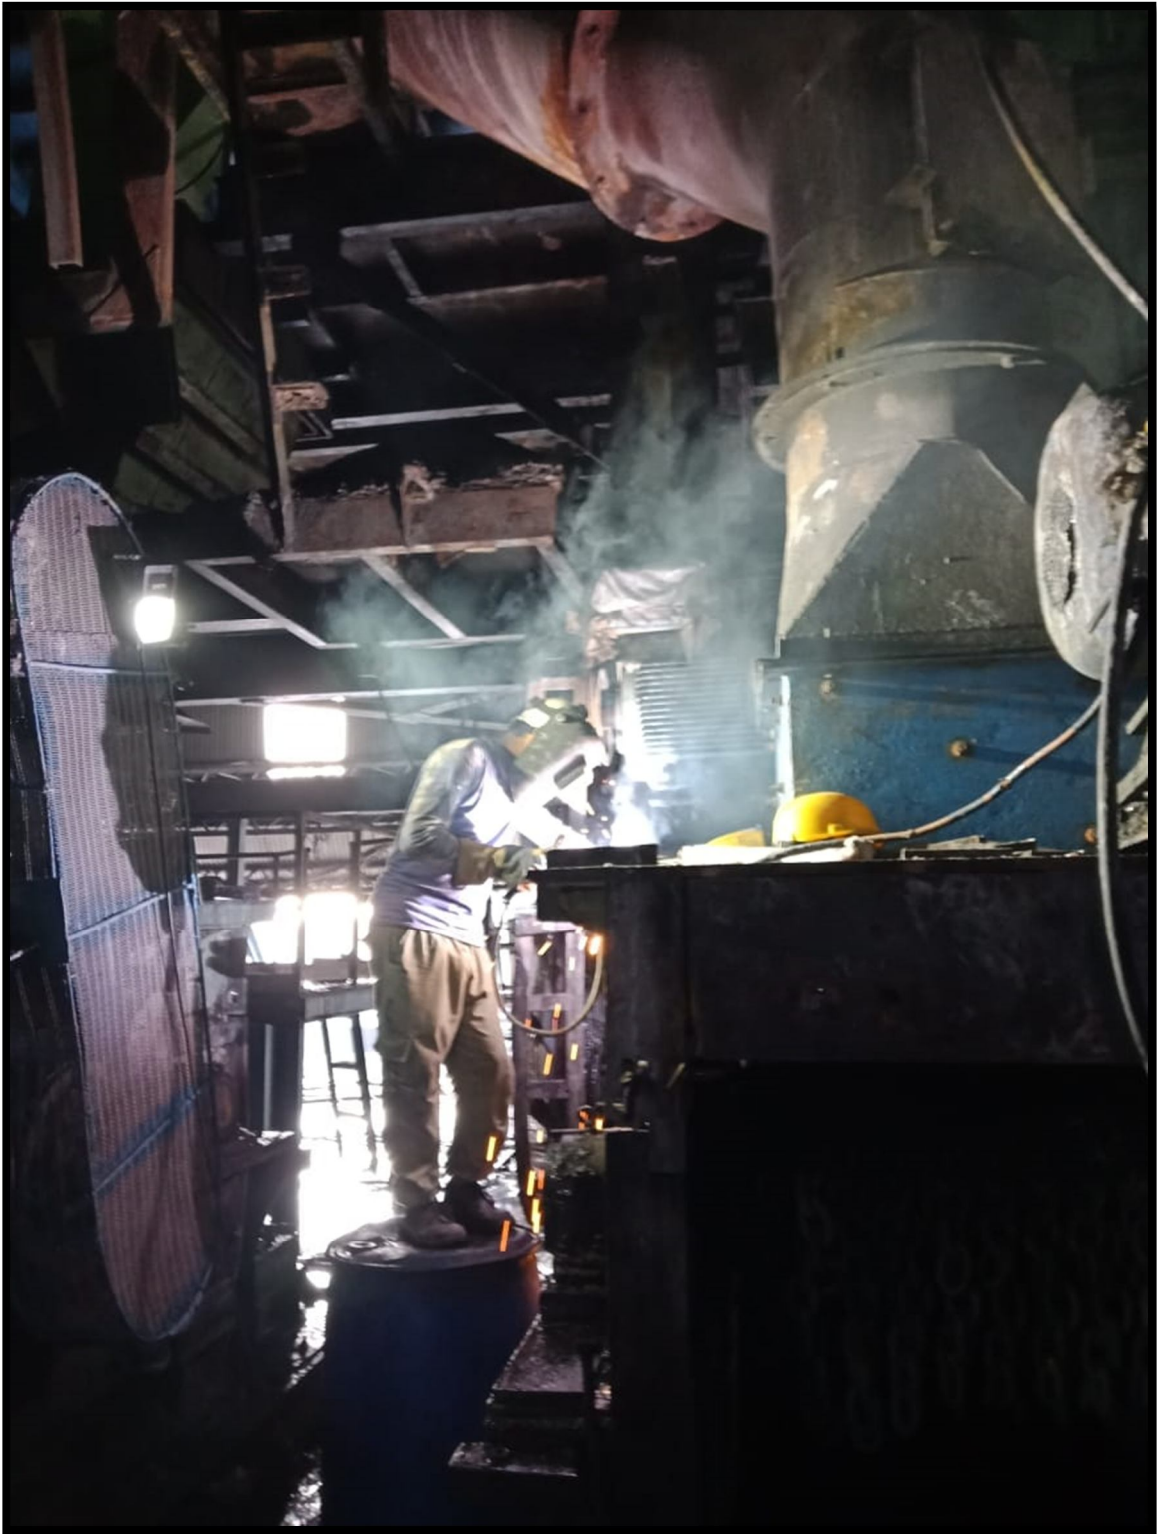
Chainmill Welding Work

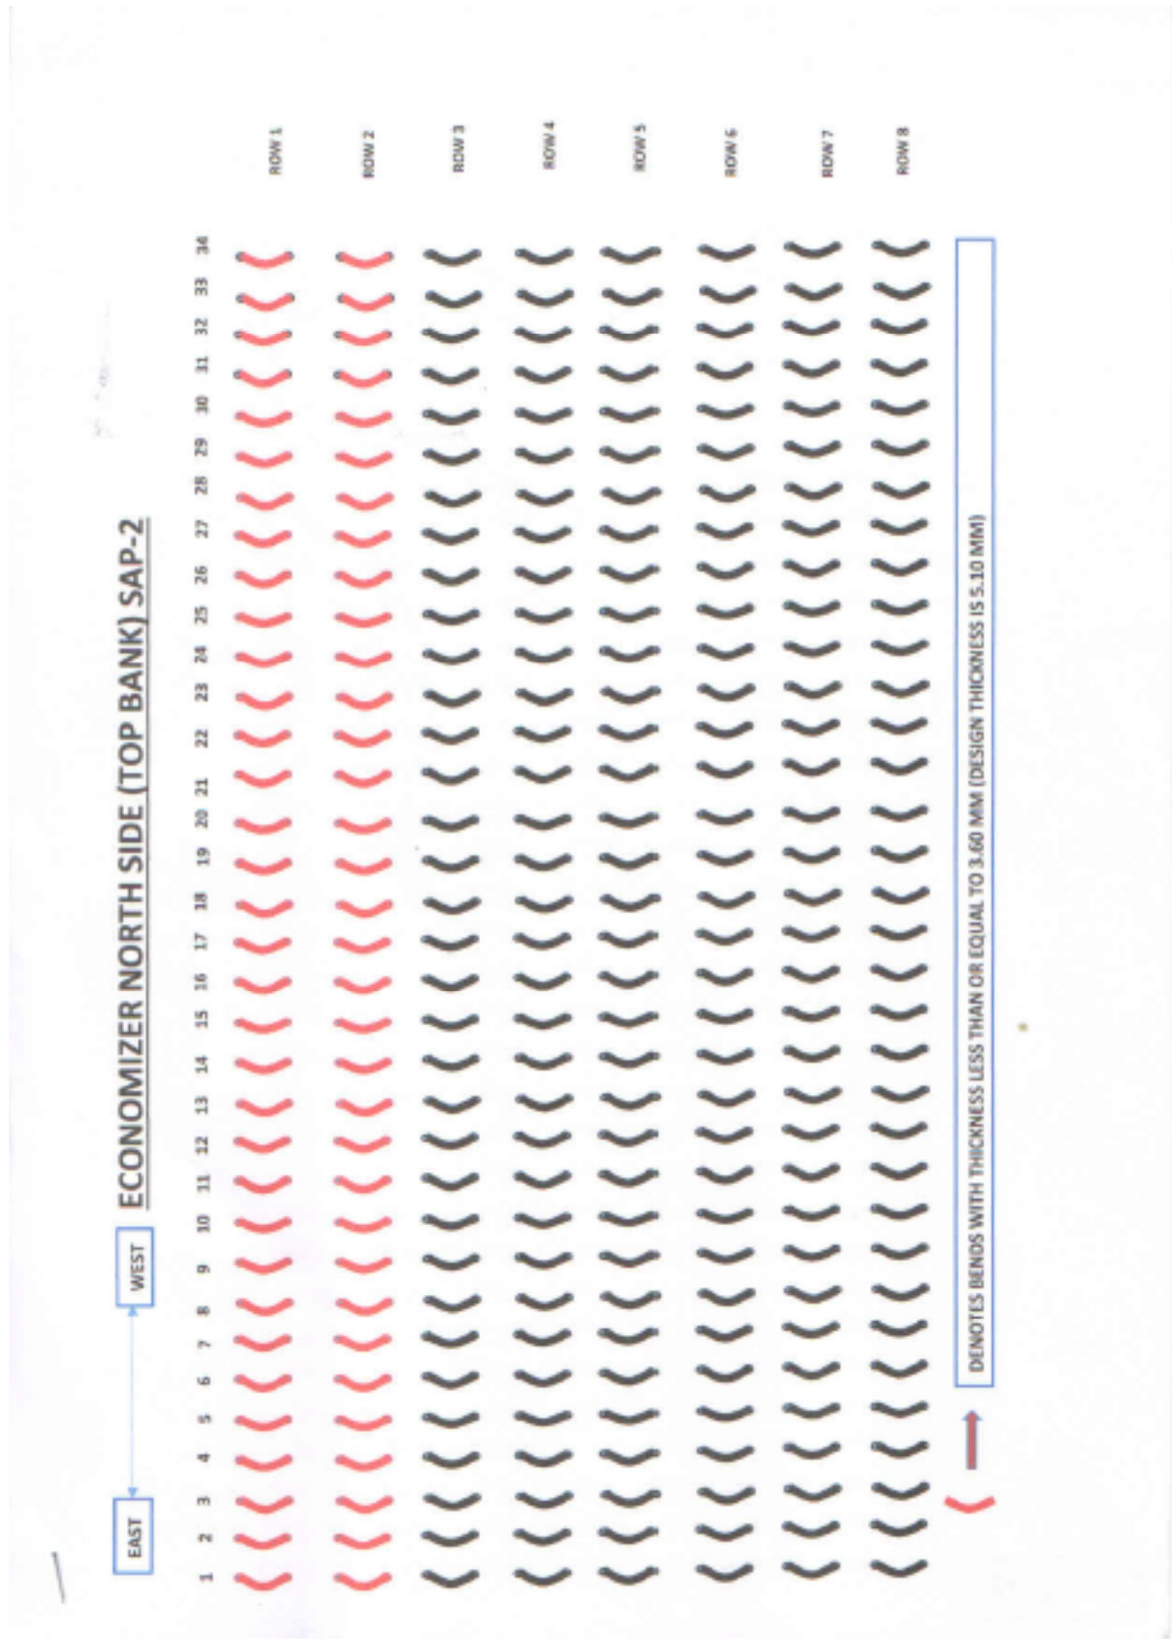
ECONOMISER NORTH SIDE (TOP BANK) FINNED TUBES REPLACED (MARKED IN RED COLOUR)

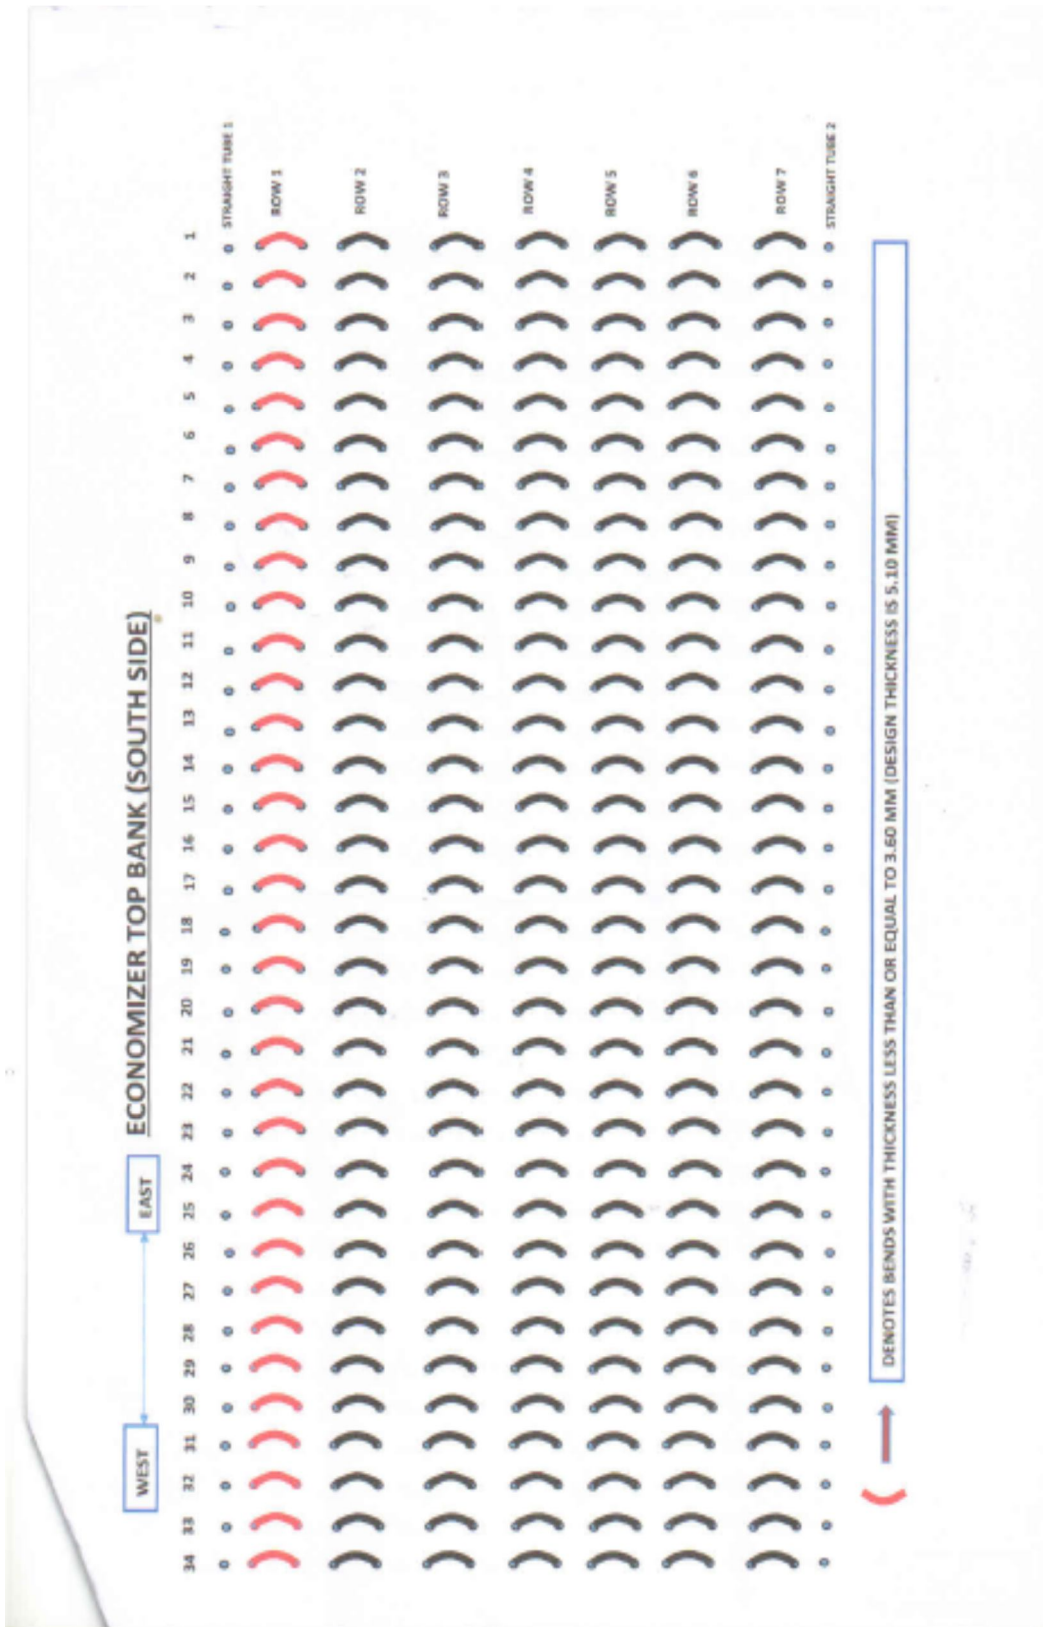
ECONOMISER SOUTH SIDE (TOP BANK) BENDS REPLACED (MARKED IN RED COLOUR)

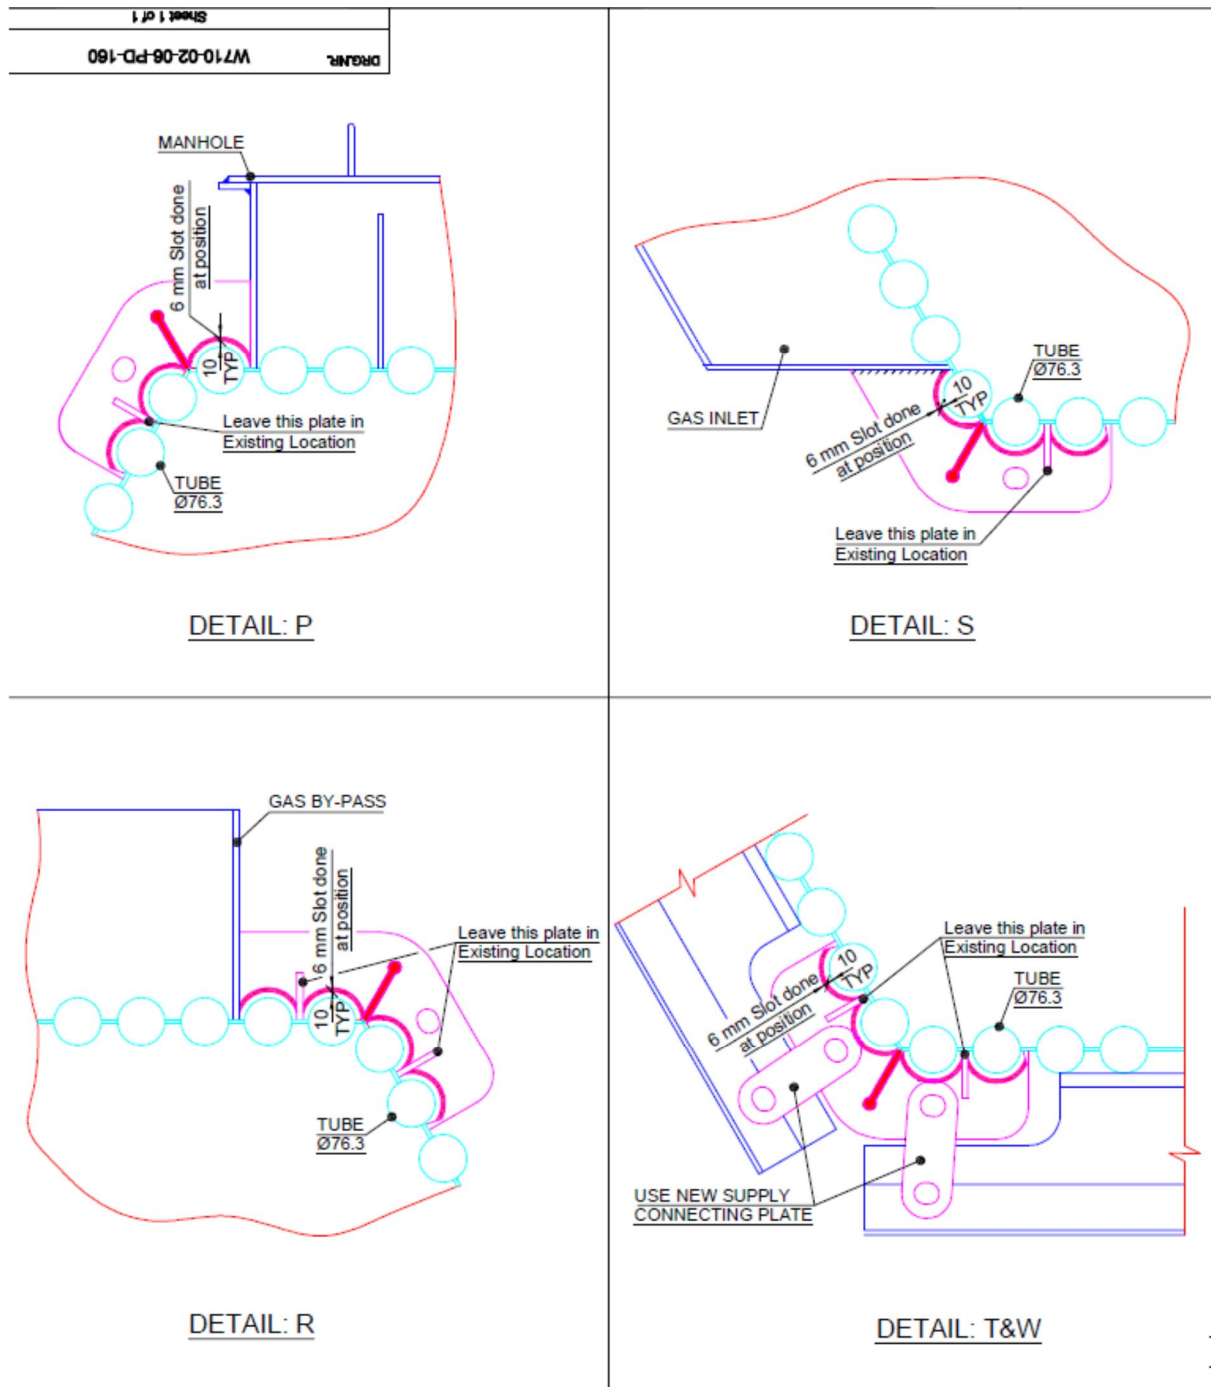
- a) To avoid membrane tubes failures and restriction of thermal expansion at Buck stay, corner plates of buck stay are modified as follows as suggest by M/s Thermal systems (Hyd.) Pvt Ltd

There are total 58 No of corner plates installed where 42 nos out of 42 nos above radiation zone (i.e. above El +7.4 m) are modified- as per following drawing.

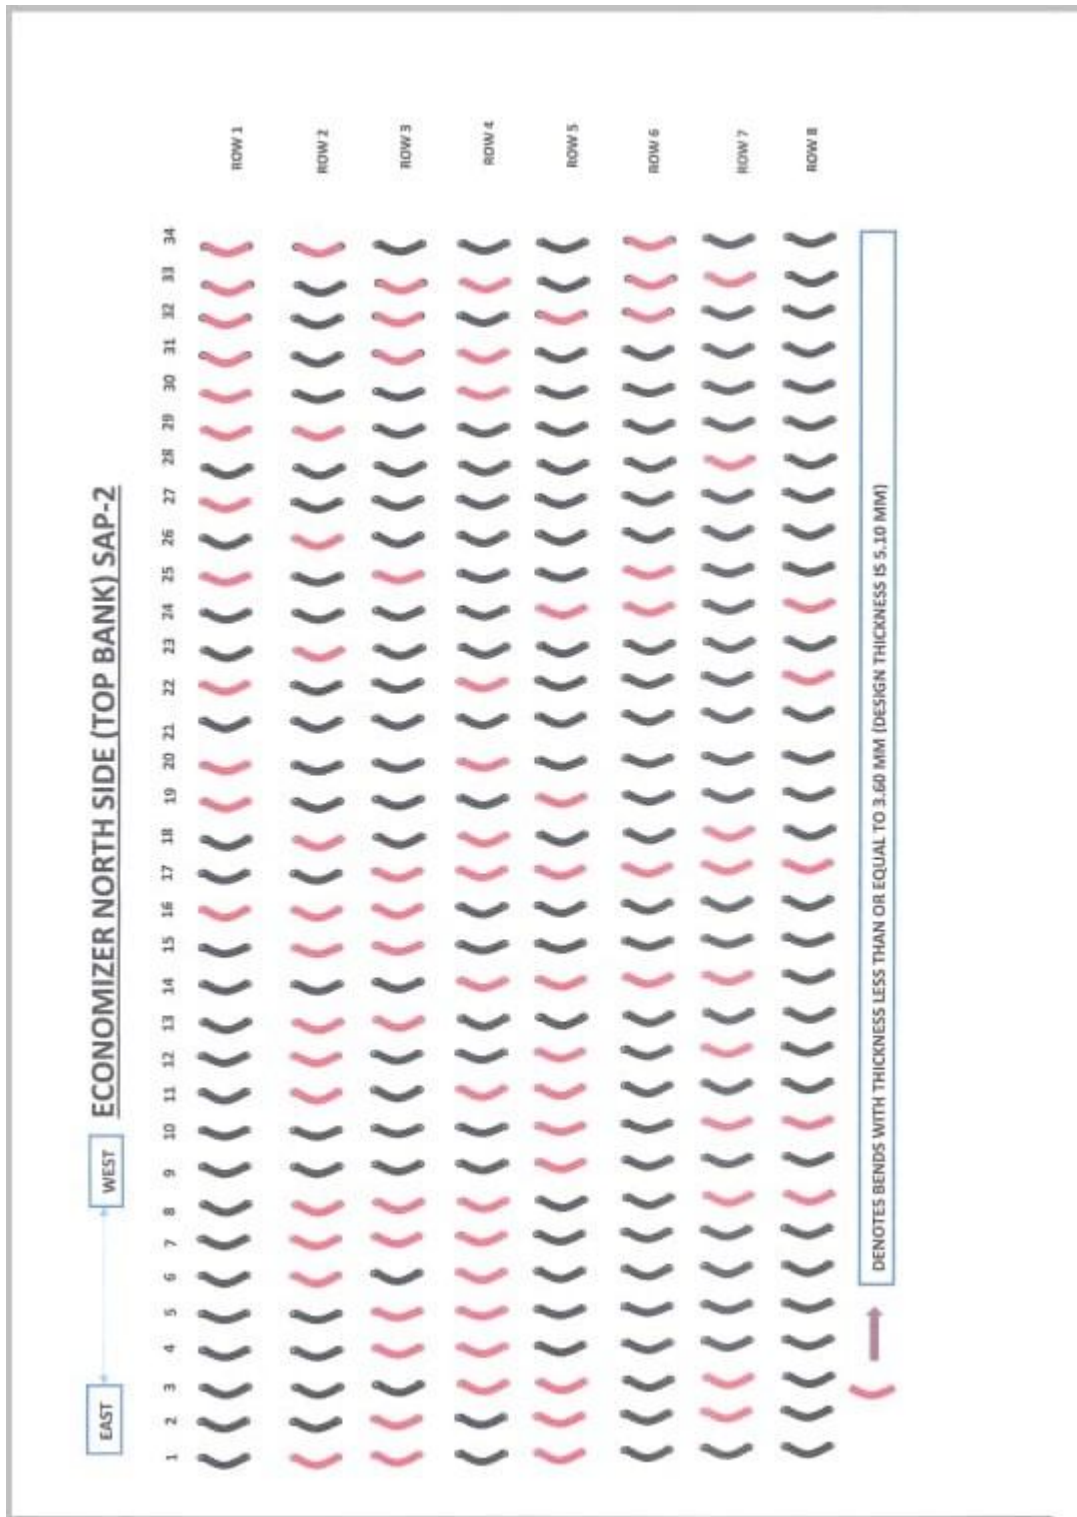
ECONOMISER NORTH SIDE (TOP BANK) BENDS REPLACED (MARKED IN RED COLOUR)
