ATR REPORT-2021

**INDIAN FARMERS FERTILISERS CO OPERATIVE LTD.
PARADEEP UNIT**

ATR REPORT: 2021

DAP PLANT

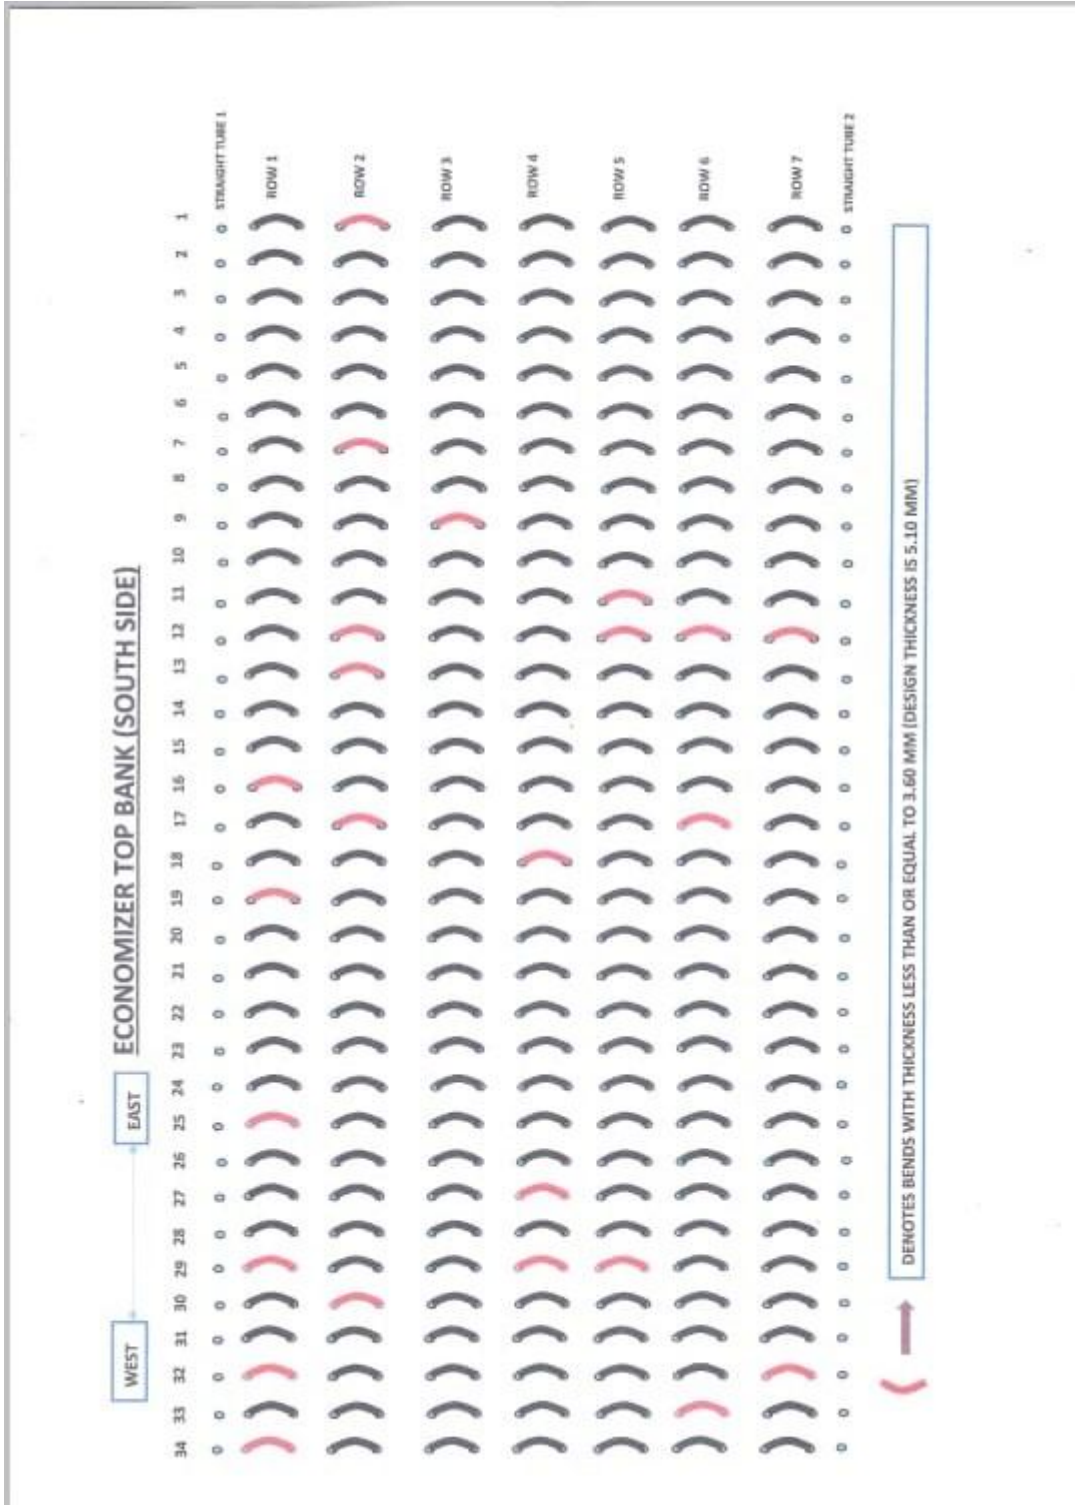
ECONOMISER SOUTH SIDE (TOP BANK) BENDS REPLACED (MARKED IN RED COLOUR)

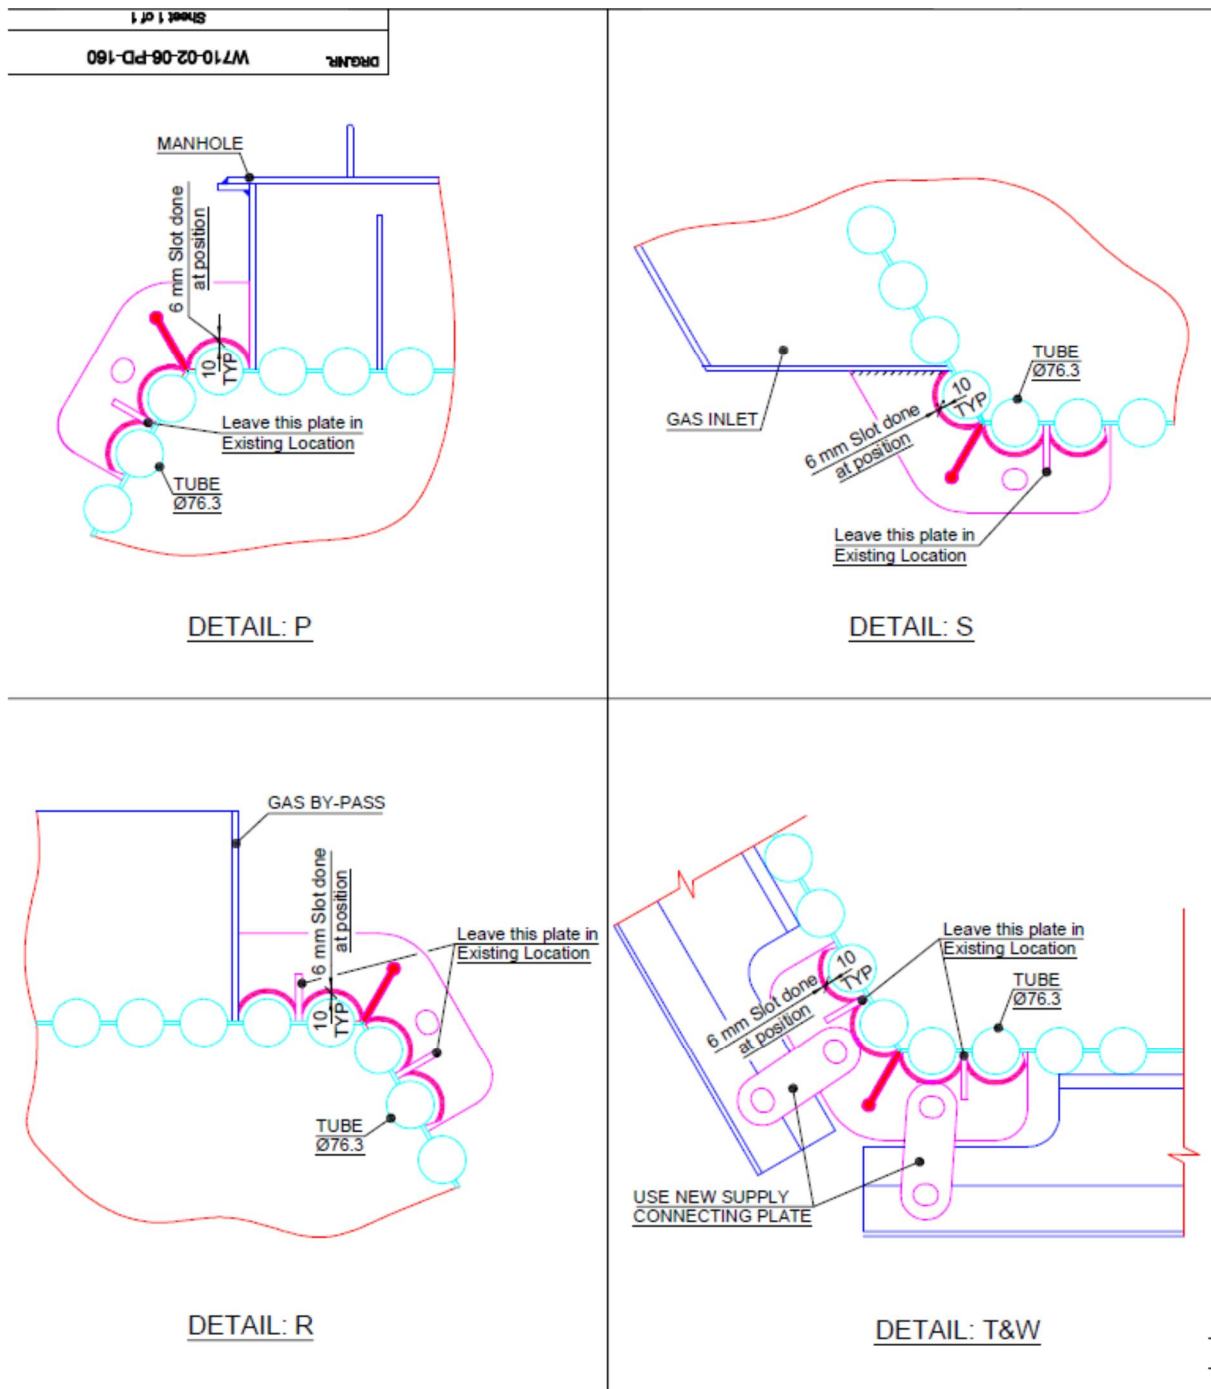
There are total 58 No of corner plates installed where 38 nos out of 42 nos above radiation zone (i.e. above El +7.4 m) are modified- as per following drawing.

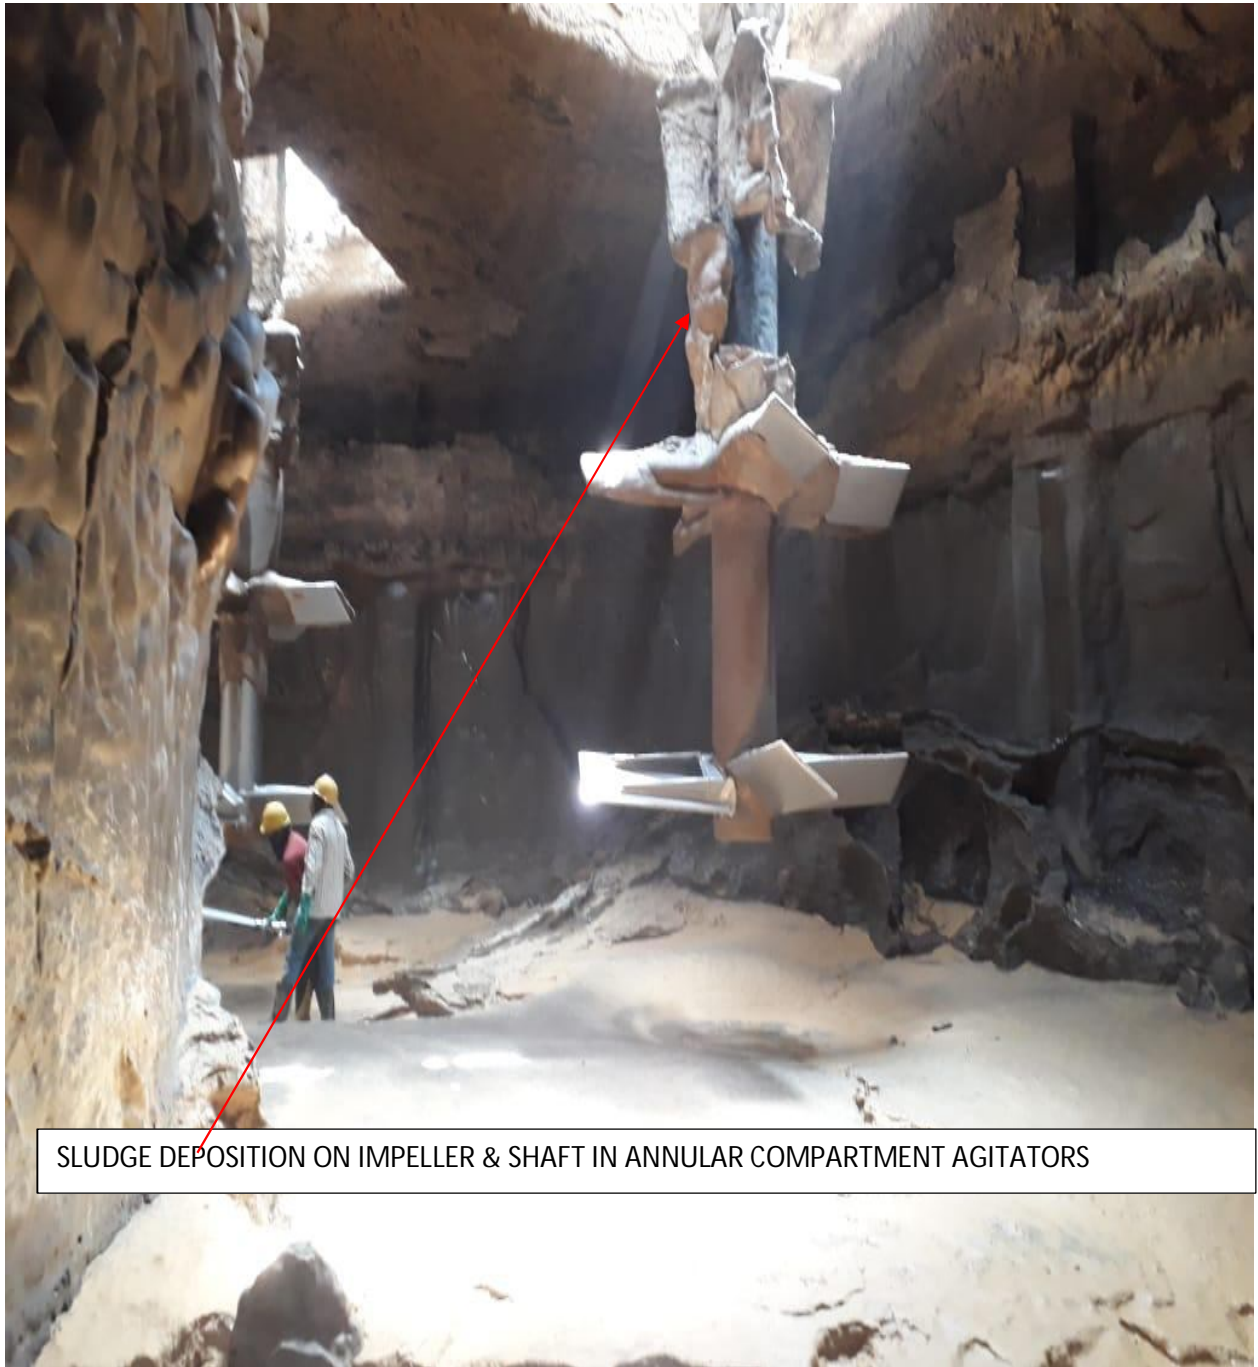
SLUDGE DEPOSITION ON IMPELLER & SHAFT IN ANNULAR COMPARTMENT AGITATORS

Name of Compartment	Total No. of Agitator Installed	Agitator Tag No.	Action Taken	Remark
Annular	7	05-111 to 05-117	All Seven (07) agitators replaced with spare repaired PBT type agitator , MOC: SS-904L as per original design.	<p>Out of Fifteen (15) no. of agitators, 12 agitators were replaced (11 no. repaired agitator & 01 No. New Agitator) and remaining three (03) agitators were in-situ repaired.</p>
Central	2	05-120 & 05-130	Agitator (05-130) was replaced with spare repaired PBT type agitator & Agitator (05-120) was In-situ repaired	
VCFT	2	05-171 & 05-172	Agitator (05-172) was replaced with spare repaired PBT type agitator & Agitator (05-171) was In-situ repaired	
VCST	2	05-141 & 05-142	Agitator (05-142) was replaced with spare repaired PBT type agitator & Agitator (05-141) was In-situ repaired	
Adjustment	1	05-150	Replaced with spare repaired PBT type agitator , as per original design.	
FFT	1	05-160	Replaced with New PBT type agitator , as per original design.

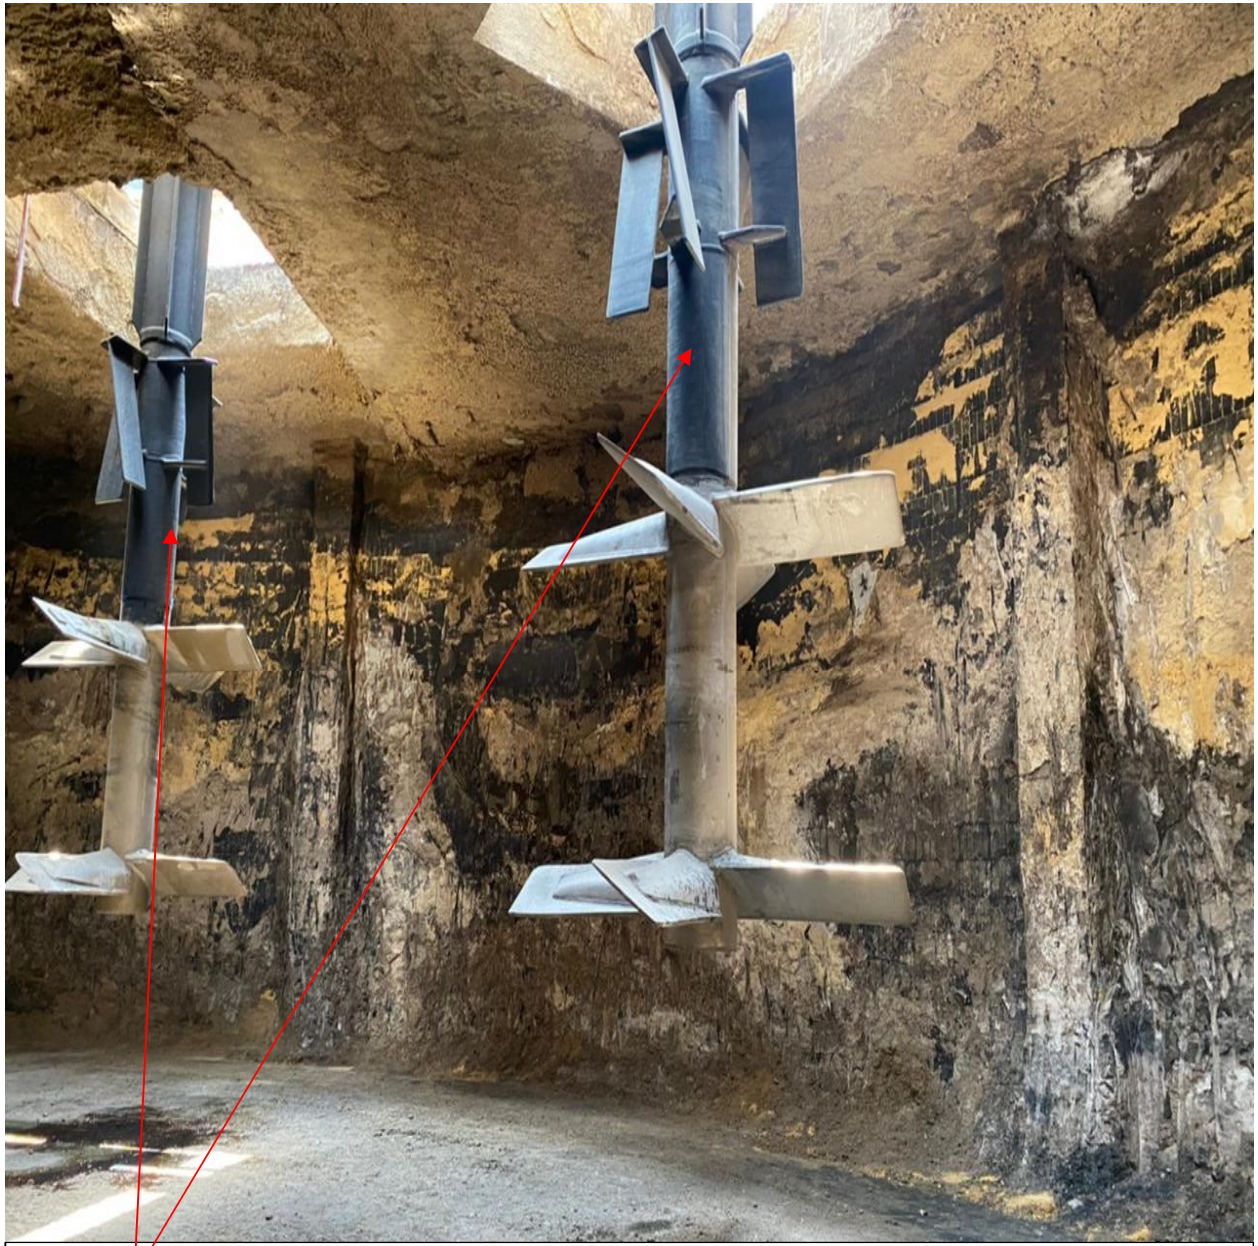
REPAIRED SPARE AGITATORS INSTALLED IN 05-111 & 05-112 LOCATION IN ANNULAR COMPARTMENT.

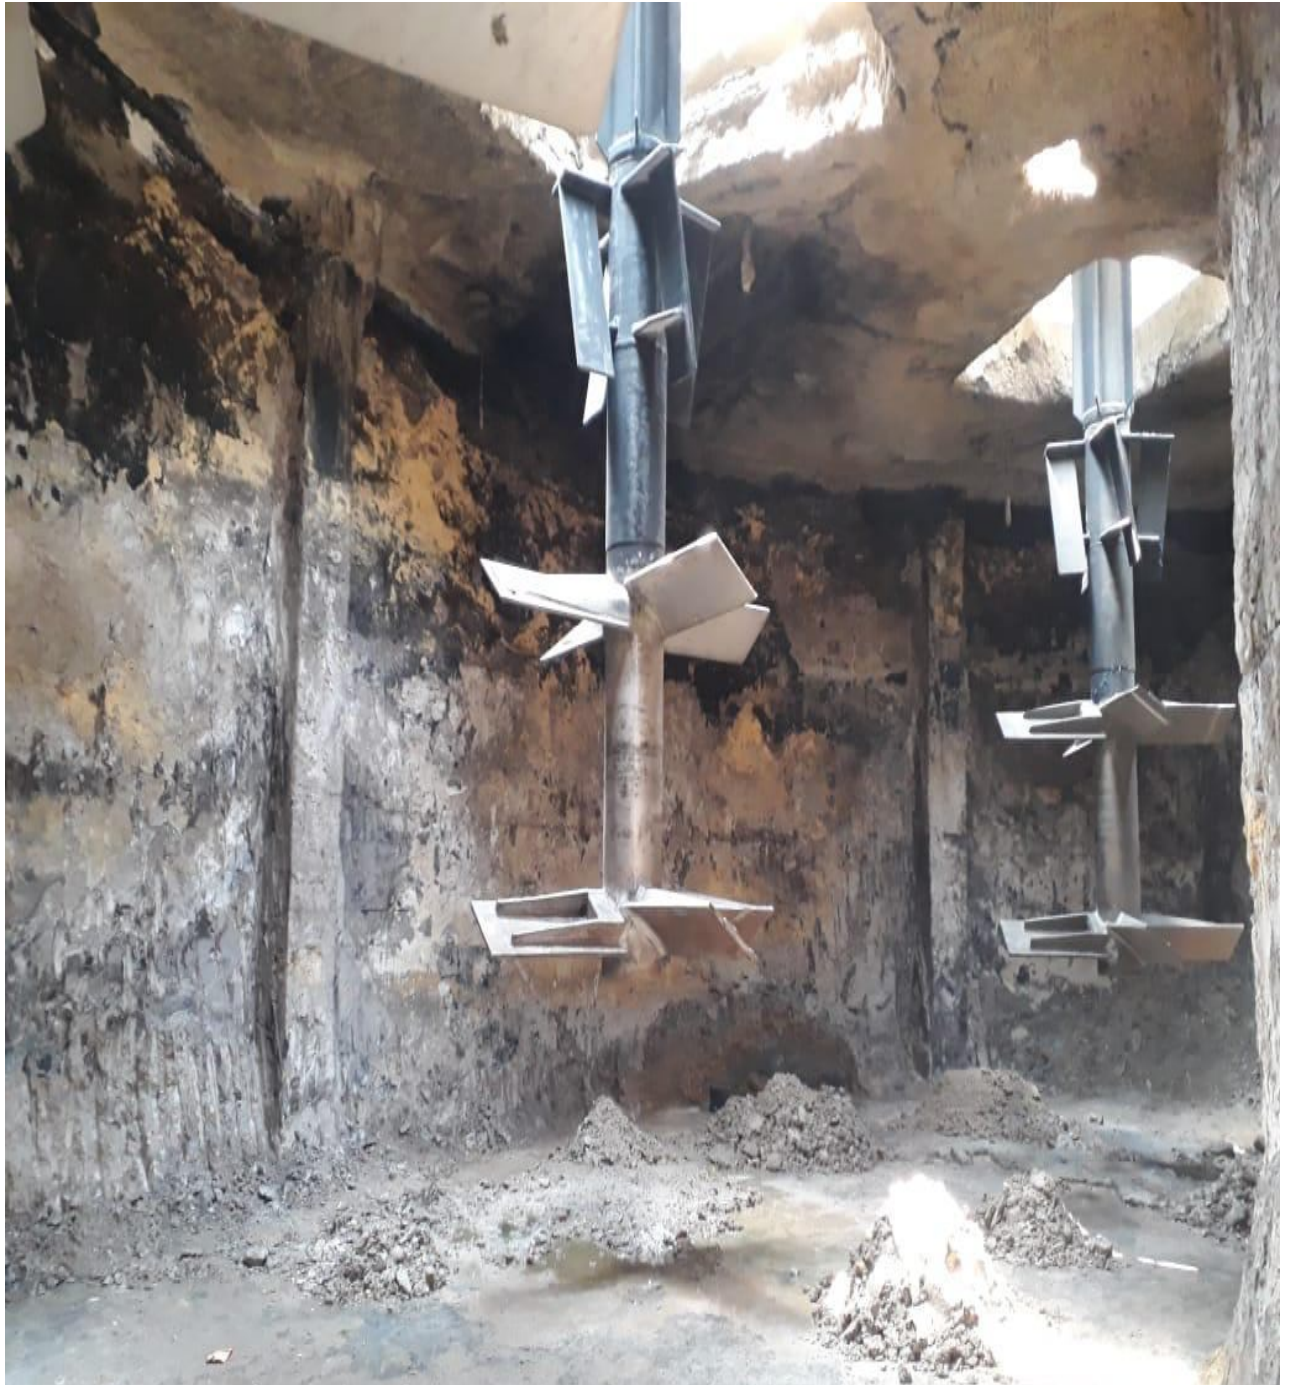
REPAIRED SPARE AGITATORS INSTALLED IN 05-113 & 05-114 LOCATION IN ANNULAR COMPARTMENT

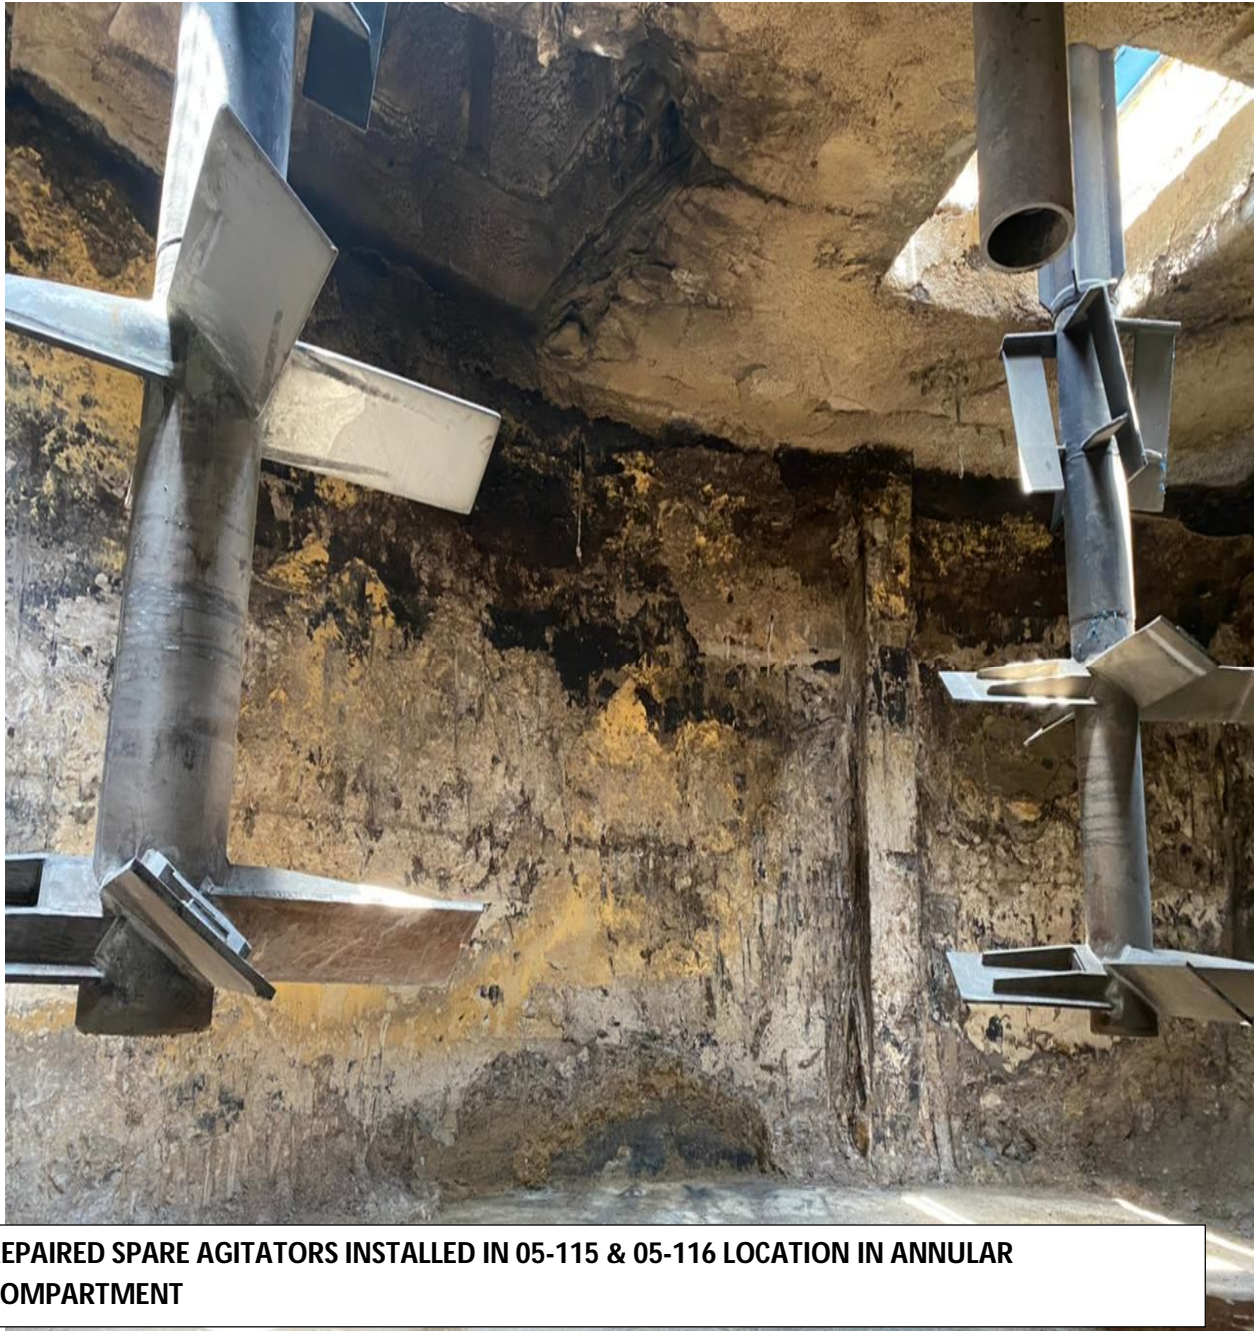
REPAIRED SPARE AGITATORS INSTALLED IN 05-115 & 05-116 LOCATION IN ANNULAR COMPARTMENT

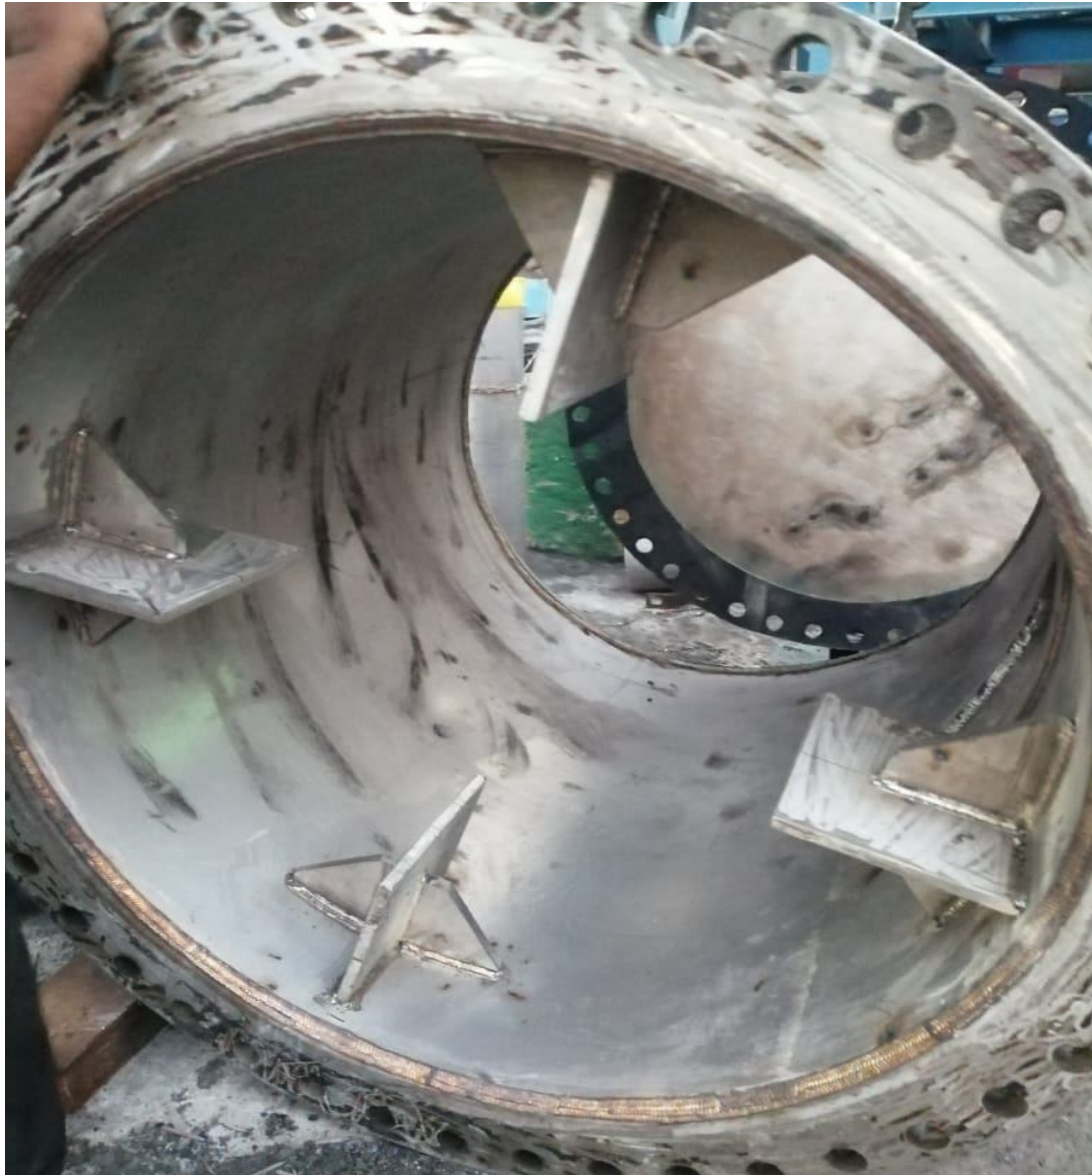
- Suction spool piece, Impeller & Shaft sleeves of the subject vacuum cooler circulation pump, size: 48" NB was found worn out significantly.
- Thus, suction spool piece, Impeller & shaft sleeves of the subject pump was replaced with new one to improve pumping efficiency & overall performance of the reactor circuit.
- Vortex breaker provided in suction spool piece to avoid churning in the pump.
- New Impeller of MOC: Sanicro-28 was fitted by maintaining uniform impeller radial clearance of 4.5 mm around the circumference.
- New rubber expansion bellow of size: 48" NB X 350 mm was provided in the suction & discharge line.
- Complete discharge Pipe-line was upgraded to SS-904L .
- The subject pump was handed over to operation after replacing the damaged pump components as cited above.

VORTEX BREAKER PROVIDED IN SUTION SPOOL PIECE IN (P-113) TO AVOID CHURNING IN THE PUMP

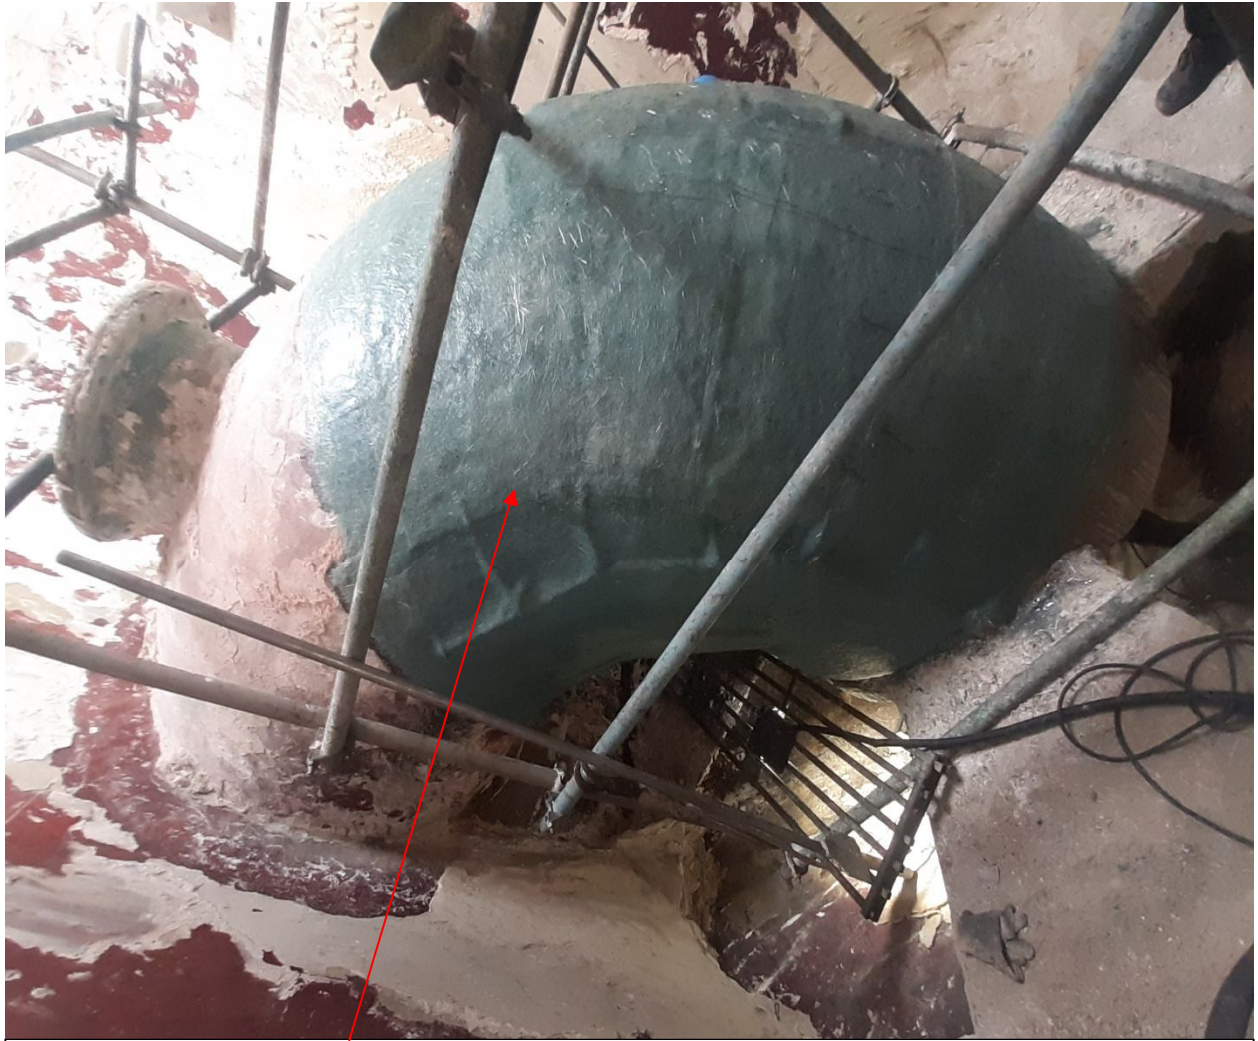
PRE-SCRUBBER INSIDE DUCT REPAIR WITH FRP VINYL ESTER RESIN MATERIAL

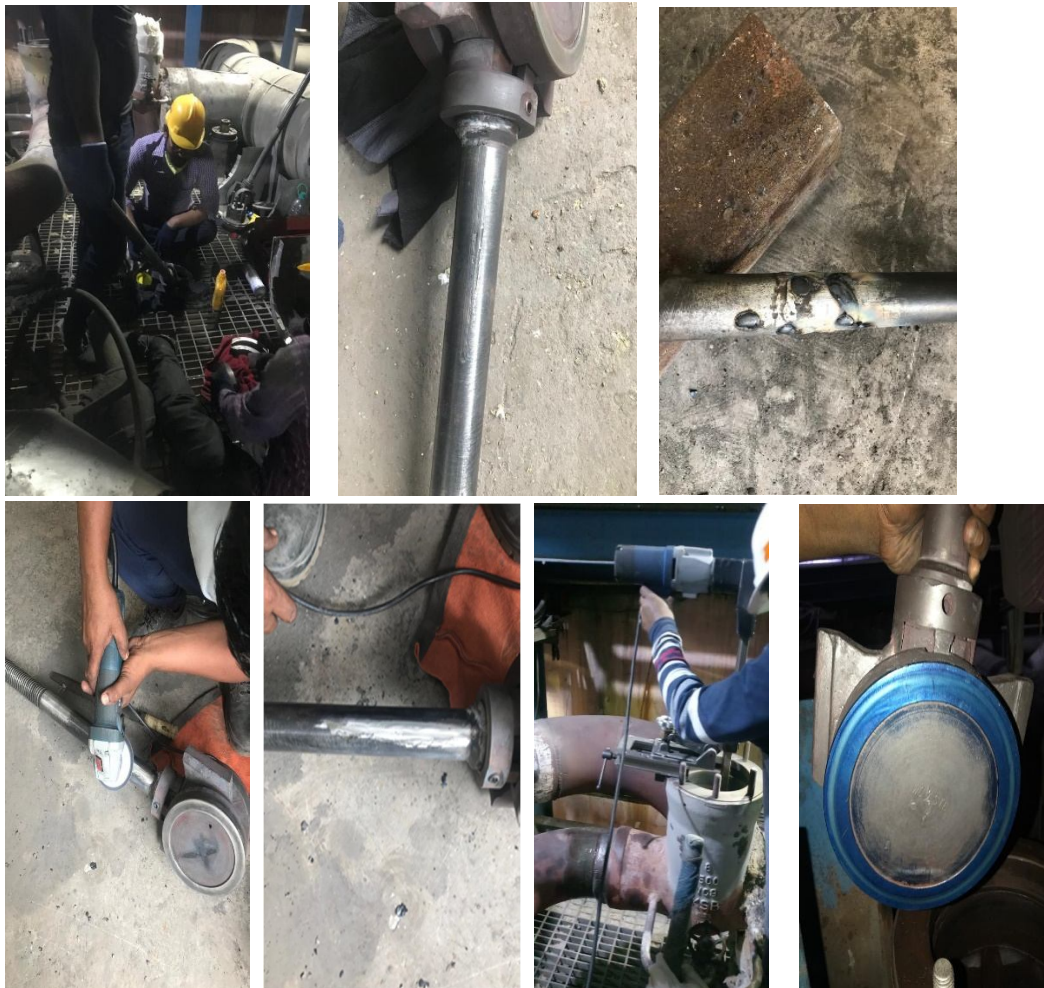
Repairing: - Scratch marks are seen on stem of the valve. Welding was done to repair scratches on stem. ESAB 309 electrodes are used for welding. After welding stem send to workshop for machining and polishing.

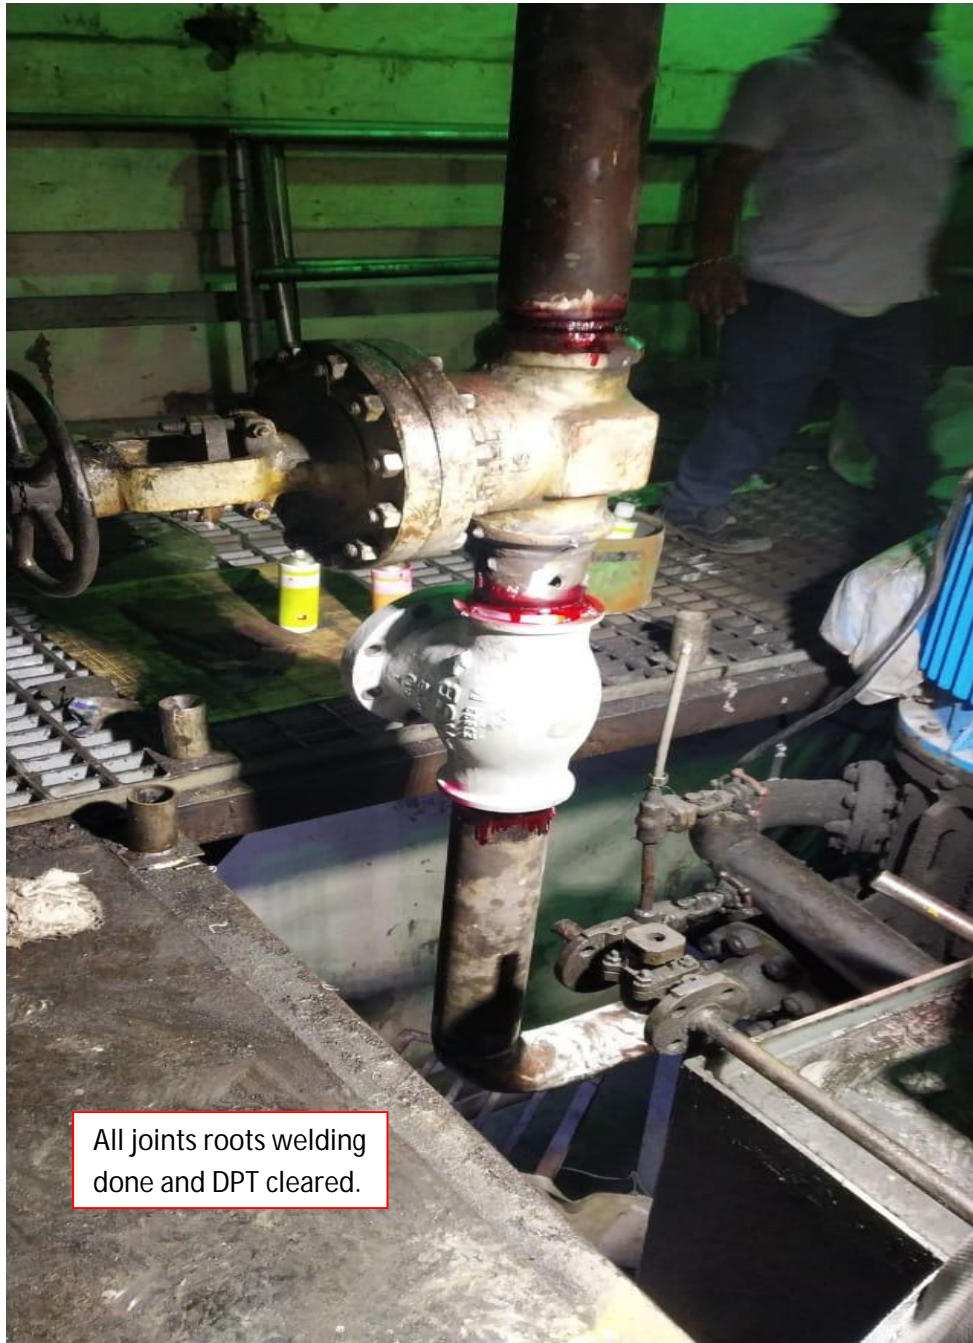
Figure 6: GOP(M) NRV replaced and Valve & NRV relocated

shifted to the oil system room where it was fitted with GOP(M) discharge header. Both end joint roots of that assembly were welded and DP test for all root joints was done.

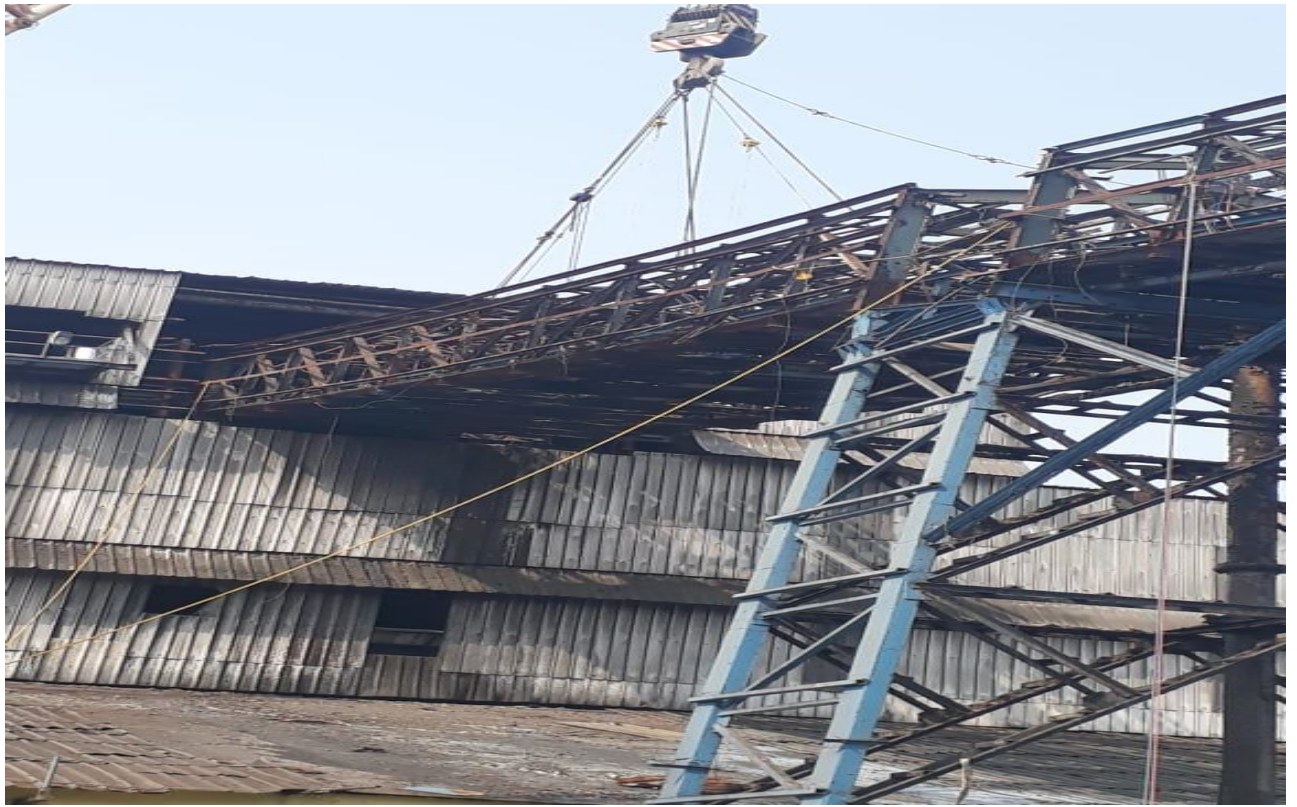
SAGGED PORTION OF GALLERY- BC- 130 /132 – BAGGING PLANT

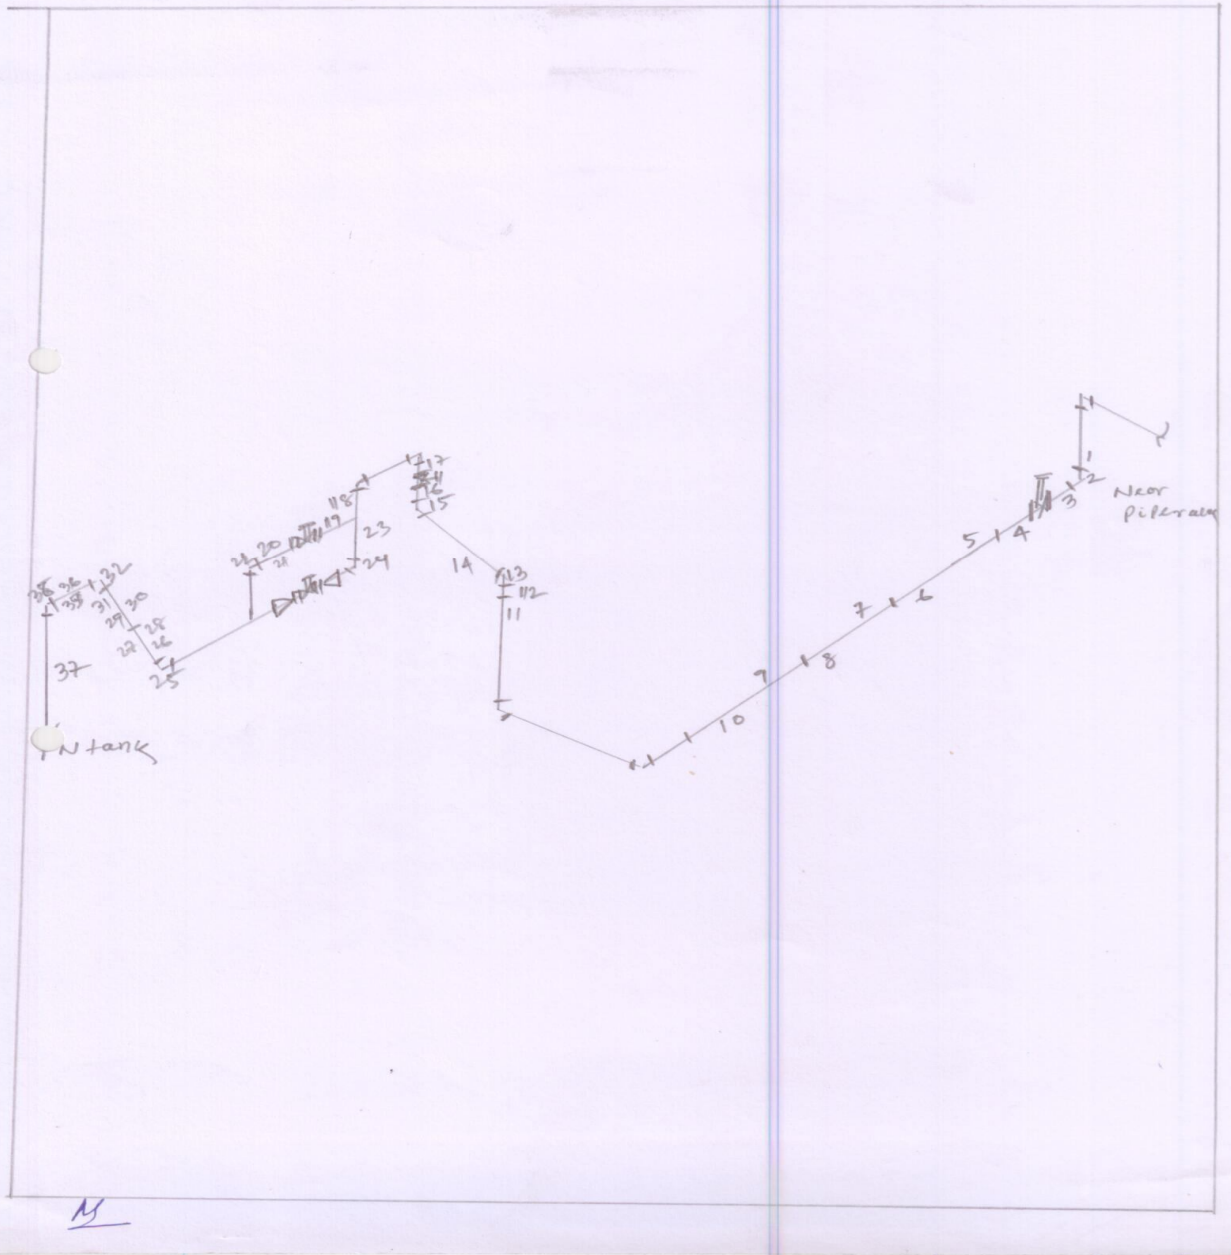
4" NB H₂SO₄ Line from DAP TR#A Pipe rack to
DAP TR#A PN tank

MAXIMUM THICKNESS OBSERVED 6.95 MM & MINIMUM THICKNESS IS 4.41 MM

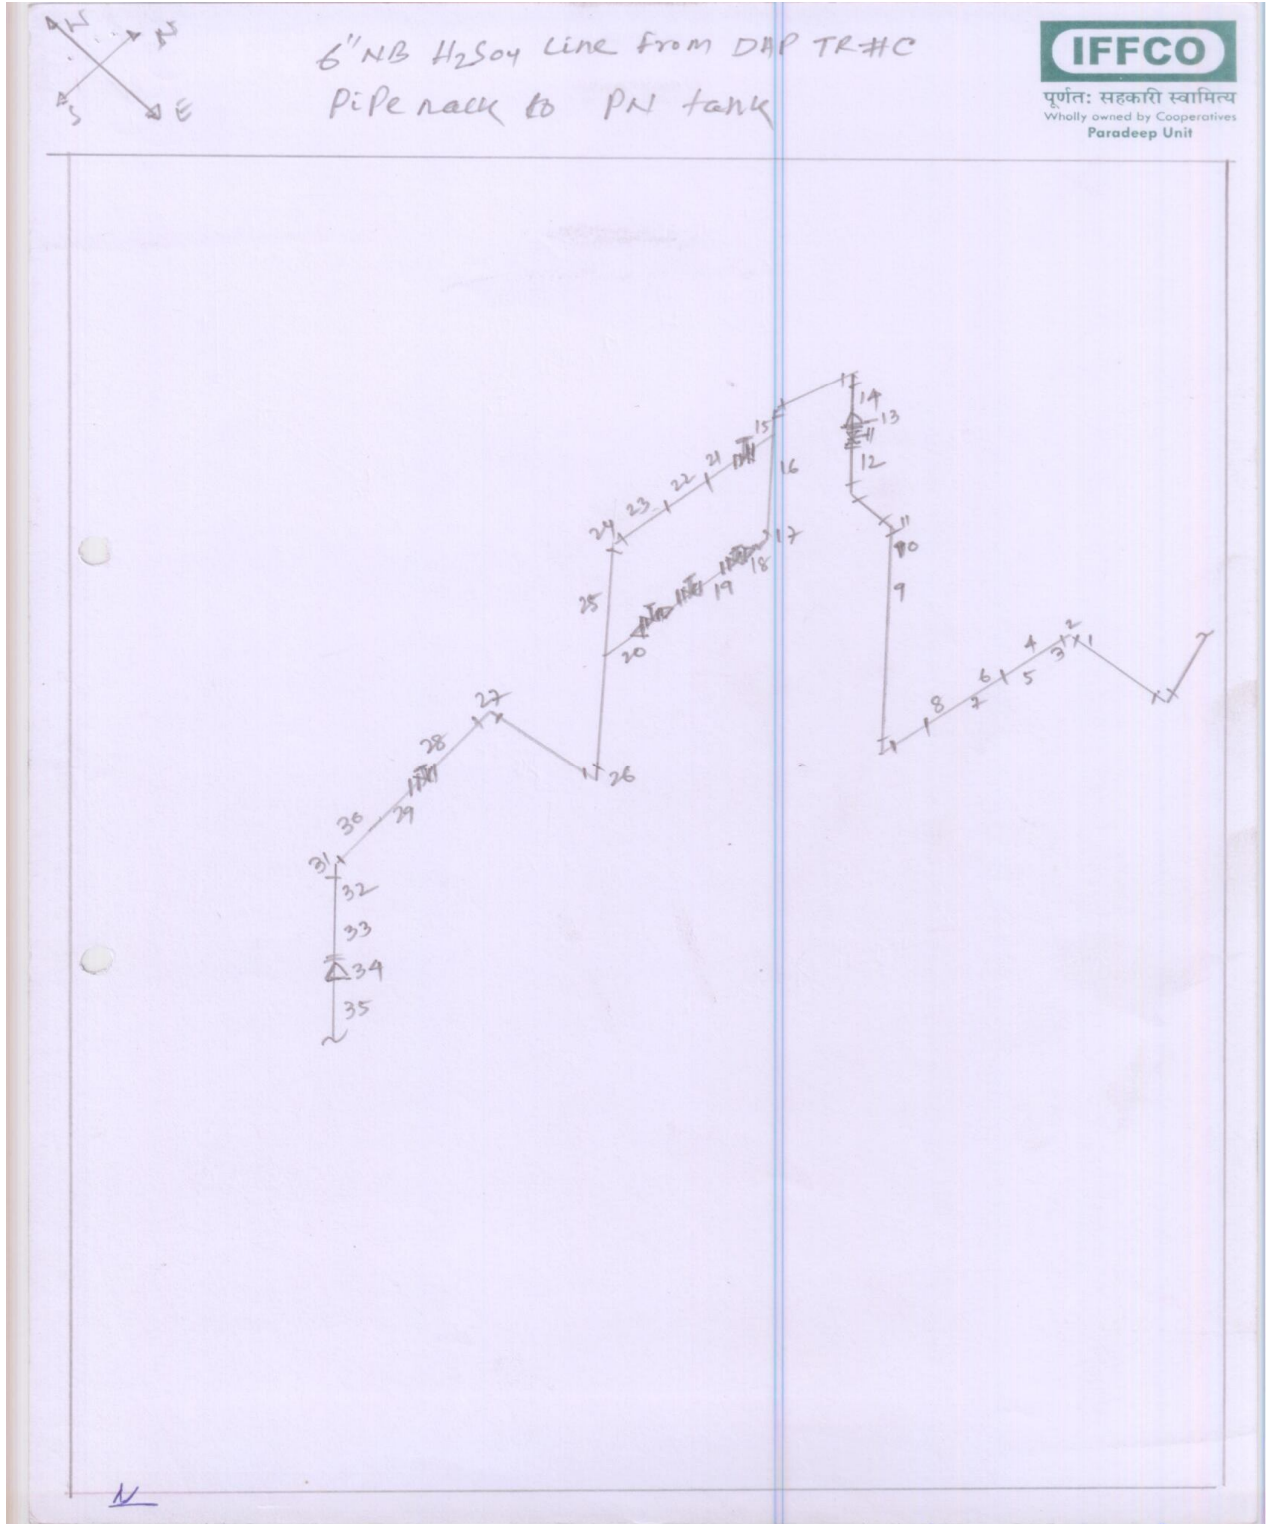
MAXIMUM THICKNESS OBSERVED 6.93 MM & MINIMUM THICKNESS IS 3.92 MM ON BEND AT SL NO: 27 (DESIGN THK: 6" NB SCH 40 (7.11 MM) & 4' NB SCH 40 (6.02 MM) LINE DIAGRAM OF 6" NB SULPHURIC ACID LINE FROM DAP TR # C PIPE RACK TO PN TANK IN DAP TR # C.
