## **REPORT ON FAILURE OF VACUUM COOLER CIRCULATION PUMP (01.113) IN PAP ON 07.04.2014 AT 21:15 HRS**

**Dated: 10/04/2014**

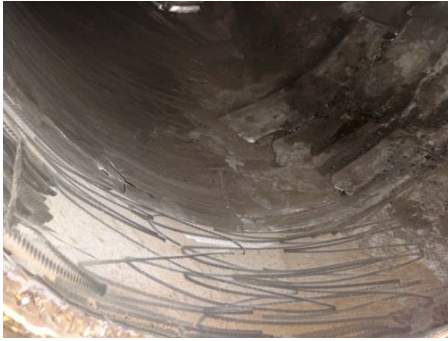
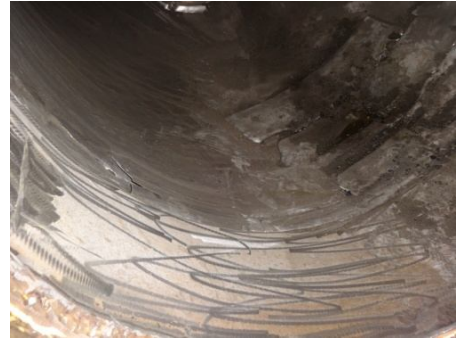
- The pump was in open condition, casing has been patched at several locations due to corrosion and erosion.

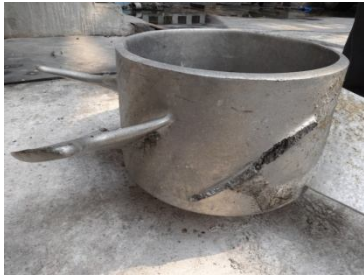
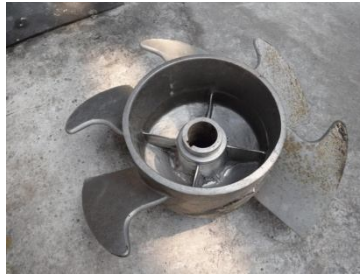
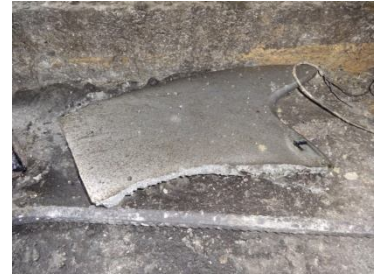
- Pump was in dismantled condition. One vane of the impeller (RECO supplied) was broken from the root.

Description	Original thickness, mm	Thickness @ failure, mm
904 L Liner / wear ring	16	5.92 to 8.53
Impeller blade	26.2 to 26.9	7.39

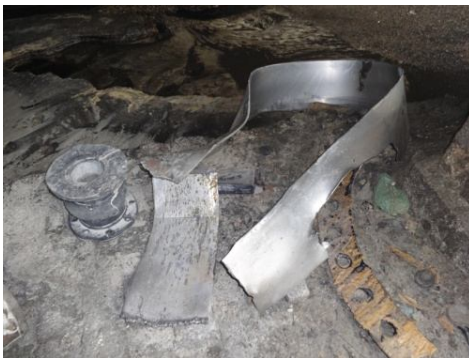
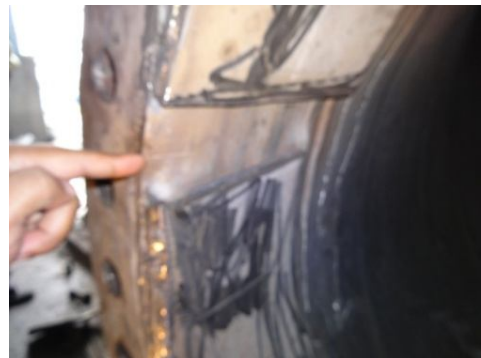
- VCCP 01.113 failure may be due to erosion of the 904 L liner / wear ring (last replaced on 24.02.14) and which would have loosened in the casing of running pump, leading to pump impeller sticking up in the liner leading to jamming of the pump. This would have broken the pulley of the pump into pieces as motor was in running condition. This also led to bending of the pump shaft. The eroded and buckled liner can be the reason of pump failure.

- 16 mm thick 904 L liner (wear ring) had wear & tears / thinned and it was in buckled condition. New liner with 16 mm thickness was already provided in the casing.

- 6) Due care shall be taken in welding of the 904-L liner in the pump casing to avoid detachment of liner.
- 7) Proper record of periodic checking for all equipments, history of equipments, log sheet for field instruments etc. shall be maintained.

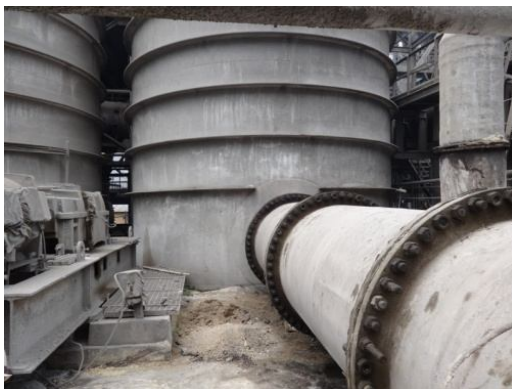
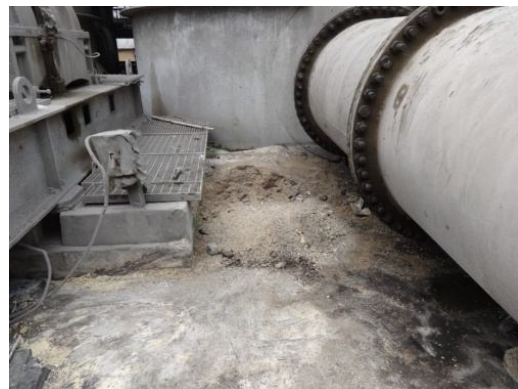
- PAP was in operation with 100 % Peru rock on 09.04.2014. Small quantity of pebbles was coming out from the reject chute through Trommel screen of the ball mills.
- There was sound from Mills Sludge Tank (MST) pump due to pebbles in the slurry flowing to SST.
- Ball mills A, C and D were in operation with Peru rock since morning shift. The Rock screens of all ball mills were not in line. The Rock screens of all the ball mills seems to be bypassed and not in operation since long.
- Huge quantity of small size pebbles were being collected near the vacuum cooler outlet pipe to reactor and same was being loaded to the tractor trolley.

- 2) The Trommel screen operation for all ball mills shall be checked every hour with respect to rejection of stones / pebbles through reject chute and appropriate corrective action shall be taken by operator / technician if it is not rejecting the oversize stones / pebbles.

- 3) To keep the vibrating Rock screen at SST inlet always in line to avoid pebbles going to the SST and subsequent pumping to the reactor. To avoid chocking of the rock screen and also to avoid overloading of the ball mills, it is suggested to increase the screen size of rock screen from existing opening of 10 mesh (1.615 \* 0.991 mm) to 7 mesh (2.794 mm). This can avoid > 2.8 mm size pebbles going to reactor (about 80 % stones going to reactor may get reduced)..

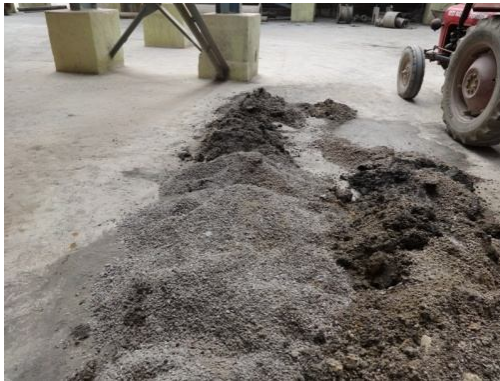
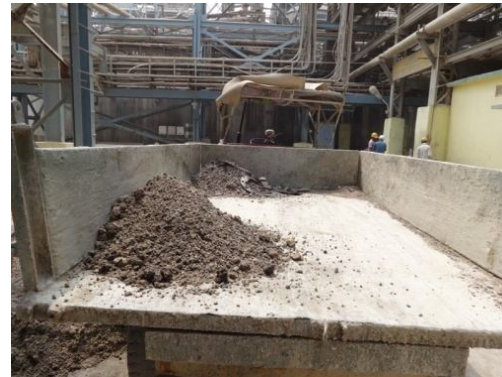
- The sample of pebbles was analyzed and it indicates + 4 mm size pebbles 68.4 %. The sieve analysis of pebbles sample is given below:
