**REPORT ON ACCIDENT OF Mr.A.R.KHAN DUE TO FLASHOVER IN PDB-2  
INSTALLED AT BAGGING PLANT MCC ROOM ON 02.05.2014**

## 2.0 Observation of Committee at site

## 3.0 Possible Reasons

#### **4.0 Recommendation by Committee**

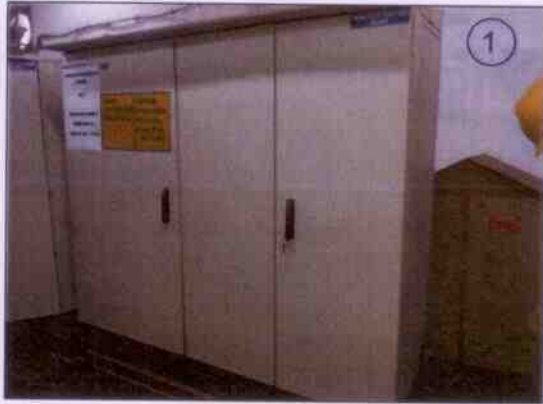
POWER DISTRIBUTION BOARD - 2

- a) PDB-2 (Power Distribution Board) has one incoming feeder of 400 A rating, 1 no.200 A SFU (Switch Fuse Unit) type outgoing feeder & 5 nos.of SFU type outgoing feeders of 63 A each.

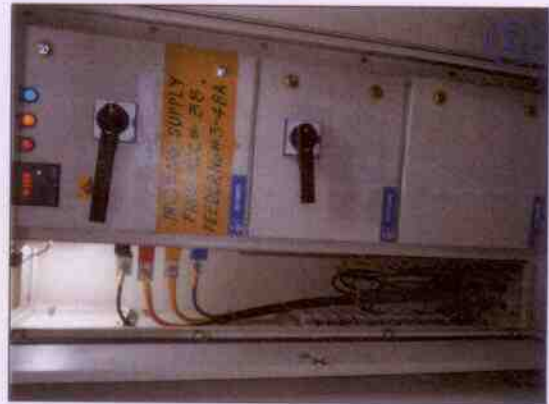
INCOMER, FEEDER No.- 1F2 &1F3

- b) There are 6 nos.of 4P MCB (Miniature Circuit Breaker) of 63 A each were installed in Feeder no.2F3 in two separate row.
- c) Incoming supply to all of the above MCB is taken from 200A SFU, Feeder No.1F3.

- f) As reported the feeder no.1F3 from which power supply of all 6 nos.4P MCB is connected was in energized condition. The particular MCB in which fan was connected switched off before disconnection.

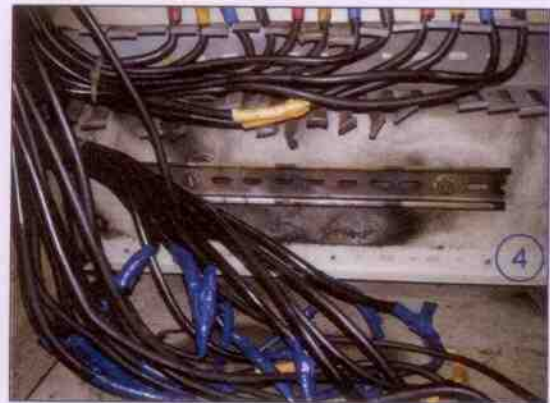
- d) At the time of visit bottom row damaged MCB found removed & all incoming and outgoing cables wrapped with PVC tapes (Photo attached)
- e) As reported by electrical in-charge temporary connection for the single phase pedestal fan was taken from one of the 4P MCB directly from the MCB outgoing and accident occurred during disconnection of fan.

- g) Heavy deposit of carbon particles observed at incoming side of bottom row MCB indicating that flashover might have occurred in incoming side of particular MCB.

FLASH OVER LOCATION WITH MCB REMOVE CONDITION.

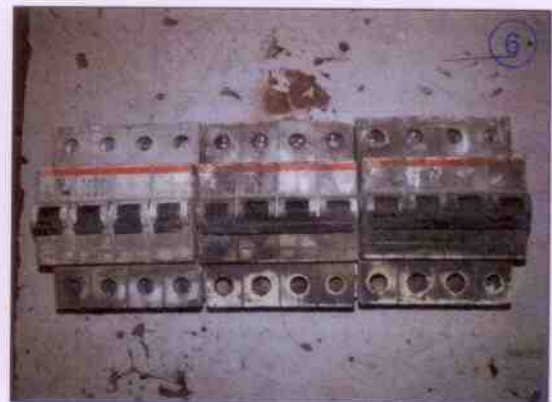
DAMAGED MCB FRONT VIEW

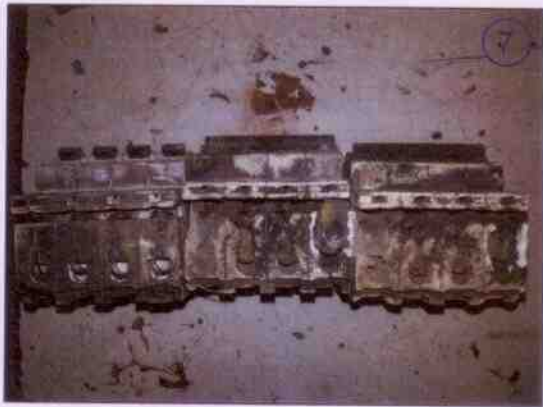
DAMAGED MCB INCOMING SIDE VIEW

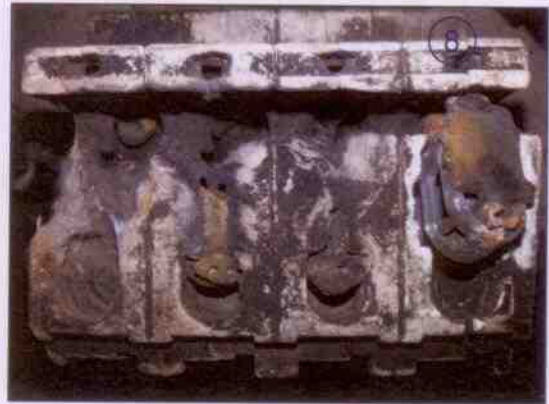
DAMAGED MCB -1

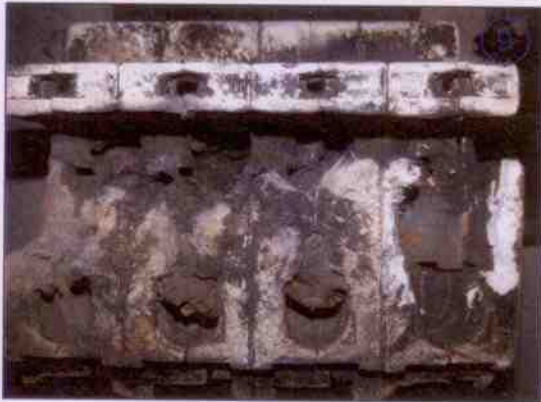
DAMAGED MCB -2

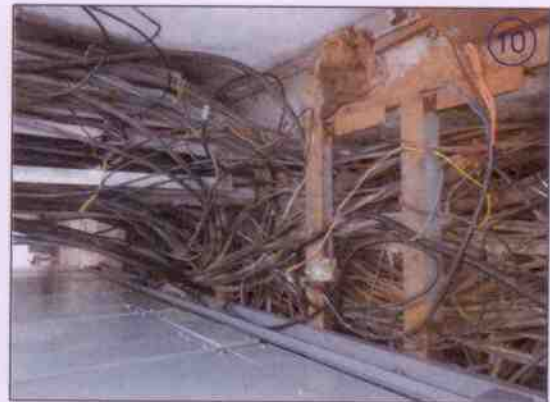
CABLE DRESSING REQUIRED

- j) Cables shall be properly dressed on the trays in the incoming cable trays behind the newly installed Bagging MCC room.
- k) Call station of PA system may be installed inside MCC room for communication in emergency.

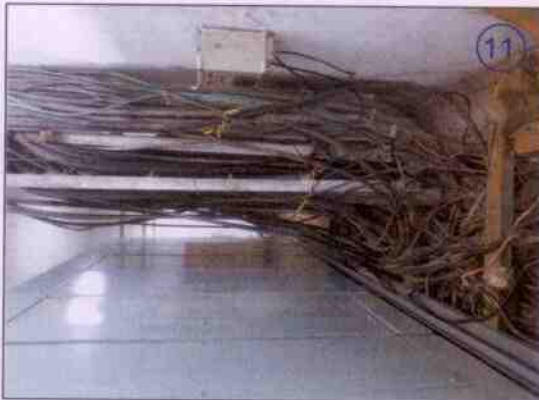
CABLE DRESSING REQUIRED

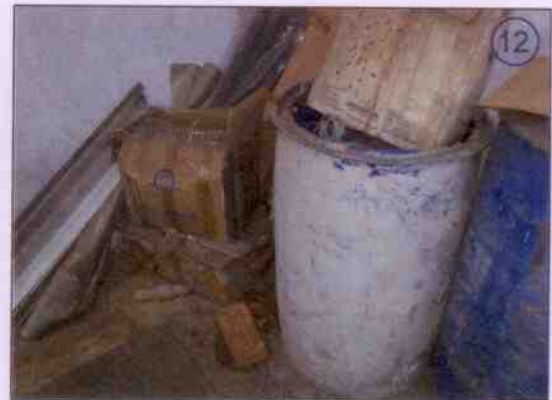
UNWANTED MATERIAL TO BE REMOVED

- h) Storing of unwanted items inside the MCC room may be avoided.
- i) Some live panels found in open condition due to temporary connection of live cable above the floors. Hence all looping cables laid should be removed if not required otherwise they should be taken through gland plate with proper glanding & termination.
