**INDIAN FARMERS FERTILISER
COOPERATIVE
LTD, PARADEEP, ORISSA**

March- 2013

Health survey of the existing plant structures at IFFCO
Paradeep Unit.

INSPECTION REPORT
For
Condition Assessment
For
“BOILER HOUSE”
Of
A F B C BOILER PLANT
At
Paradeep, Orissa.

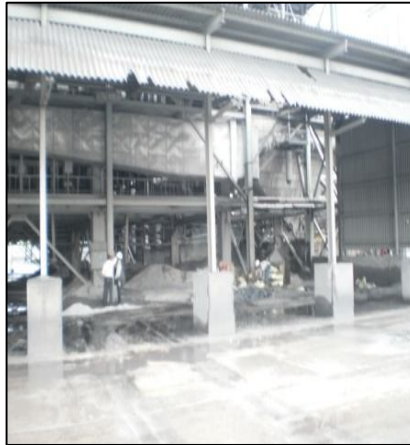
5. East and west side structures are in the form of shade used to store raw material. Columns of the shade have been constructed with new RCC pedestals. Some steel columns noted bent due to hit of vehicles.

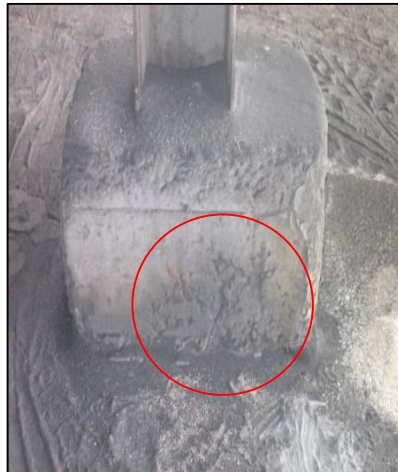
At Ground floor

- The foundation are encased with RCC pedestal; noted with honey combing and deposition of raw material

➤ **Honey Combing / Cracks:-**

- These areas shall be grouted with cement grouting with addition of non shrinking additives.
- Aluminum / PVC multiperforated nipples may be used to carry out the injection operation.
- The pressure of 1.00 to 1.5 kg per sq cm may be applied for grouting.
- Care should be taken to remove trapped air inside the crack / honey combing areas to avoid back pressure.

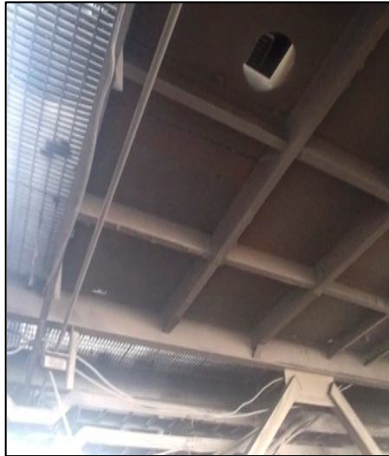
At 3.35 level

- Structural platform noted with minor to severe corrosion, also noted localized missing of welding and cleat angle. Holes were made in the platform as per the process requirement.

➤ Few General distresses like Existing corrosion of the steel members shall be removed as per standard method and all the Structural Steel members shall be treated with application of 3 coats of 'SUNPUGUARD' (a high quality Anti corrosive two component Polyurethane coating) or equivalent as per Manufacturer's recommendations. Proper surface preparation of all Structural Steel members shall be done before application of SUNPUGUARD or equivalent, as per manufacturer's recommendations.

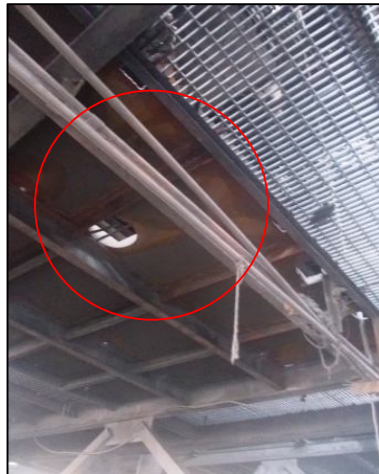
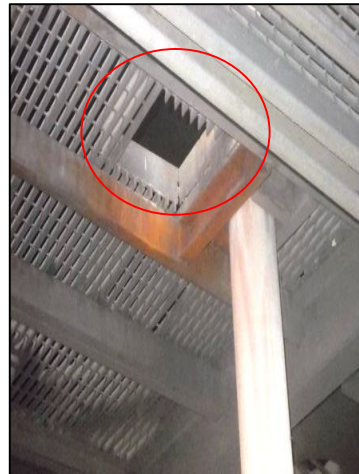
At 3.35 and 3.60 level

- Severe corrosion noted at localized area.

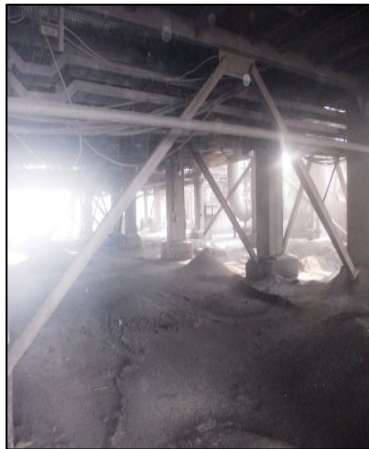
At 3.35 level

- M.S bracings have been provided at ground level as per requirement.

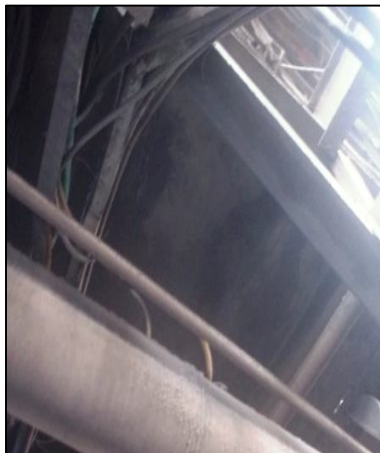
- Severe corrosion scaling, rusting and peeling/delamination of protective paint noted in structural framing system.

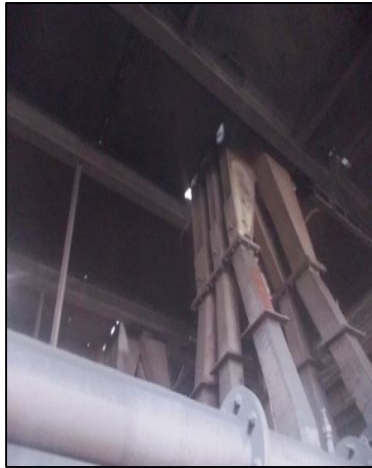
At 7.90 level

- Severe corrosion scaling, rusting and peeling/delamination of protective paint noted gusset plate and structural system. Also noted localized missing of cleat and seat angle.

➤ Localized replacement of the deteriorated steel elements as also further strengthening has to be done and need to be followed for the proposed rehabilitation work. However, the said strengthening work shall be done according to the design.

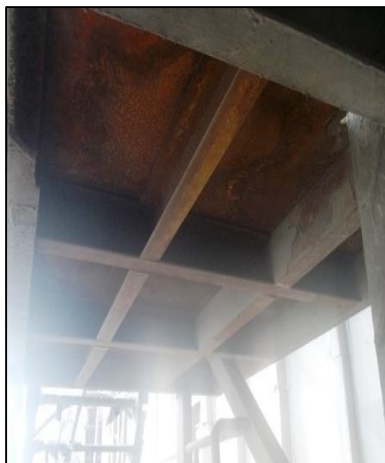
At 9.05 level

- Existing structural framing system noted with severe corrosion in ms platform and localized missing of seat and cleat angles.

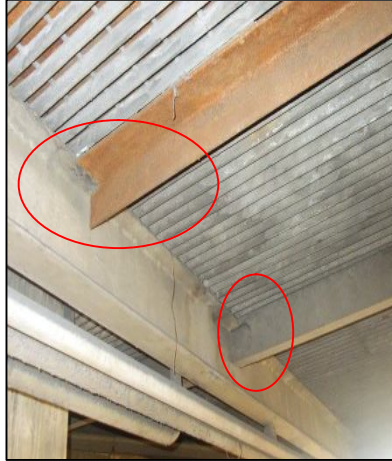
At 9.05 level

- Inadequate connection of main beam and secondary beams.

➤ Most of the distresses related to the inadequate connection details need be re-done with providing ideal connection details as can be best designed with improved specifications.

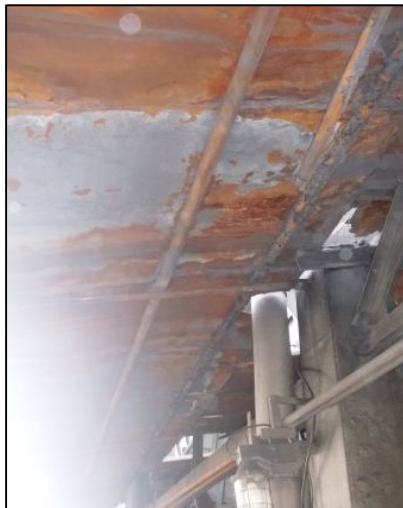
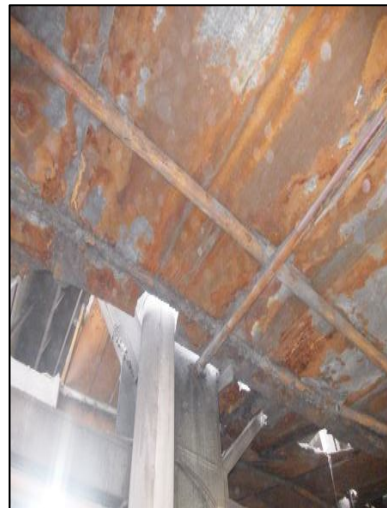
At 12.15 level

- M S plate provided to cover the passage noted with severe scaling, rusting, peeling of existing paint.

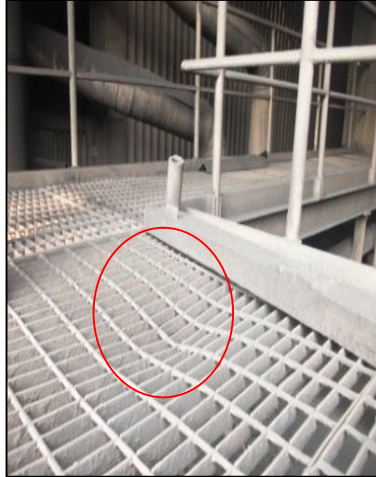
At 14.75 level

- As a matter of critical observation; upheaval noted in M S grating platform/walkway.

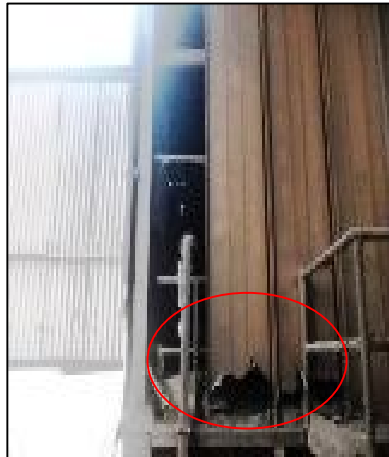
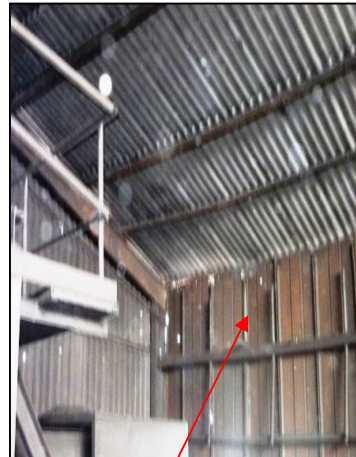
At 33.68 level

- Damaged cladding at top level noted with severe corrosion and peeling of paint.

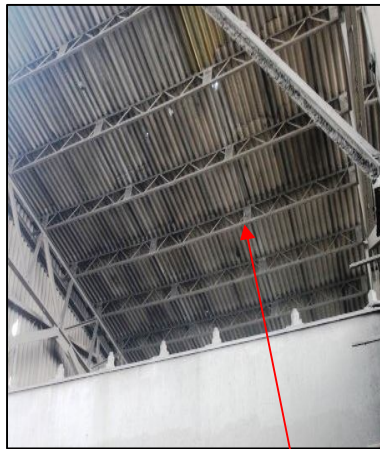
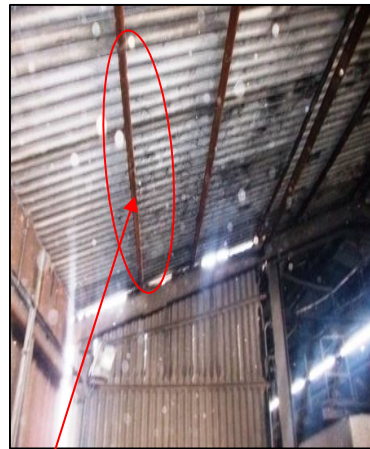
At 33.68 level

- Roofing structural supporting members noted with severe corrosion and bent at some location.
