**INDIAN FARMERS FERTILISER  
COOPERATIVE  
LTD, PARADEEP, ORISSA**

**Health survey of the existing plant structures at IFFCO**  
**Paradeep Unit.**

**INSPECTION REPORT**  
**For**  
**Condition Assessment**  
**For**  
**Control Room**  
**Of**  
**AFBC PLANT**  
**At**  
**Paradeep, Orissa.**

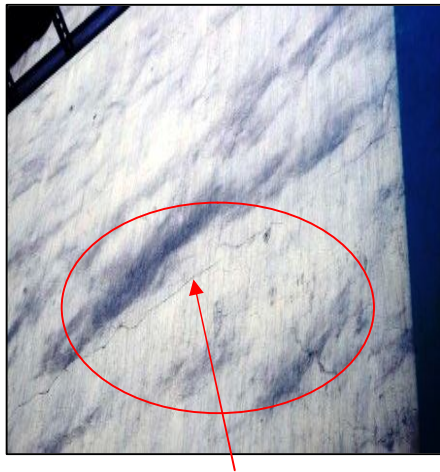
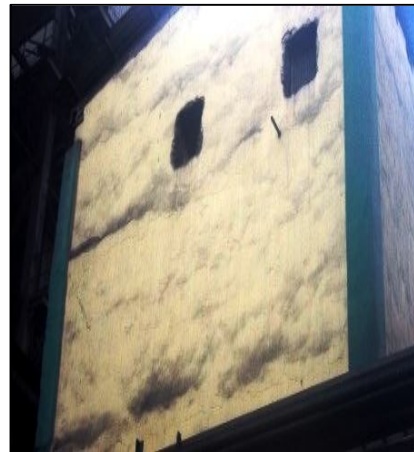
This area reveals distresses like undulation in external plaster at various locations, also noted openings were made are kept unfinished. Please refer below photographs.

**Undulation and cracks noted at external facade.**

- The area affected shall be removed manually or mechanically.
- R.C.C members shall be treated with proper polymer mortar and hack-aid-plaster bonding coat.
- After the preparation of the surface, the first coat of 12mm thick plaster shall be applied and the surface shall be made rough for proper bonding of second coat.

- After the application of first coat, minimum three days of curing shall be done for the surface.
- The second coat of 8mm sand faced plaster shall be applied on that rough surface.
- After giving second finishing coat, plaster shall be cured for minimum seven days.
- All plastered surfaces shall be protected by applying paint similar as existing of approved manufacturer as per matching shade & specifications shall be applied.

- Unfinished cut – outs in the masonry walls & at terrace shall be finished with Micro concrete of reputed manufacturer as per specifications.

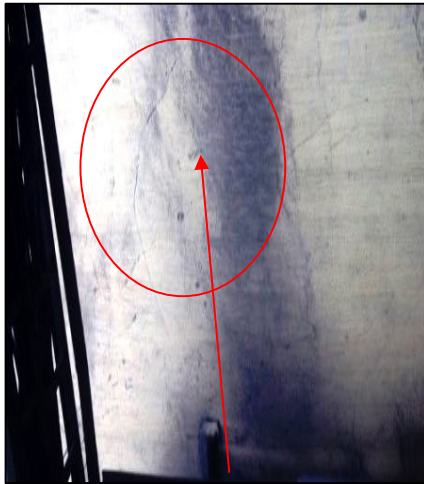
**Discoloration and cracks in external plaster.**

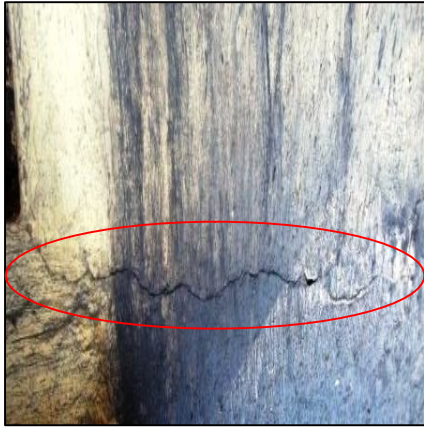
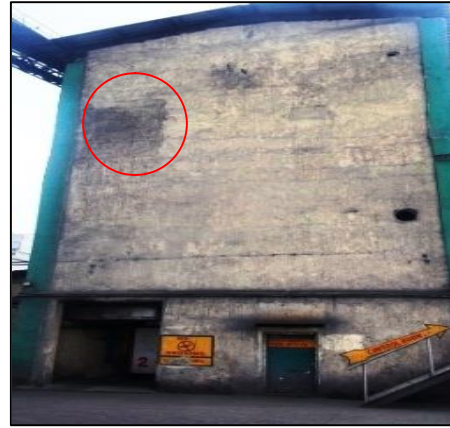
This area reveals distresses like cracks in external plaster at various locations, discoloration and seepage mark noted on external façade. Please refer below photographs.

**Horizontal cracks and seepage mark noted.**

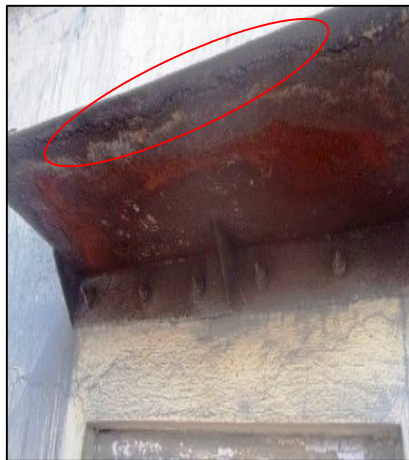
**Cracks and seepage marks noted**

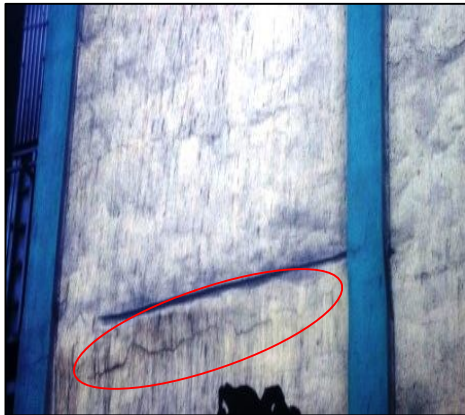
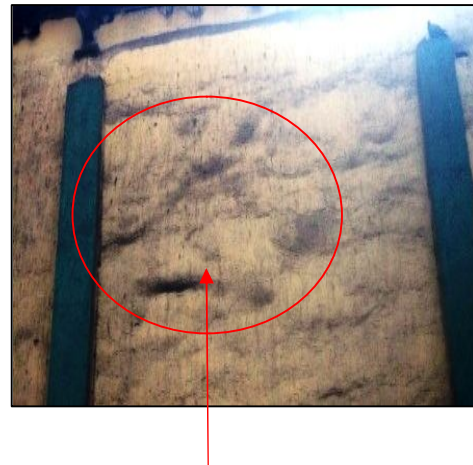
This area reveals distresses like, undulation in external plaster and horizontal crack at various locations.

**Horizontal cracks with undulation**

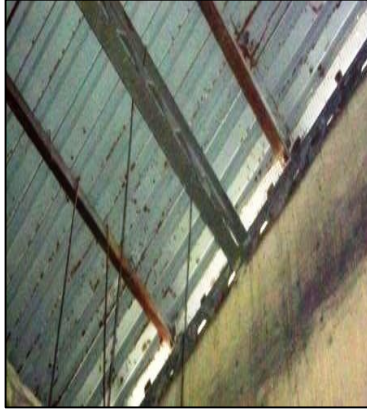
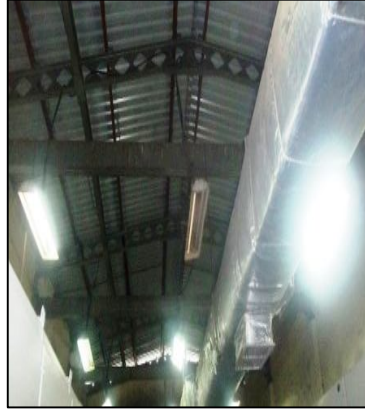
Internal area noted with distresses like severe corrosion in structural framing system of roof including corrosion in pre-coated sheets. Also been noted gap between wall and roofing sheets. Please refer below photographs.

**Corrosion/pitting noted in pre-coated sheets & structural framing system at roof.**

- Gap between masonry wall & roof shall be filled with adequate masonry and the area to make watertight as per standard specifications.

- Localized replacement of the deteriorated steel elements as also further strengthening has to be done and need to be followed for the proposed rehabilitation work. However, the said strengthening work shall be done according to the design.
- Few General distresses like Existing corrosion of the steel members shall be removed as per standard method and all the Structural Steel members shall be treated with application of 3 coats of 'SUNPUGUARD' (a high quality Anti corrosive two component Polyurethane coating) or equivalent as per Manufacturer's

recommendations. Proper surface preparation of all Structural Steel members shall be done before application of SUNPUGUARD or equivalent, as per manufacturer's recommendations.
