INSPECTION REPORT FOR “CONVEYOR BELT 5, 6 & 7 and TRANSFER TOWERS OF AFBC BOILER”

**INDIAN FARMERS FERTILISER COOPERATIVE
LTD, PARADEEP, ORISSA**

March – 2013

INSPECTION REPORT
For
Condition Assessment
OF
Conveyor belt support structures
Of Belt No. 5, 6 & 7.
And Transfer Towers
Of
AFBC BOILER
At
Paradeep, Orissa.

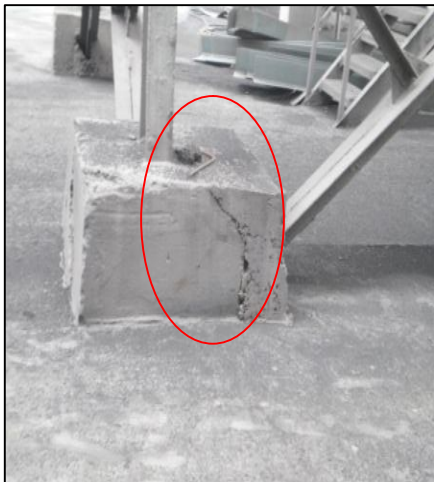
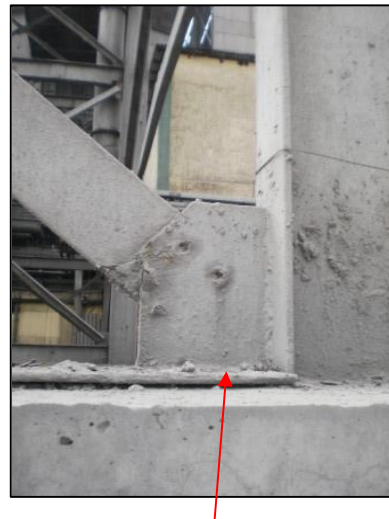
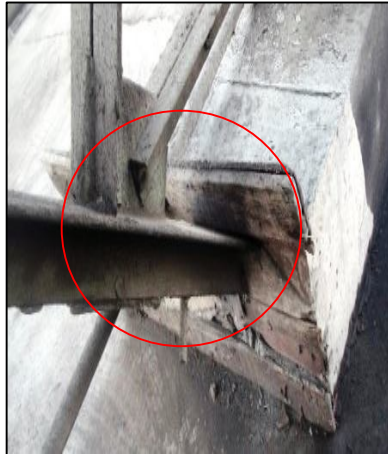
- **R.C.C. encasement** done at the bottom of steel columns noted with honey combing, unfinished construction joints, shuttering material left in the concrete matrix and gap between base plate and RCC pedestals.

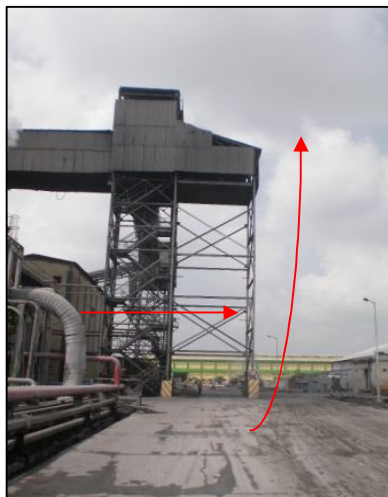
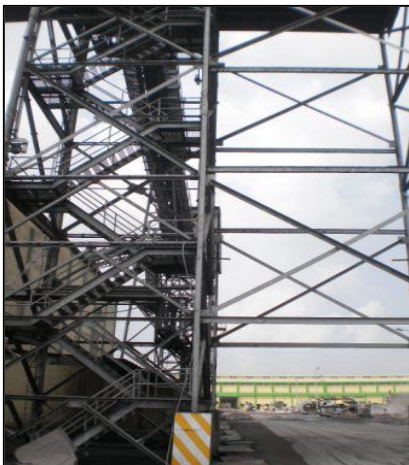
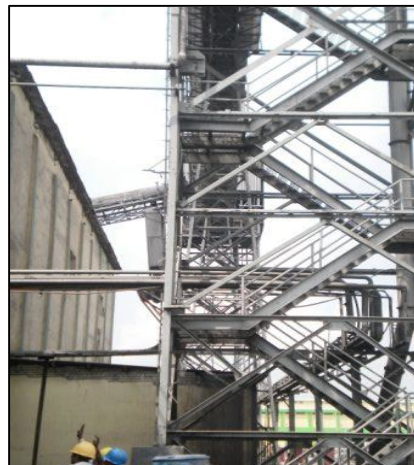
- As a matter of critical observation; deflection noted in the steel columns as seen in the photograph below; might be due to the original construction deficiency however the area need to be monitor for further development; if any.

- **Vertical support system of conveyors (i.e. Trestles) needs strengthening according to the actual design. Provision of additional trestles also required for enhancing the load carrying capacity of the conveyor belt support systems; according to the actual design.**

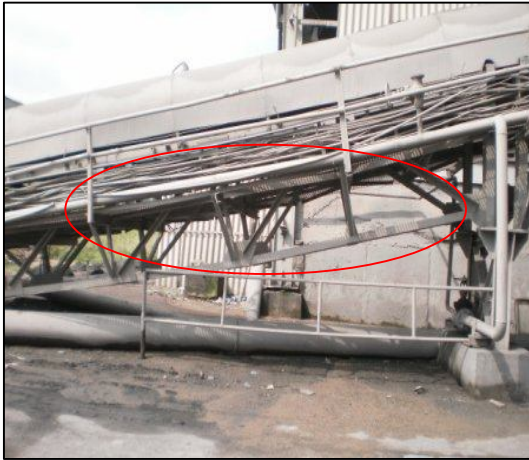
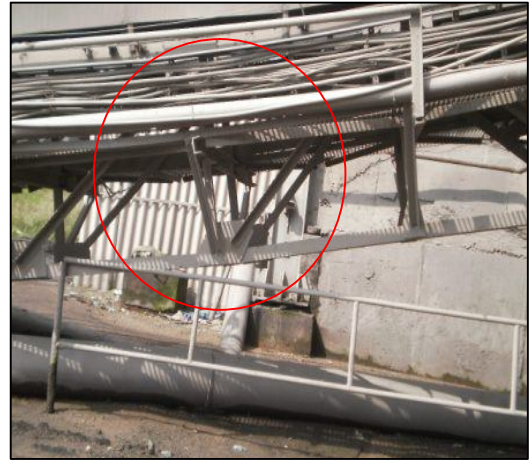
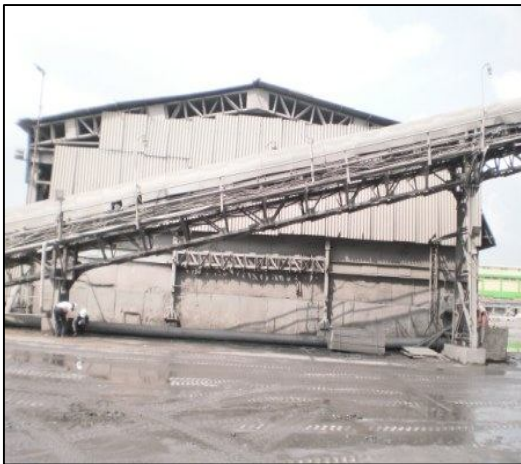
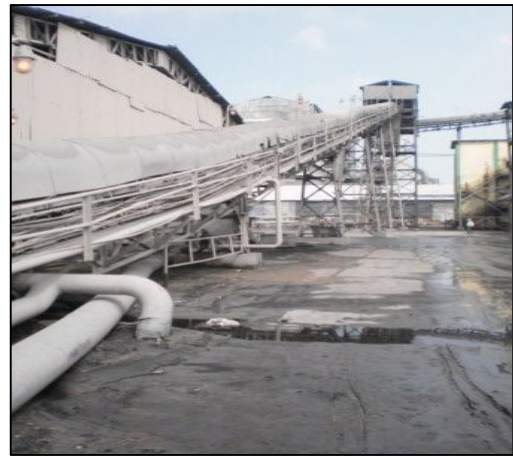
Conveyor 5

- As a matter of critical observation; Conveyor belt support system between subsequent trestles noted with sag at few locations; as seen in the photographs below. This area needs further detailed investigation in the form of proof checking according to the load/design parameters.

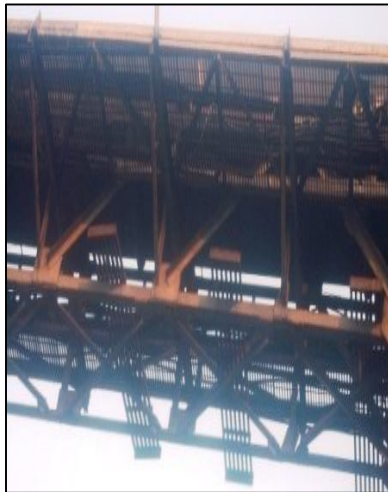
Conveyor 5

- **All the steel members of the Bottom Part of the framing system** (i.e. Longitudinal & horizontal members, cross bracings, side & central gusset plates, steel plates provided at walkways and middle area and localized weld joints etc.) noted with **Minor to severe corrosion**, deposition of dust of raw material, localized scaling and peeling / delamination of existing protective paint at almost all locations. Please refer typical photographs below.

- Few General distresses like Existing corrosion of the steel members shall be removed as per standard methodology and all the Structural Steel members shall be treated with application of 3 coats of 'SUNPUGUARD' (a high quality Anti corrosive two component Polyurethane coating) or equivalent as per manufacturers recommendations. Proper surface preparation of all Structural Steel members shall be done before application of SUNPUGUARD or equivalent, as per manufacturer's recommendations.
- Severely damaged/fallen/broken A.C. sheets of cladding & roof shall be removed and replaced with new sheets, as per the existing design with the material of similar specifications.
- This is the broad assessment of the structural health at this stage.

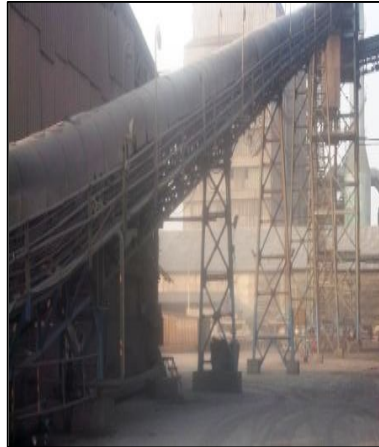
Conveyor 5

- External side of the conveyor enclosed with MS sheet (for conveyor belt no. 5) and conveyor belt no. 7 has been covered with A.C sheet cladding with supporting structure framing system. A C sheets noted damaged and observed cracked, with holes and also broken etc. at many locations.
- Please refer typical photograph below.

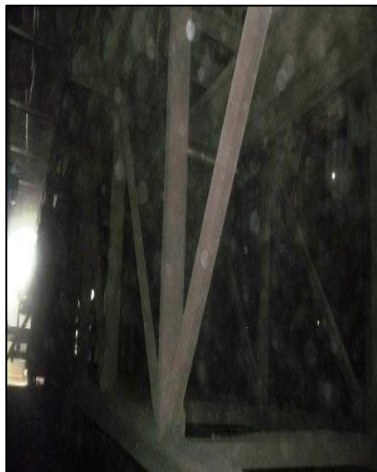
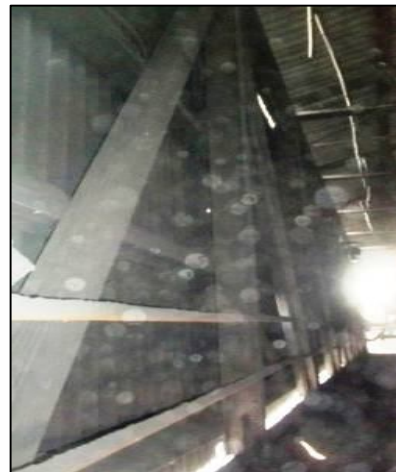
Conveyor 7:

- **All the steel members of the framing system on elevations** (i.e. Longitudinal & vertical members, cross bracings, side gusset plates, steel runners supporting claddings, anchor bolts and localized weld joints etc.) noted with **corrosion**, deposition of dust of raw material, localized scaling and peeling / delamination of existing / new protective paint at almost all locations. Please refer typical photographs below

Note: - Pictures are not clear due to accumulation of dust of raw material.

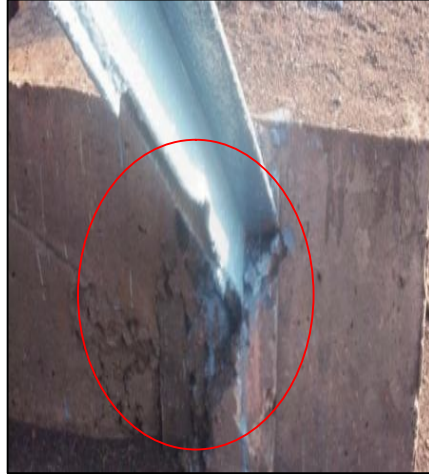
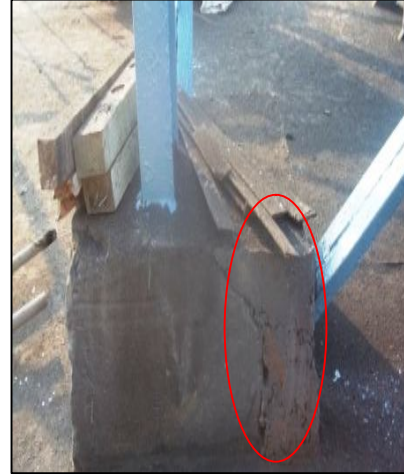
- **R.C.C. encasement** done at the bottom noted with localized cracks & deposition of dust of raw material at many locations. Please refer typical photographs below.

Honey combing and crack noted at subsequent concrete pour

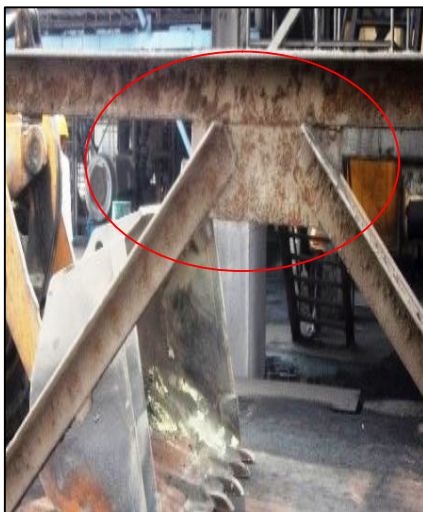
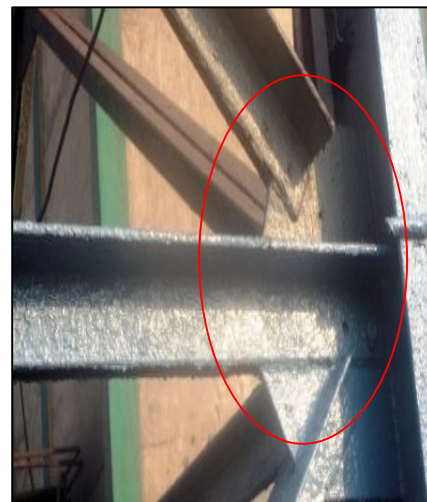
- **All the steel members of the Transfer House system (i.e. vertical & horizontal members, cross bracings, side & central gusset plates, anchor bolts and localized weld joints etc.)** noted with corrosion, deposition of dust of raw material, localized scaling and peeling / delamination of existing / new protective paint at almost all locations. Please refer typical photographs below.

Severe corrosion & scaling, pitting on bracing and cross bracing

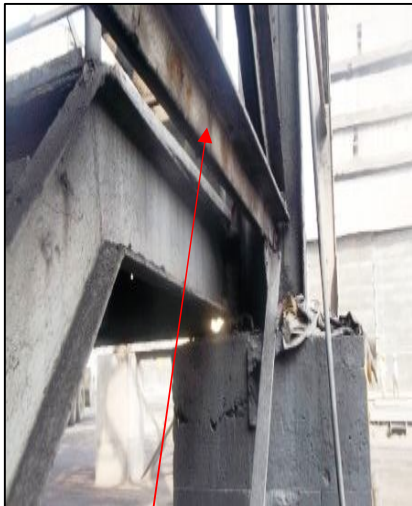
Corrosion in horizontal bracing

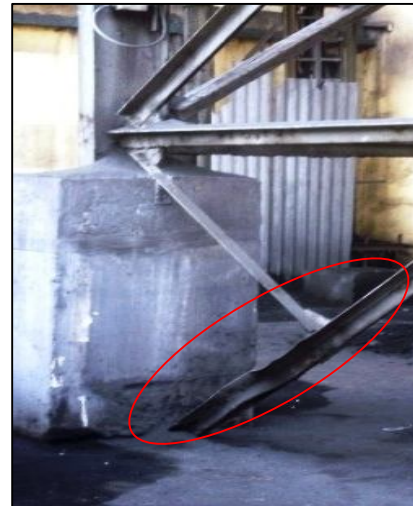
Noted bent cross bracing with corrosion

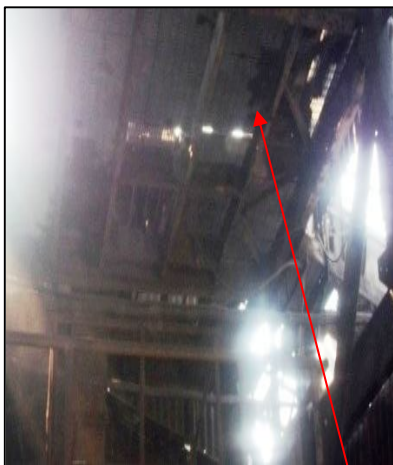
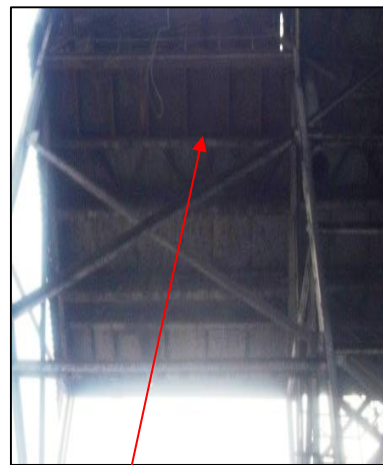
- **All the steel members of the Bottom Part of the framing system** (i.e. Longitudinal & horizontal members, cross bracings, side & central steel plates provided at platforms, anchor bolts and localized weld joints etc.) noted with **severe corrosion**, deposition of dust of raw material, localized scaling and peeling / delamination of existing / new protective paint at almost all locations.. Please refer typical photographs below.

Severe corrosion, scaling, deposition of raw dust in longitudinal member, bracing, steel platform grating

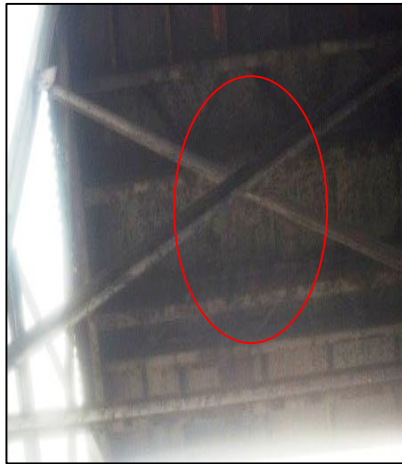
Sever corrosion & deposition of dust on the all the members

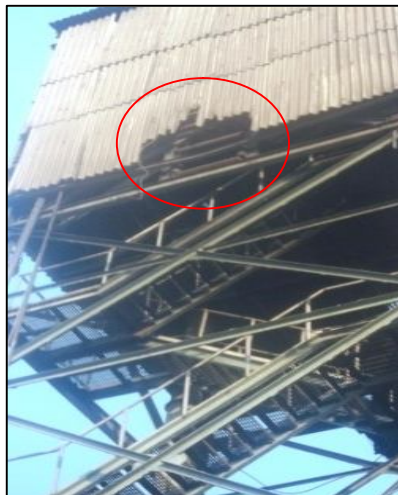
- External elevations on either side of the Transfer supporting structure enclosed with A. C. sheets cladding supported with steel runners. However, A. C. sheets noted damaged and observed in the form of cracks, holes, broken etc. at many locations.

A.C sheet broken/ damaged

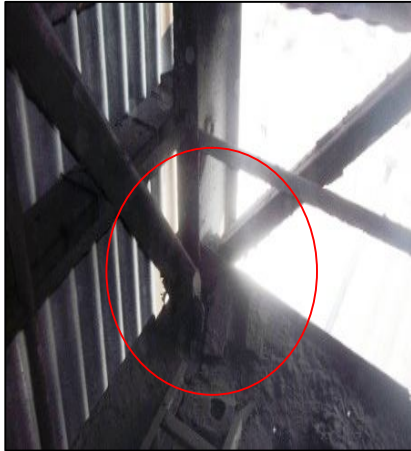
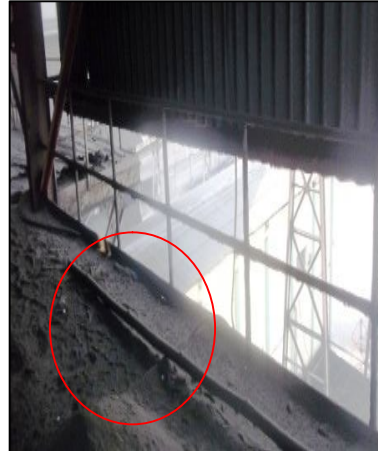
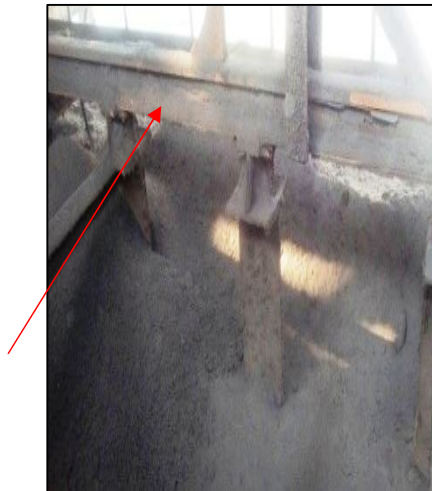
- **All the steel members of the framing system on elevations** (i.e. Longitudinal & vertical members, cross bracings, side gusset plates, steel runners supporting claddings, anchor bolts and localized weld joints etc.) noted with **corrosion**, deposition of dust of raw material, localized scaling and peeling / delamination of existing / new protective paint at almost all locations. Please refer typical photographs below.

Heavy deposition of dust & corrosion noted on the member
