INDIAN FARMERS FERTILISER COOPERATIVE

Health survey of the existing plant structures at IFFCO
Paradeep Unit.

INSPECTION REPORT

“AFBC Boiler”

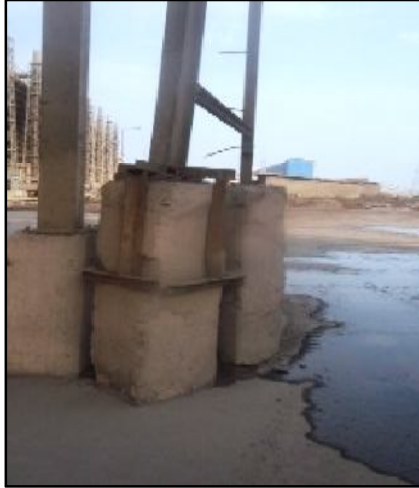
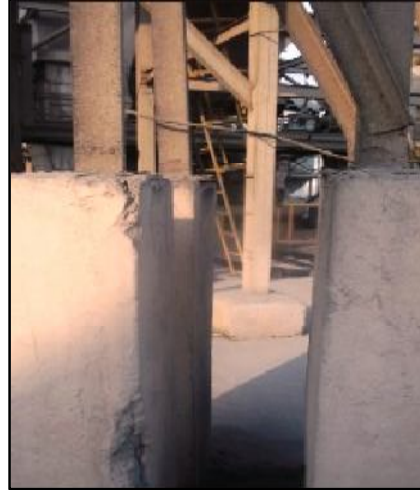
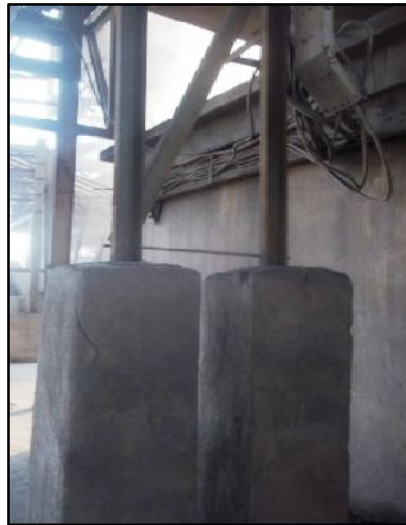
- RCC pedestals noted with honey combing and localized damaged edges.

- These areas shall be grouted with cement grouting with addition of non shrinking additives.
- Aluminum / PVC multiperforated nipples may be used to carry out the injection operation.
- The pressure of 1.00 to 1.5 kg per sq cm may be applied for grouting.
- Care should be taken to remove trapped air inside the crack / honey combing areas to avoid back pressure.

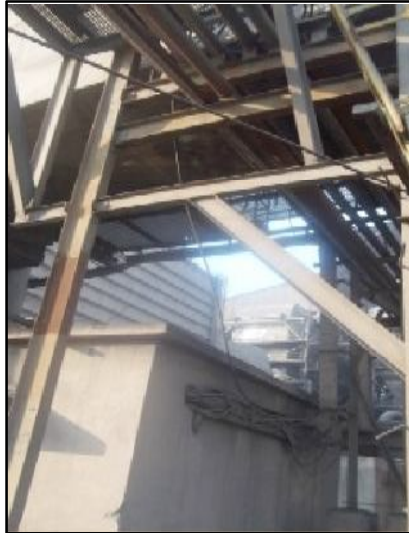
- The pipe rack i.e. vertical members, horizontal members, cross bracings and M.S sheets etc. noted with corrosion and peeling of paint due to the environmental effects.

- Localized missing / cut down/slotted members noted at some locations.
- Localized missing of cleat/seat angles etc. noted as a matter of inadequate connections.

- Localized replacement of the deteriorated steel elements as also further strengthening has to be done and need to be followed for the proposed rehabilitation work. However, the said strengthening work shall be done according to the design.
- Most of the distresses related to the inadequate connection details need be re-done with providing ideal connection details as can be best designed with improved specifications.
- Few General distresses like Existing corrosion of the steel members shall be removed as per standard method and all the Structural Steel members shall be treated with application of 3 coats of 'SUNPUGUARD' (a high quality Anti corrosive two component Polyurethane coating) or equivalent as per Manufacturer's recommendations. Proper surface preparation of all Structural Steel members shall be done before

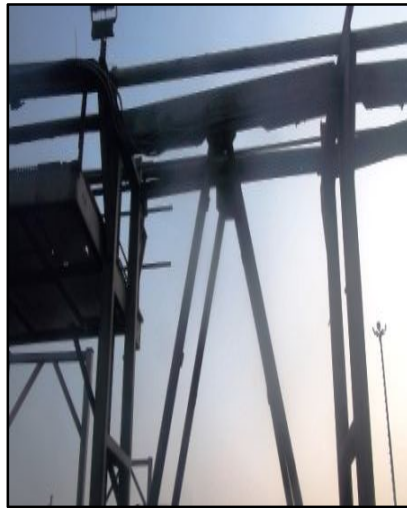
- The structure noted with minor corrosion in structural members, scaling on nut bolts, pitting and peeling of paint observed at many locations. Please refer photographs below.

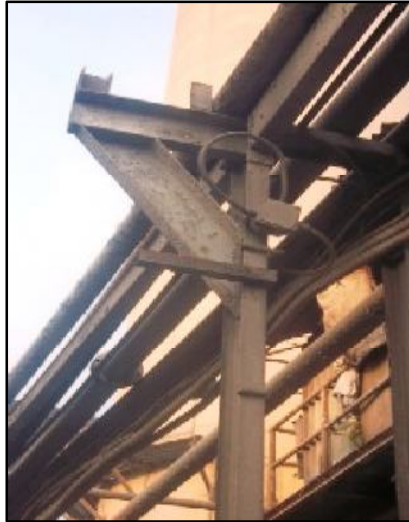
- Pipe rack noted with minor to severe corrosion and pitting at some locations. Please refer photographs below.

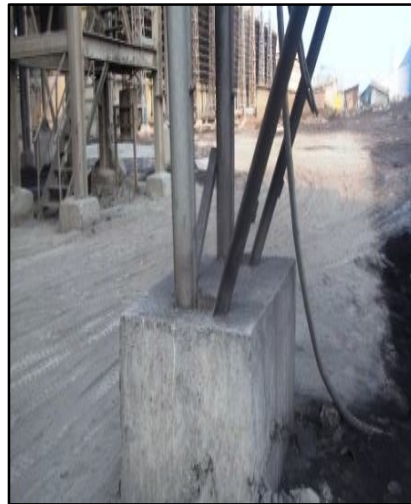
- RCC pedestal have been provided at the bottom of the vertical members; noted with honey combing and localized damaged edges.

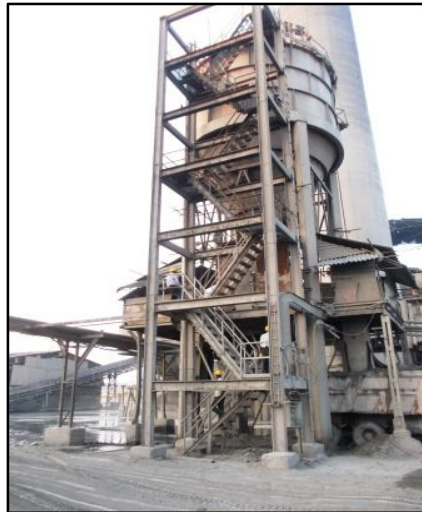
- Steel platform / walk way provided with shed, noted with corrosion in structural elements, localized missing of proper welding and cleat angles etc. Please refer photograph below.

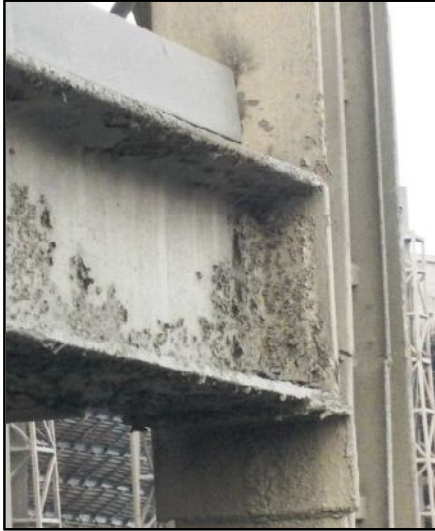
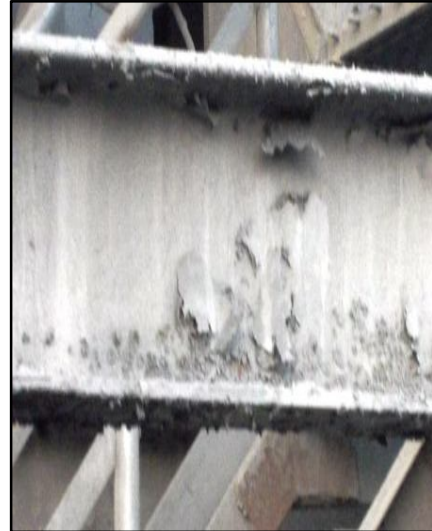
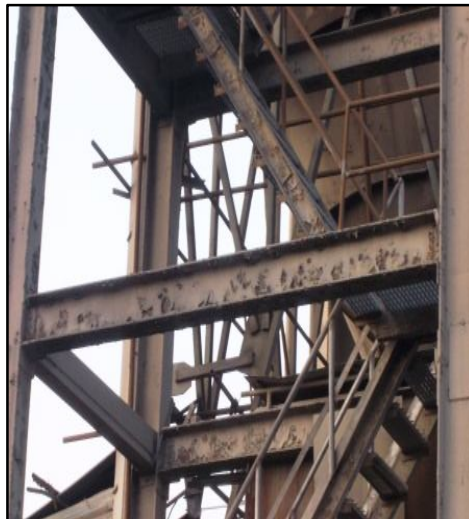
- Peeling of paint and deposition of raw material noted on Steel elements. Please refer photographs below.

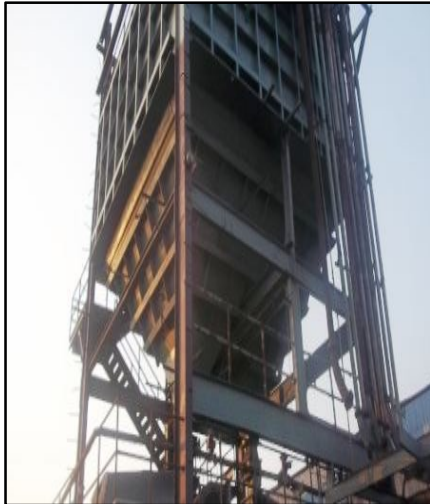
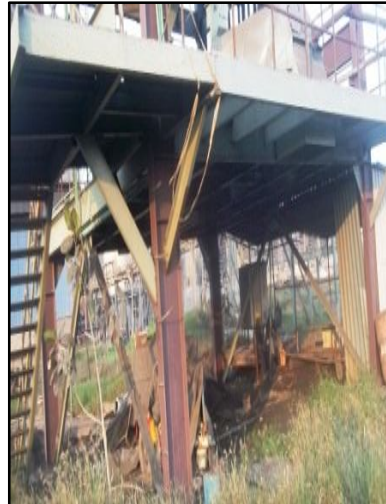
- Newly fabricated structure noted with localized missing of proper welding, cleat/seat angles at some locations. Please refer photographs below.

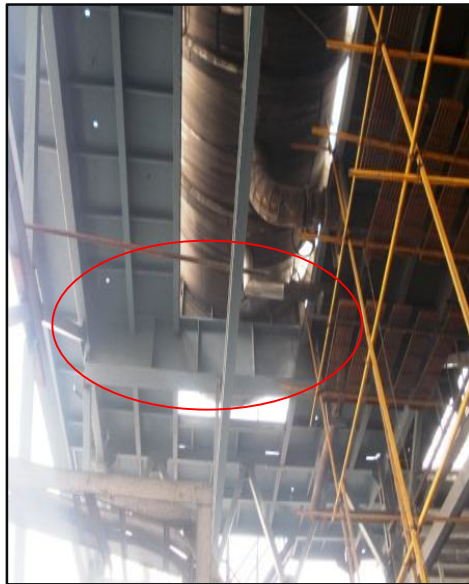
- As a matter of critical observation; huge steel tank noted rest on steel beams as seen in the photograph below. However, the said steel beams (supporting the said tank) connected with comparatively small / undersized main beams. The system needs cross verification with fresh design and accordingly to re-done.

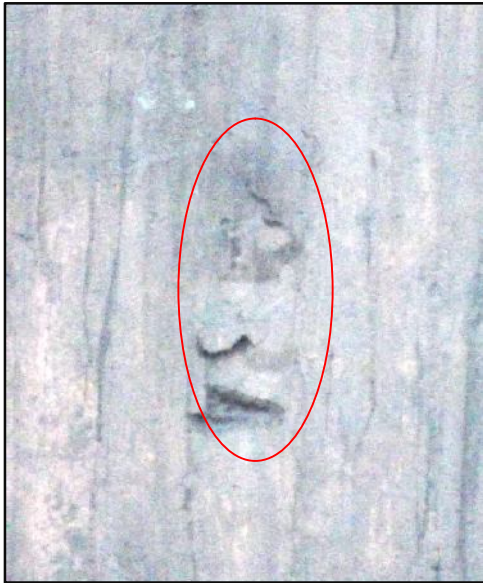
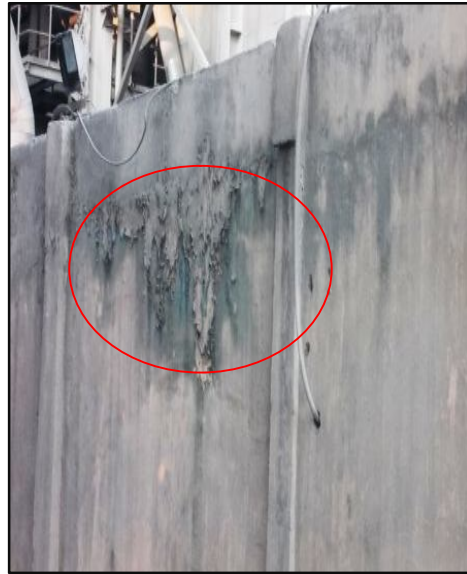
- Peeling of external paint, localized damaged plaster, separation crack at the junction of roof beam and masonry wall, leakage/seepage resulted in moss growth etc. noted. Please refer photographs below.

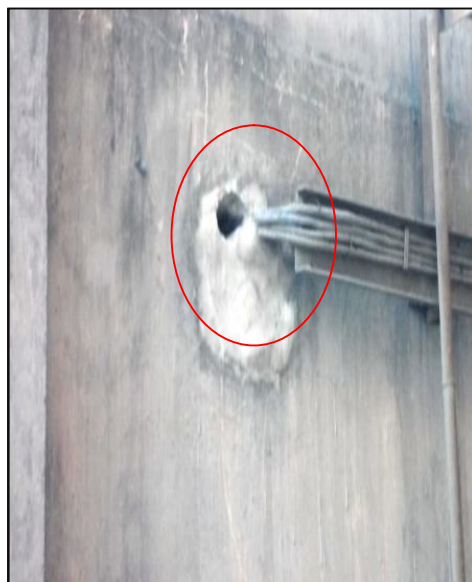
- Unfinished through holes are made in masonry walls to pass the electrical cables from external sides; it might be the source of leakage. Please refer photograph below.

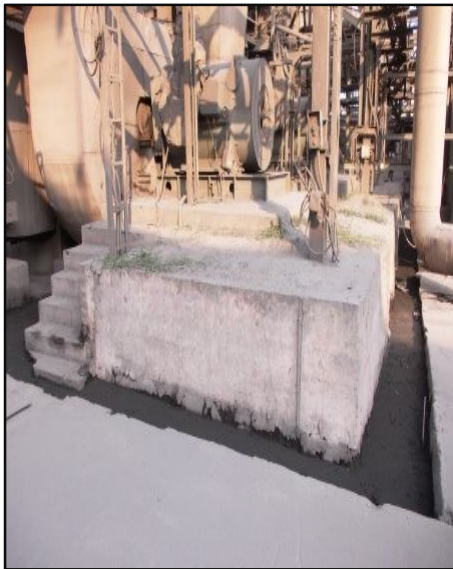
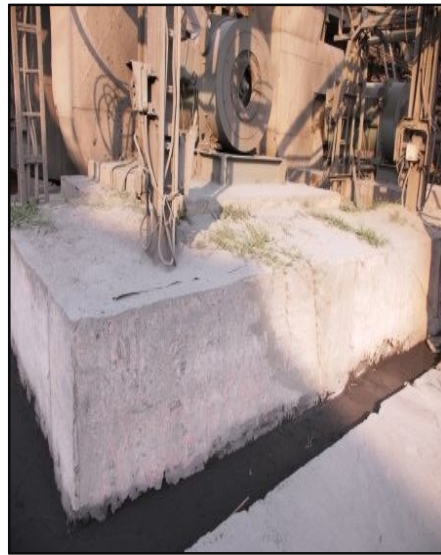
F. D. FOUNDATION noted with honey combing. It seems the said foundations directly cast/rest on existing floor and not anchored & hence horizontal separation cracks can be seen at the bottom of the said foundations.

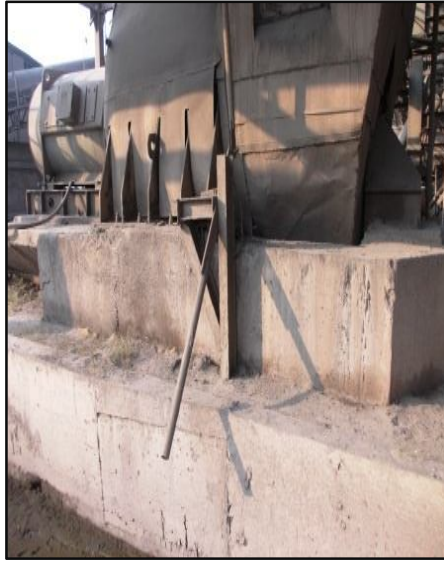
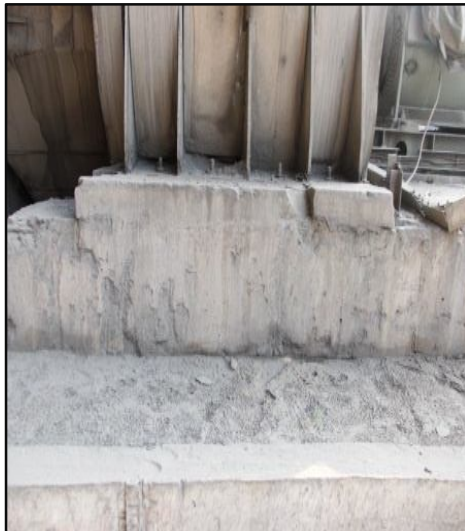
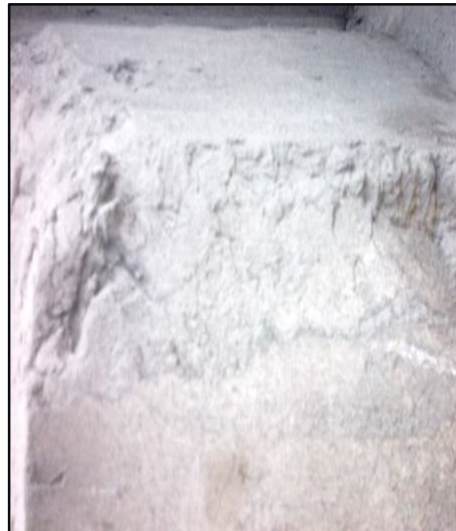
I. D. FAN FOUNDATION is the RCC foundation provided to support the Fans as seen in the photographs below. No major distresses except localized honeycombing & damaged edges noted in the said foundations.

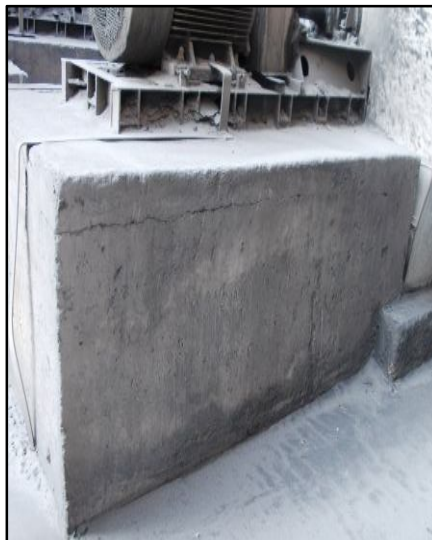
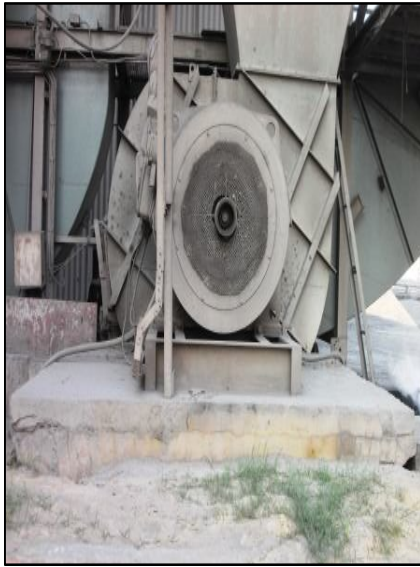
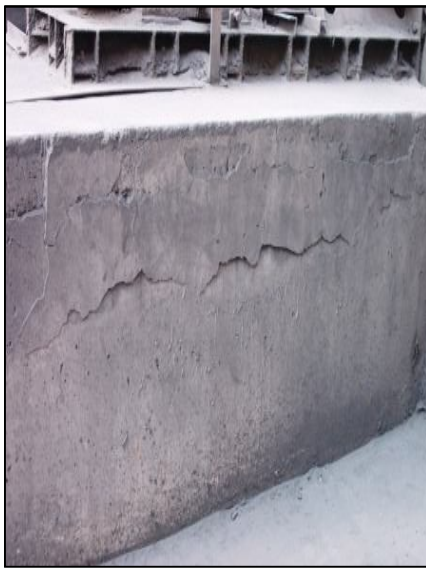
- The RCC foundations; under reference; noted with distresses like localized honey combing, horizontal separation cracks at the subsequent concrete pours and gap between RCC and top finishing layer etc. Please refer typical photographs below.

- The gap between concrete and top finishing layer (in RCC pedestals) shall be finished with suitable grouting as per existing system/method.
- Grout the area (in foundations/pedestals etc) with low viscous epoxy injections of reputed manufacturers, as per specification, for cracks and weak concrete areas to make the area itself watertight.

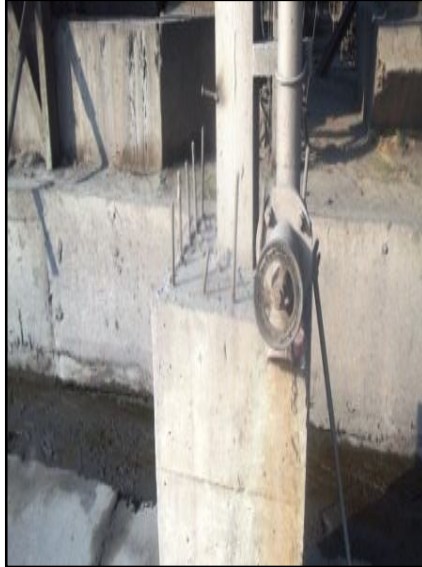
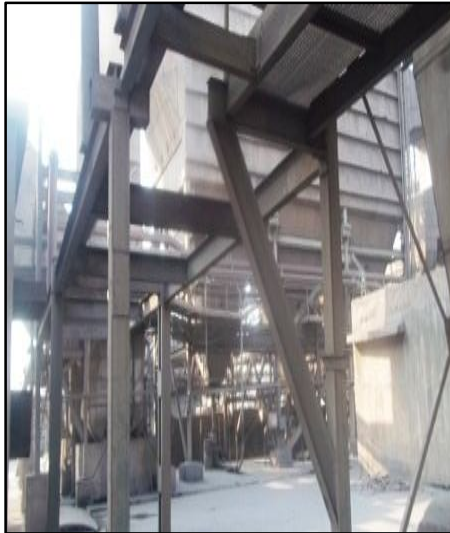
- The structure noted with distresses like exposed steel/dowel bars, minor corrosion in the steel elements, localized missing of cleat and seat angles as a matter of inadequate connections and improper / incomplete welding at localized areas etc. Please refer photographs below.

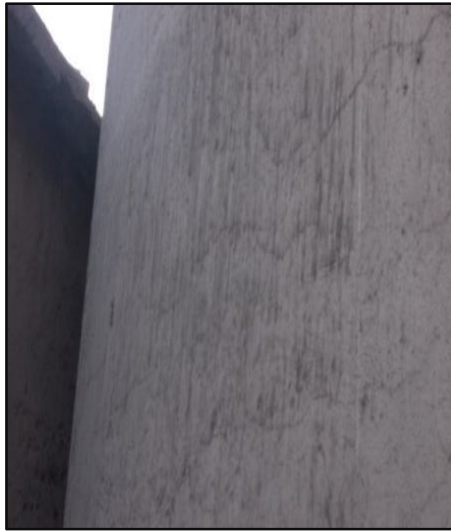
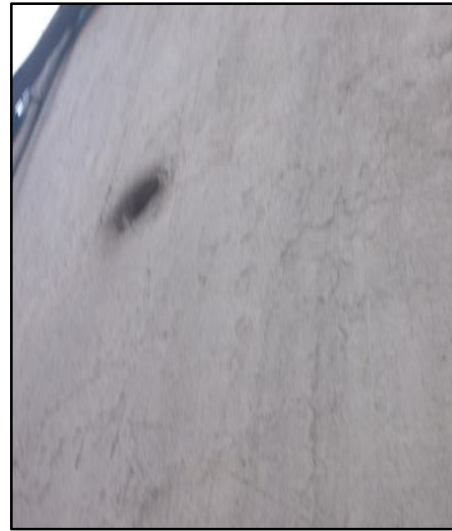
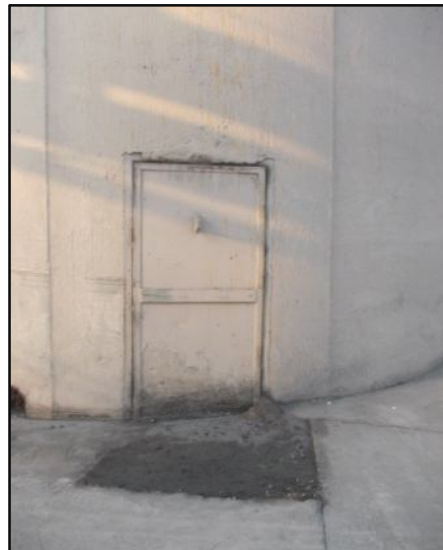
- Several horizontal cracks at subsequent concrete pours of slip form lifts, localized hollow sound in RCC wall and separation crack noted between the RCC and door frame at of entrance area; as shown in the photographs below.

- Grout the area with low viscous epoxy injections of reputed manufacturers, as per specification, for cracks and weak concrete areas to make the area itself watertight.

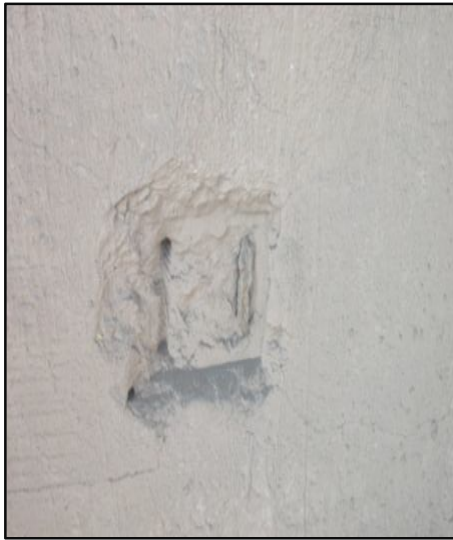
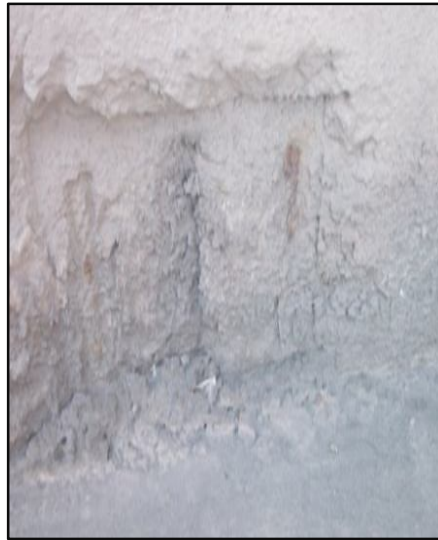
- Unfinished patches noted on the external periphery of the chimney, at few locations, which might made to fix anchor fasteners.

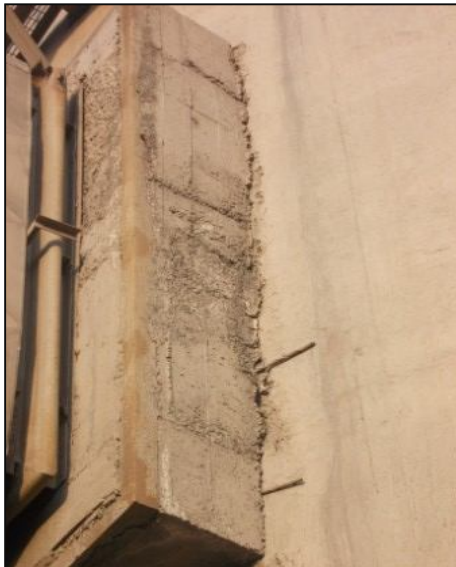
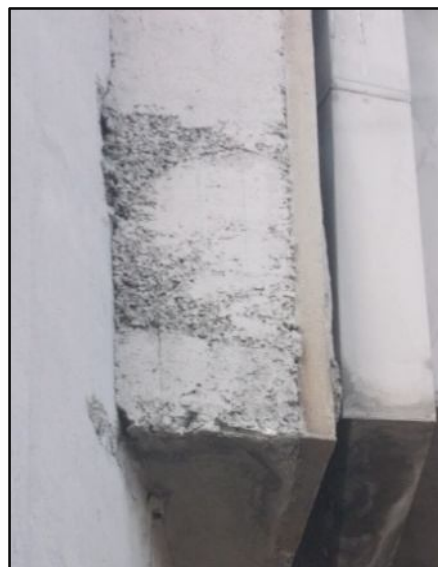
- Honey combing and exposed steel reinforcement/dowels noted in connected patch of ducting connection area.

- Remove all the loose and damaged concrete particles till sound concrete of uniform texture is visible. Use long sharp chisels of about 16-20 mm dia and hammers upto 2 lbs weight.
- Remove the complete corrosion of reinforcement with wire brushes (preferably mechanical type). Apply rust removers like 'Rusticide SS' or equivalent to the reinforcement to remove the traces of rust, if any.
- Clean the reinforcement once again with the wire brush. Wash the complete concrete surface including the reinforcement to remove the traces of rust remover. Apply a coat of rust passivator like 'Polyalk Fixoprime and Cement' or equivalent as per the recommendations of the manufacturers.
- The concrete surface treated for hollow sound shall be patch repaired with Polymer Modified Mortar as per the manufacturer's recommendations & as explained earlier.
