INSPECTION REPORT
For
Health Survey of Structures
Of
Ammonia Plant
At
IFFCO, Paradeep
Orissa

**INDIAN FARMERS FERTILISER COOPERATIVE
LTD, PARADEEP, ORISSA**

March - 2013

INSPECTION REPORT
For
Condition Assessment
For
Ammonia Plants structures
At
Utility and offsites plant
Of
Paradeep, Orissa.

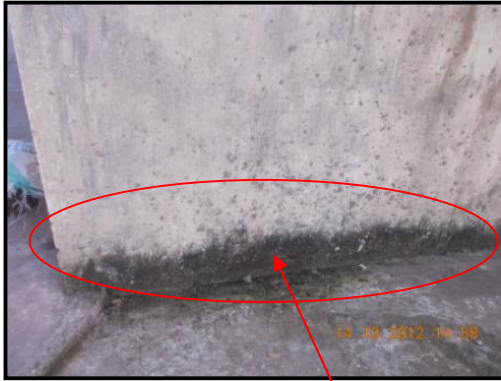
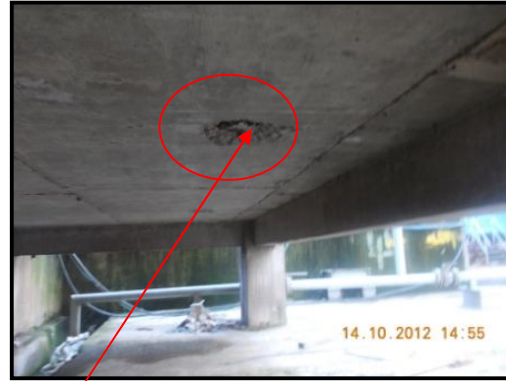
- RCC slab provided to support Pump area framing system above noted with distresses like segregation & honey combing at subsequent concrete pours, localized spalling of concrete thereby exposed reinforcement at the soffit of the slab etc. as seen in the typical photographs below.

Segregation and spalling of concrete noted.

- This area shall be rectified by the process as explained earlier i.e. in recommendation no.1.

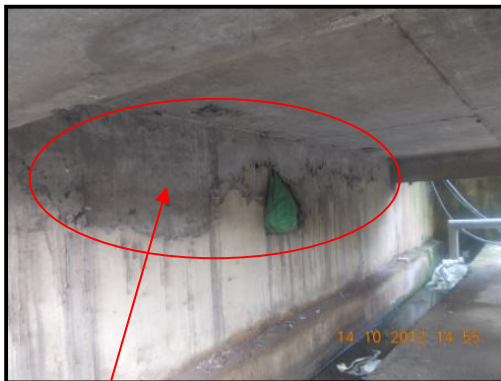
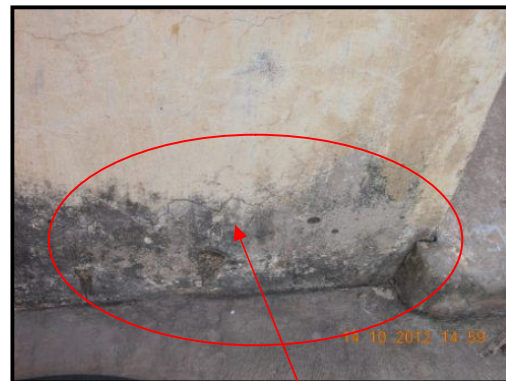
Cracks at the subsequent concrete pours & segregation noted .

- These areas shall be grouted with cement grouting with addition of non shrinking additives.
- Aluminum / PVC multiperforated nipples may be used to carry out the injection operation.
- The pressure of 1.00 to 1.5 kg per sq cm may be applied for grouting.
- Care should be taken to remove trapped air inside the crack / honey combing areas to avoid back pressure.

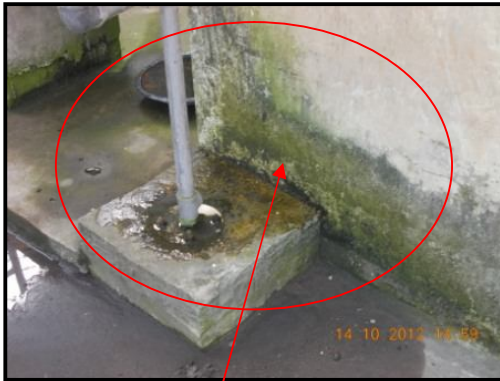
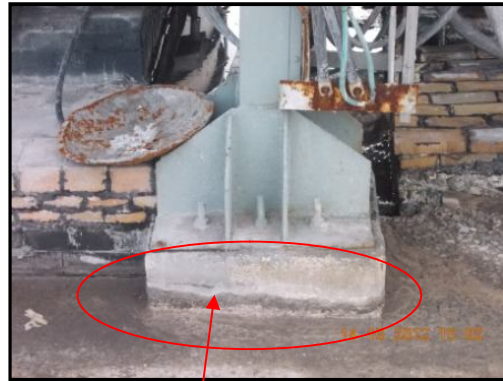
- R.C.C. encasement done at bottom part of vertical support members noted with cracks at top finishing layer and moss growth. Please refer typical photographs below.

Seepage, moss growth & cracks at top finishing layer of pedestal.

- Wherever the moss growth has been observed check that area for any hollow sound in the plaster.
- Remove and redo the damaged plaster and protect the surface with good quality paint.

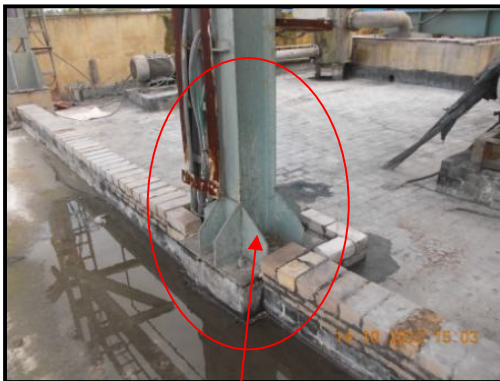
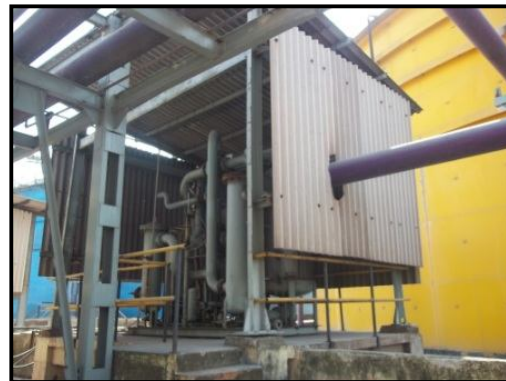
- Structural elements of the framing system i.e. steel columns, side gusset plate at various connections etc. noted with localized corrosion, scaling and peeling / delamination of existing paint etc. Please refer photograph below.

Corrosion and peeling of paint noted on the column.

- Few General distresses like Existing corrosion of the steel members shall be removed as per standard method and all the Structural Steel members shall be treated with application of 3 coats of 'SUNPUGUARD' (a high quality Anti corrosive two component Polyurethane coating) or equivalent as per Manufacturer's recommendations. Proper surface preparation of all Structural Steel members shall be done before application of SUNPUGUARD or equivalent, as per manufacturer's recommendations.

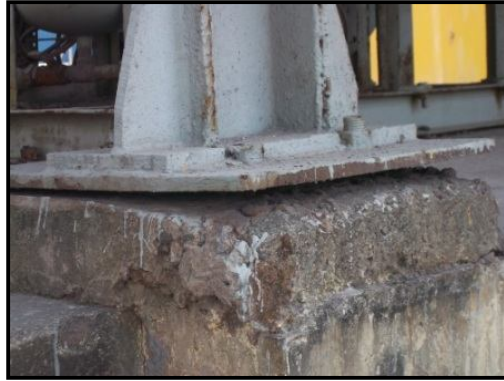
- Inadequate fixing & finishing of steel column with RCC pedestal noted as shown in the photograph below.

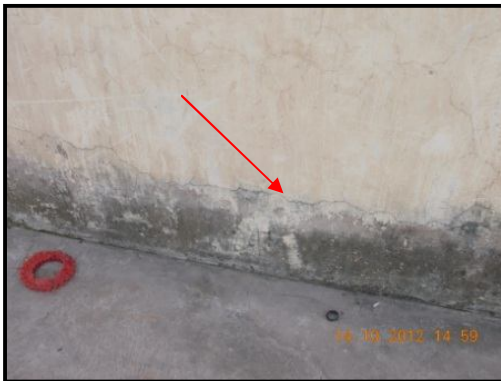
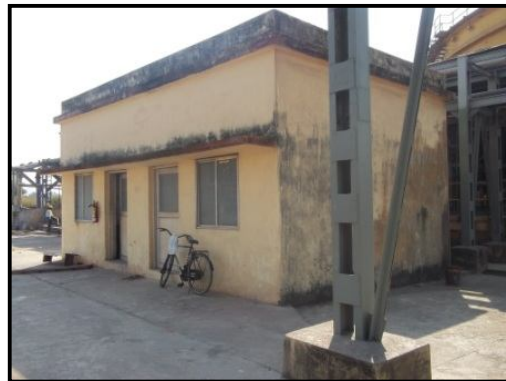
- Store Room is a RCC framed structure as seen in the photograph below noted with distresses like cracks & hollow sound in plaster, discoloration and weathered surfaces etc.

- Break open the loose and damaged concrete, till the uniform and solid stage of concrete is witnessed.
- Give Polymer Mortar Treatment to this area as per recommendation mentioned for crack due to corrosion of reinforcement in R.C.C members.
- Grout the weak concrete areas with cement and non shrink additives or with low viscous epoxy.

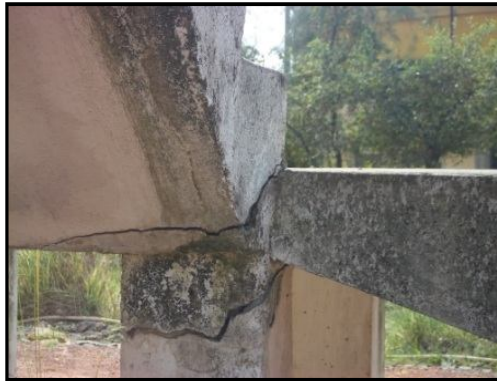
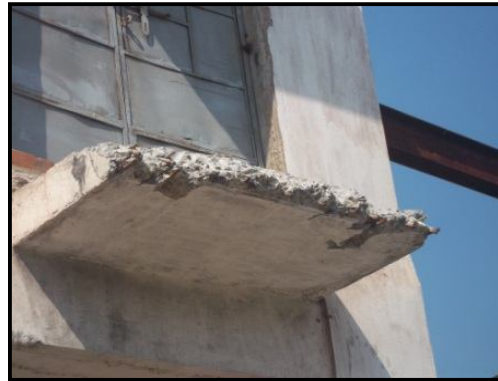
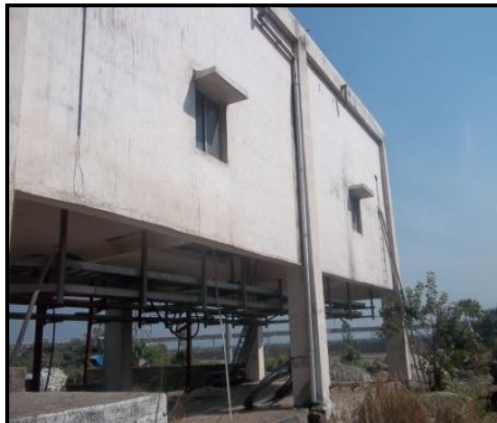
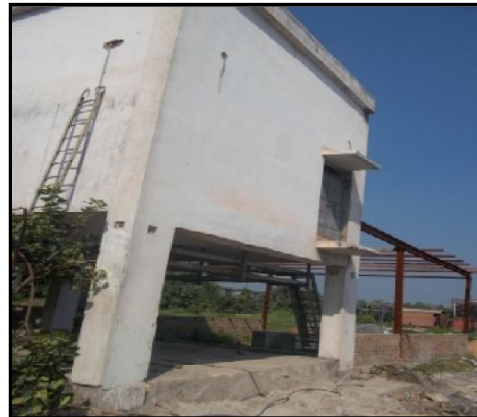
- This structure noted with distresses like damaged RCC chajja, weathered surface, leakage / seepage marks & delamination of cover concrete at staircase area and cracks in external plaster etc. as shown in the photographs below.

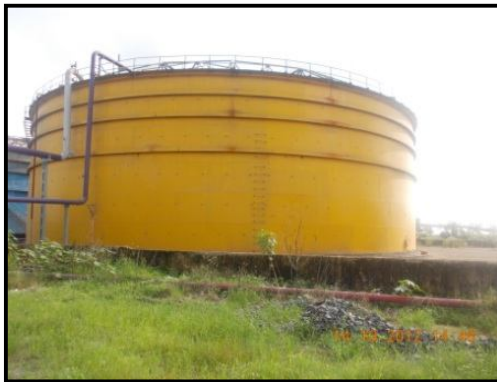
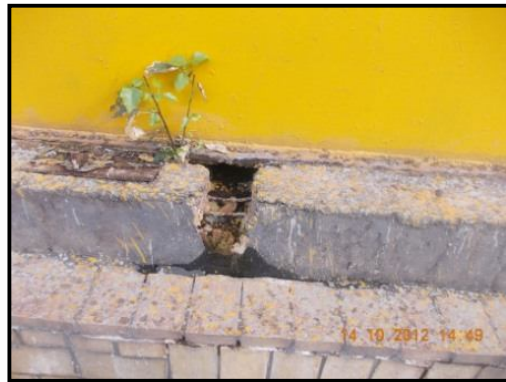
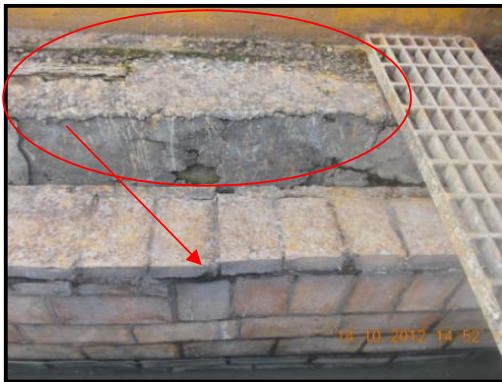
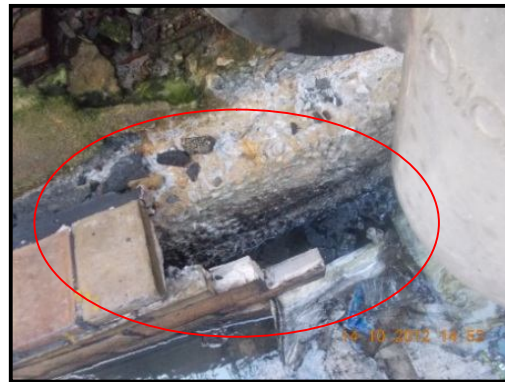
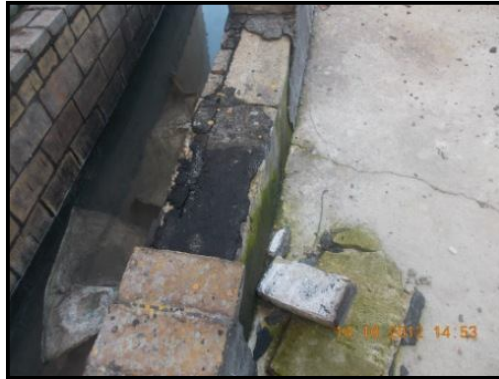
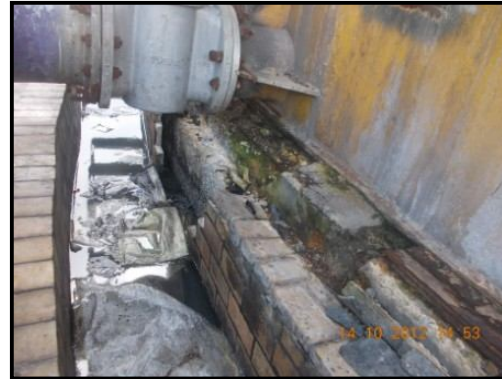
- RCC foundation noted with distresses like delamination of acid proof tiles, erosion in tile joints, localized vegetation growth and localized exposed reinforcement at the area where drain system exits. Please refer below photographs.

- Follow methodology to treat exposed reinforcement as per recommendation mentioned in corrosion cracks in R.C.C members with replacement of snapped steel with new steel reinforcement of similar diameter, as per requirement as per existing design.

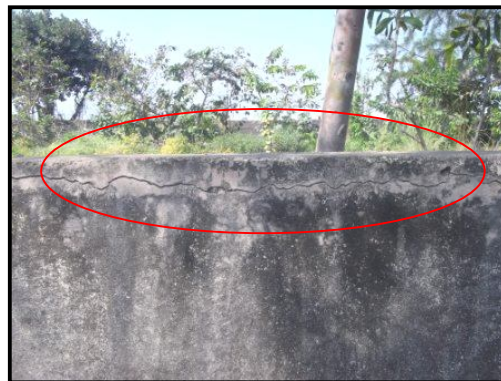
- R.C.C Dyke walls provided to enclose the peripheral area for the tanks. The said dyke walls noted with wide spread cracks on top at many locations as shown in the typical photograph below.

Cracks noted on the R.C.C dyke wall.

➤ **Grout the area (in Dyke walls/RCC tanks etc) with low viscous epoxy injections of reputed manufacturers, as per specification, for cracks and weak concrete areas to make the area itself watertight.**

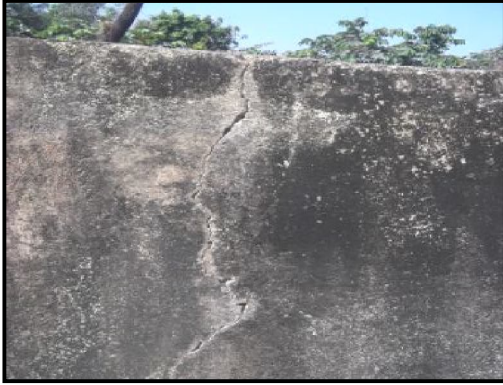
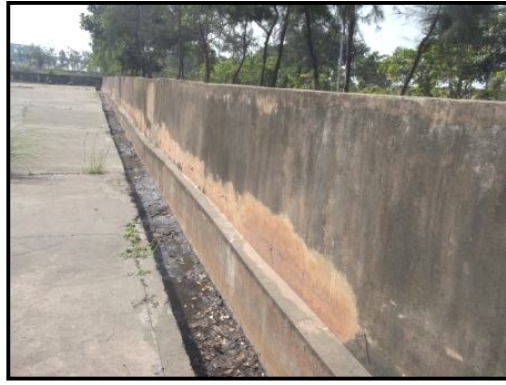
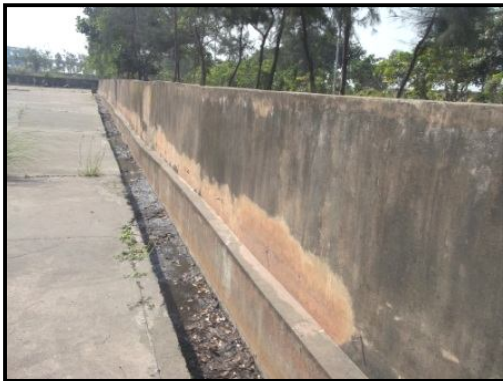
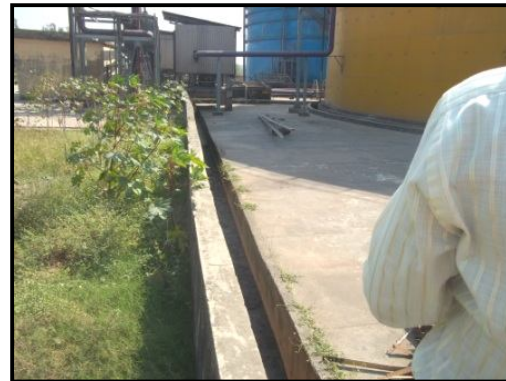
- Through & wide spread vertical crack noted on dyke wall on West side. Also, weathered surfaces and disalignment noted as shown in the typical photographs below.

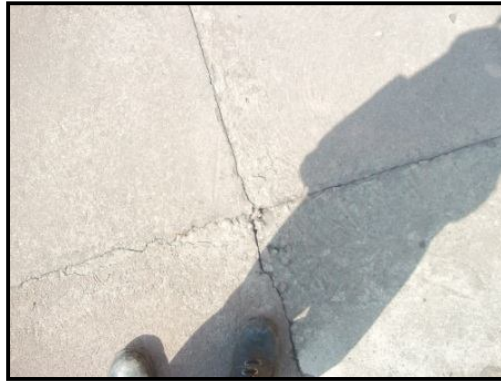
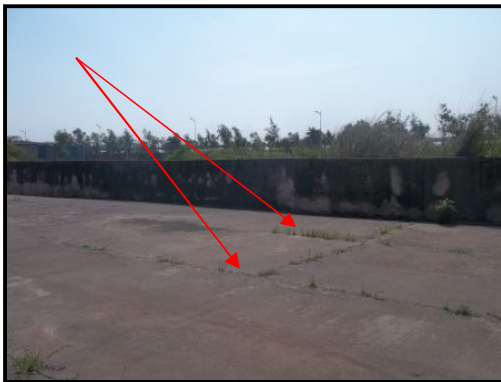
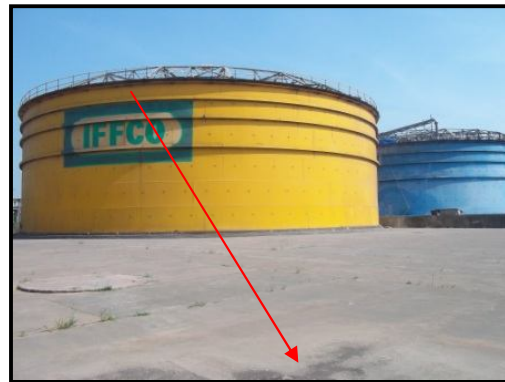
- C.C flooring done inside the area of tanks premises; noted with distresses like cracks/gaps & vegetation growth at constructions joints, holes and improper slopes etc. as shown in the typical photographs below.

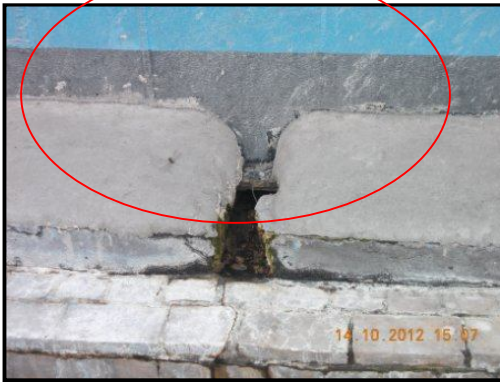
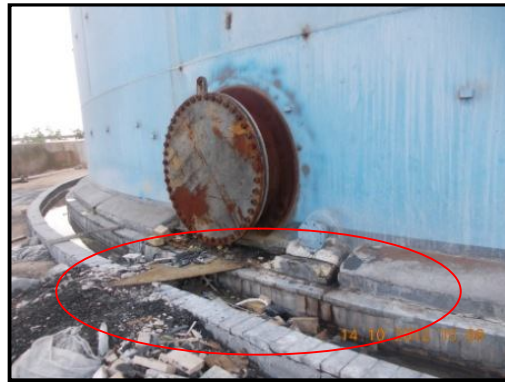
- RCC foundation noted with distresses like delamination of acid proof tiles, erosion in tile joints and localized exposed reinforcement at the area where drain system exits. Please refer below photographs.
- Repairs work was in progress at rear side of tank area; has been noted at the time of detailed inspection.

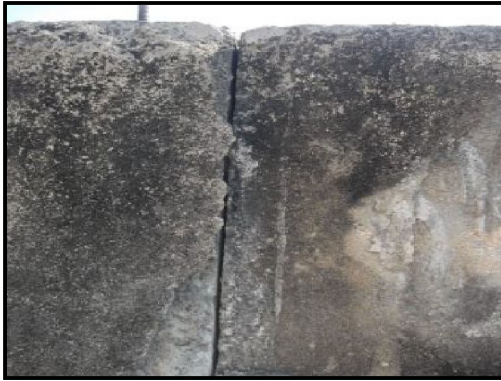
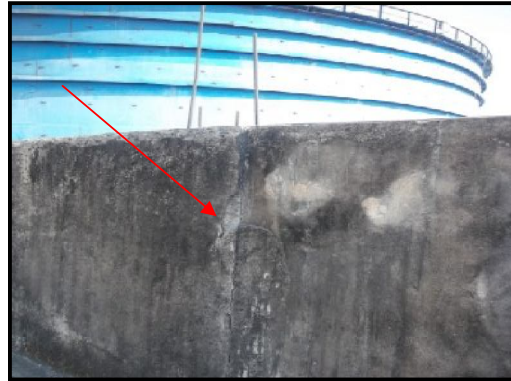
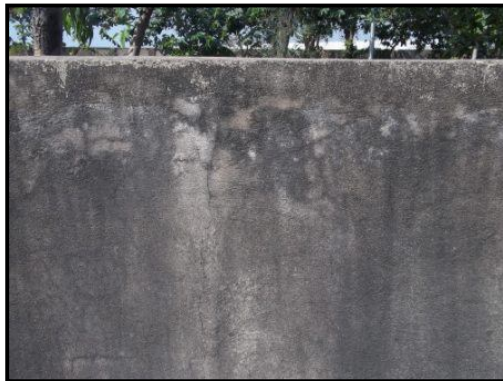
- R.C.C Dyke walls provided to enclose the peripheral area for the tanks; noted with distresses like untreated Expansion joints/expansion joints noted without filling material, localized through & wide spread vertical cracks and weathered surfaces etc. Please refer typical photographs below.

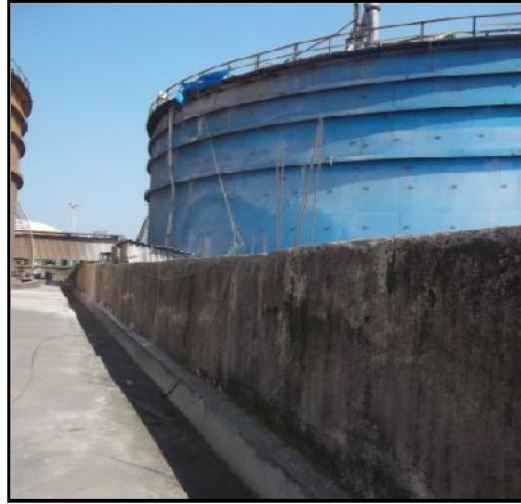
- Disalignment noted in the common RCC dyke wall between the two tanks; under reference.

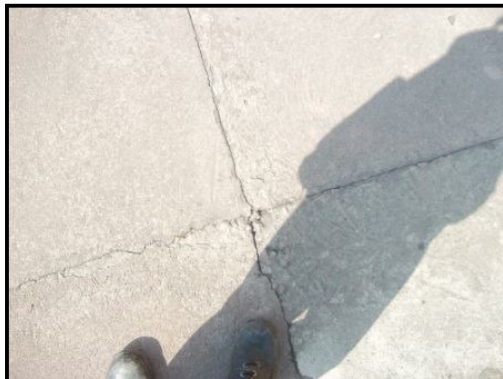
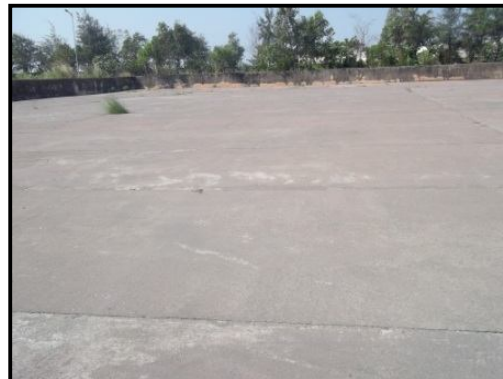
- C.C flooring done inside the area of tanks premises; noted with distresses like cracks/gaps & vegetation growth at constructions joints, holes and improper slopes etc. as shown in the typical photographs below.

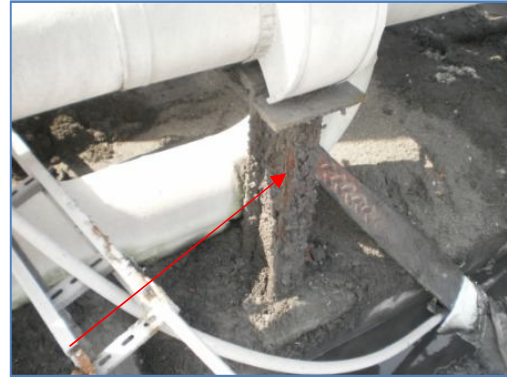
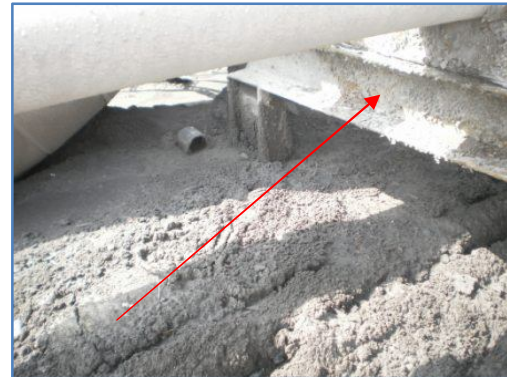
- Deteriorated condition of steel elements due to severe corrosion noted at many locations near the AFBC boiler house as shown in the typical photographs below.

- Localized replacement of the deteriorated steel elements as also further strengthening has to be done and need to be followed for the proposed rehabilitation work. However, the said strengthening work shall be done according to the design.

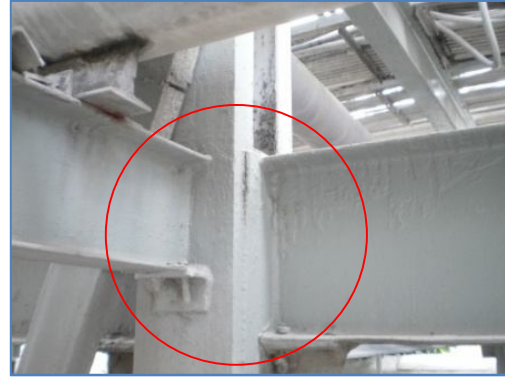
- Inadequate connections in the form of cleat angle missing on one side noted at many locations in the entire framing system as shown in the typical photographs below.

- Most of the distresses related to the inadequate connection details need be re-done with providing ideal connection details as can be best designed with improved specifications.

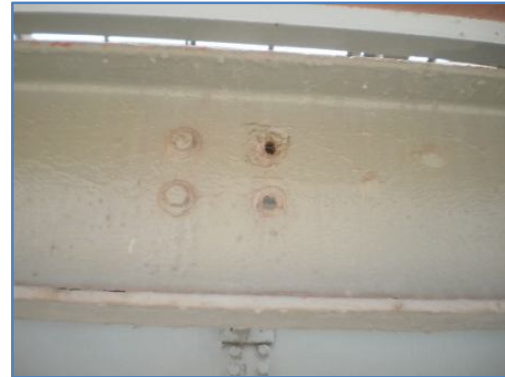
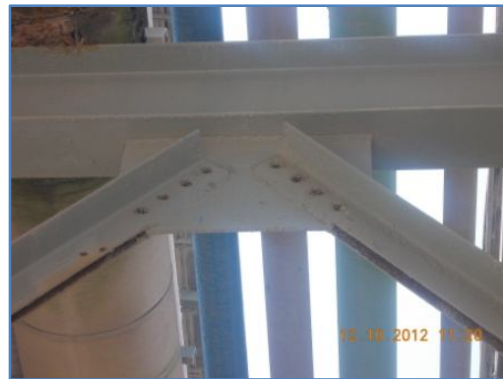
- Localized missing of nut bolts noted at many locations on longitudinal members, horizontal members and cross bracing as shown in the typical photographs below.

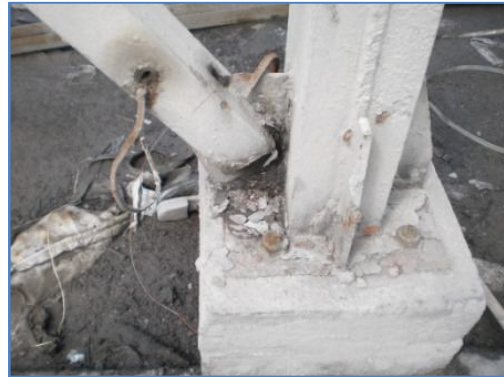
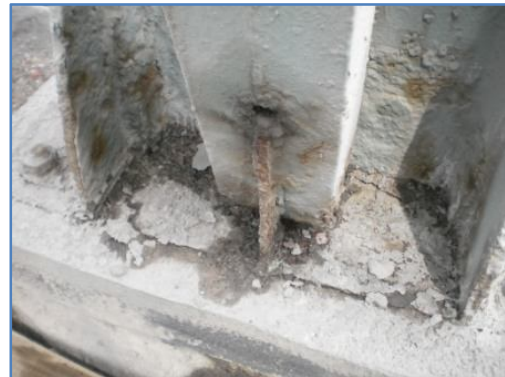
- Foundation nut bolts, base plate, side gusset plate and bottom section of the steel column noted with scaling, corrosion and pitting etc. Also RCC pedestal edges are damaged at many locations. Please refer typical photographs below.

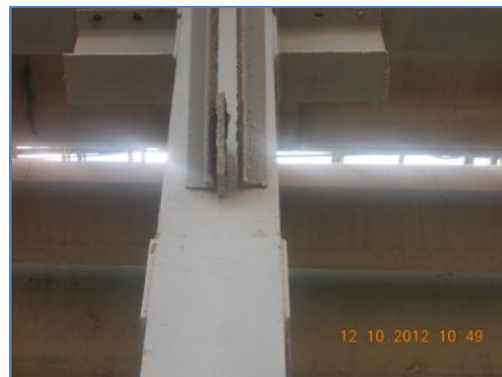
- Framing system of cantilever brackets noted with weld joints opened out due to severe corrosion and scaling at many locations as shown typical photographs below.

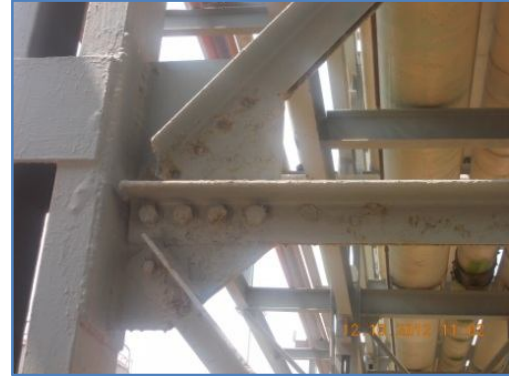
- Steel elements of connections noted with corrosion. Please refer typical photographs below.

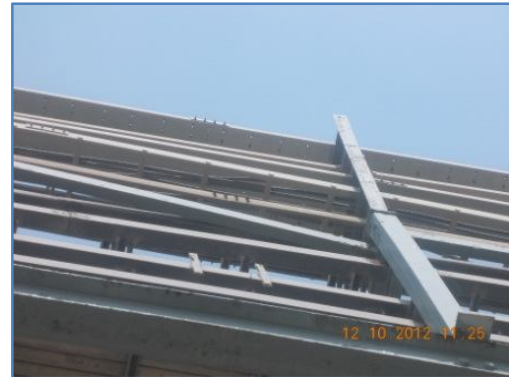
- Vertical members as seen in the photographs below noted with deflection in the alignment; might be due to the original construction deficiency. Also noted tack welding done instead of full welding. Localized missing of nut bolts at every connection also noted. Please refer typical photographs below.

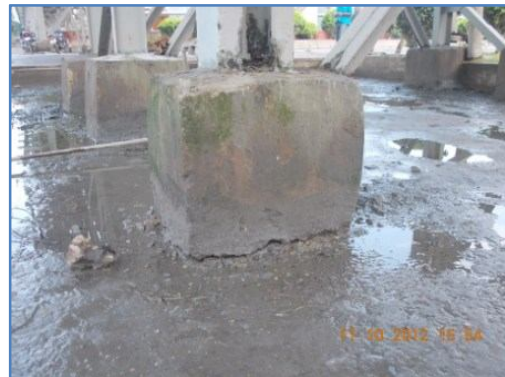
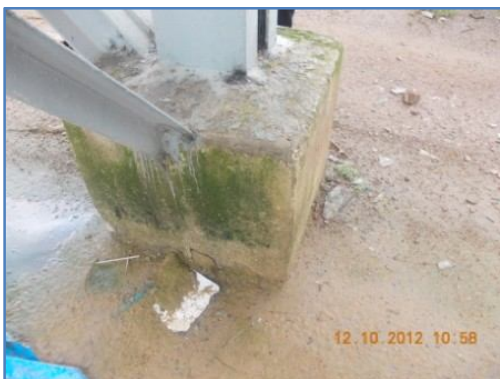
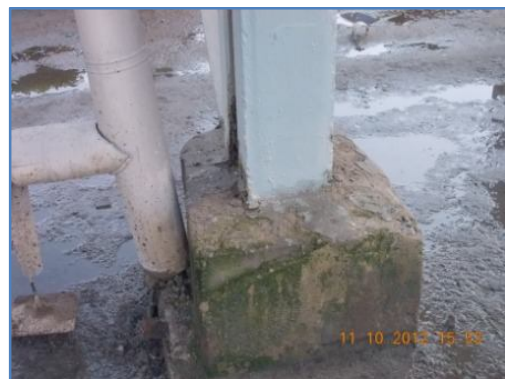
- Moss growth noted on the RCC pedestals at some locations. Also sever corrosion and scaling on vertical members & side gusset plates noted as shown in the typical photographs below.

Severe corrosion and scaling

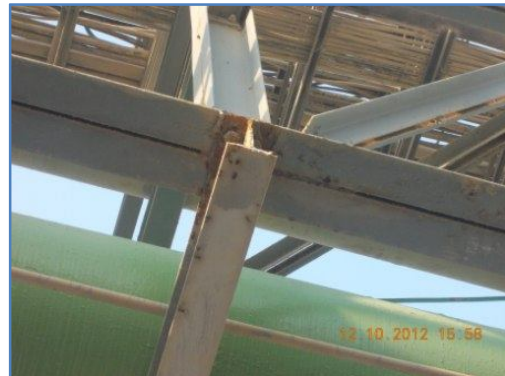
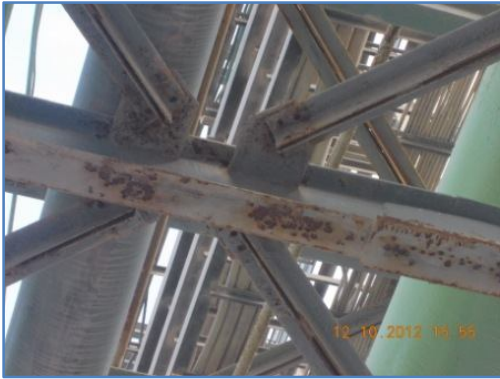
- Structural steel framing system of elevated pipe rack support system noted with localized corrosion in longitudinal members, horizontal members, cross bracings, nut bolts, vertical members, localized missing of nut bolts & cross bracings, peeling of existing paint etc. Please refer photographs below.

Corrosion and scaling

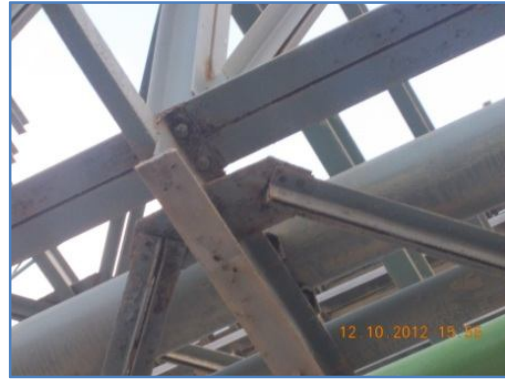
Nut bolts missing on cross bracings

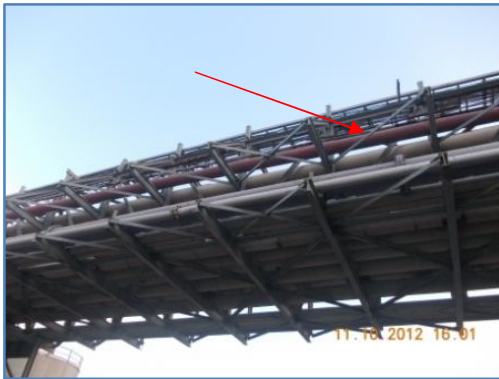
Cross bracing missing

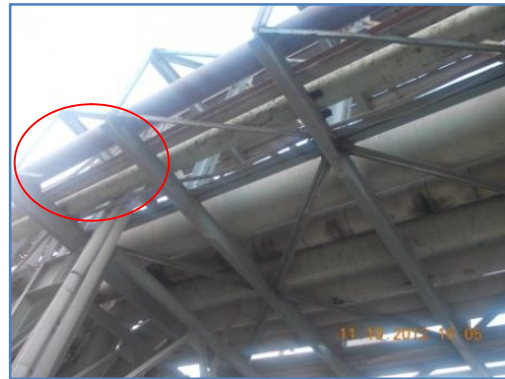
Cut/slotted cross bracing

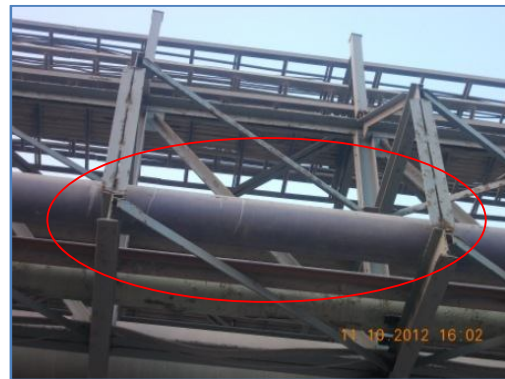
Corrosion, scaling and cut/slotted cross bracing

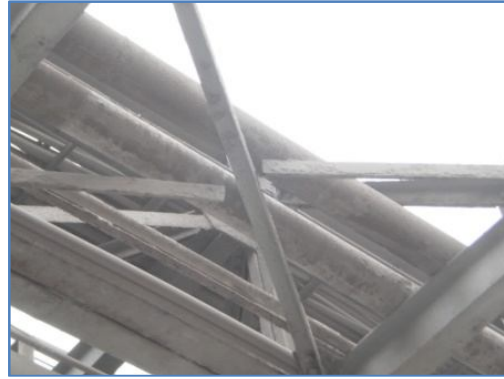
Inadequately welded connections

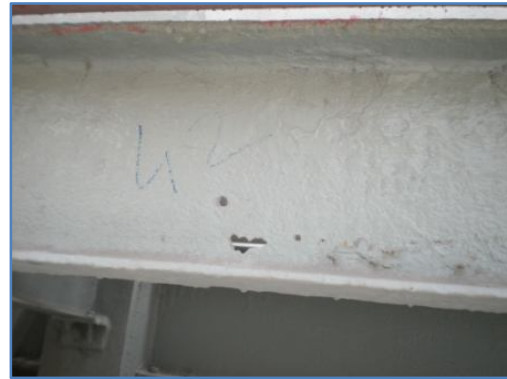
Severe corrosion

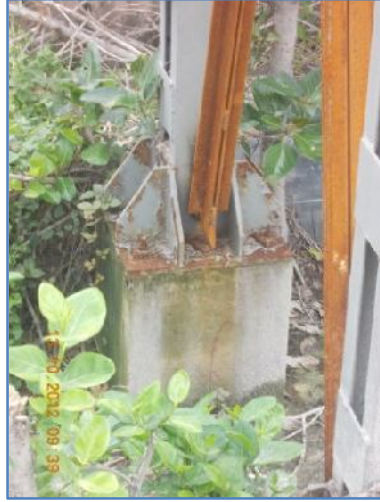
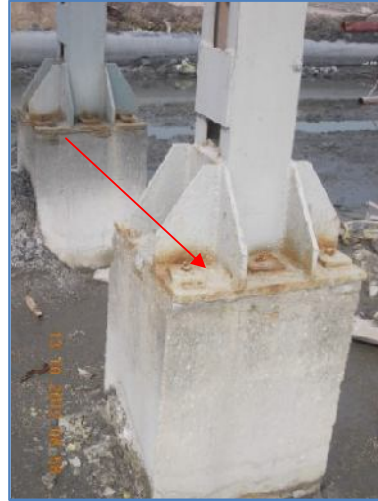
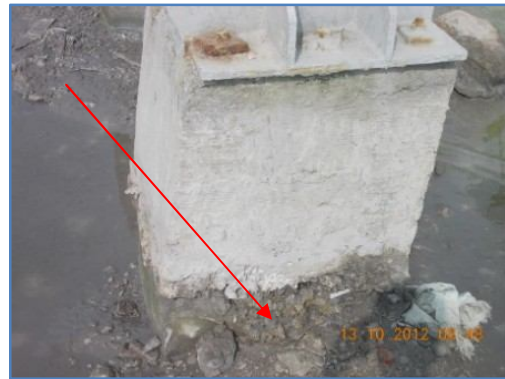
- Honey combing, moss growth, gap between base plate and RCC pedestal, corrosion and scaling on base plate, side gusset plate and foundation nut bolts and vegetation growth noted as shown in the typical photographs below.

Scaling, corrosion on base plate and gusset plate also vegetation growth and honey combing

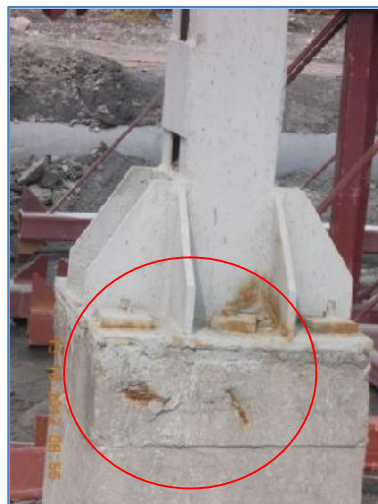
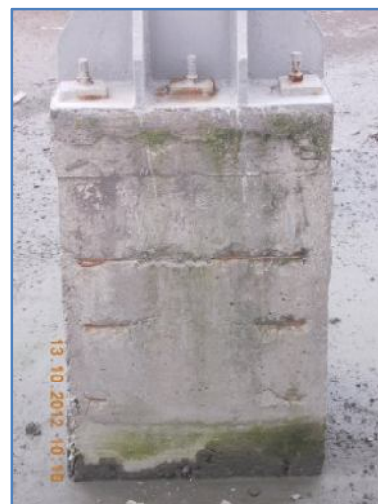
- Localized exposed reinforcement (actually it is original construction deficiency i.e. reinforcement laid without sufficient cover concrete), delamination of cover concrete of RCC pedestals etc. noted at many locations as shown in the photographs below.

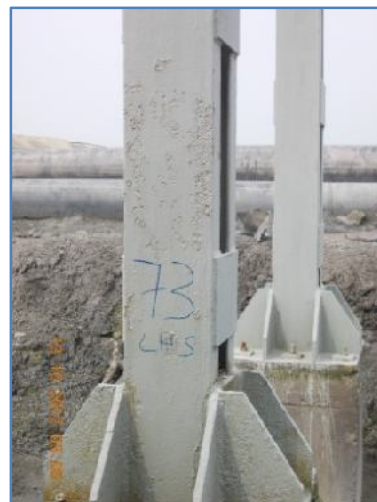
- Vertical members of the framing system noted with corrosion & pitting at many locations at many locations as shown in the typical photographs below.

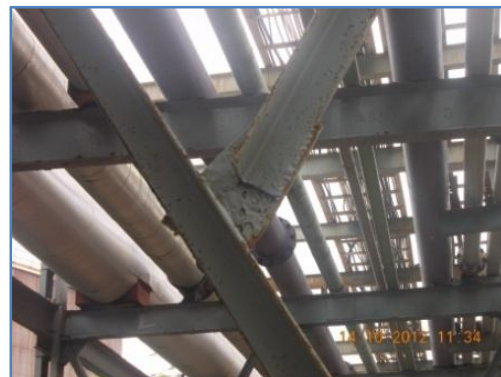
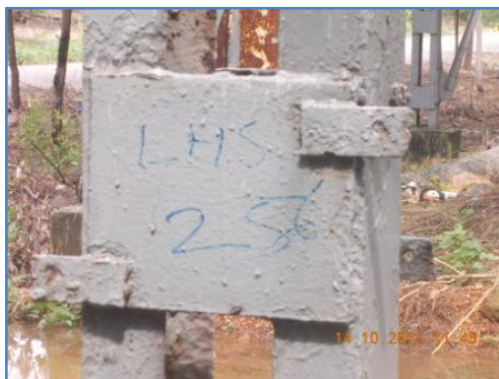
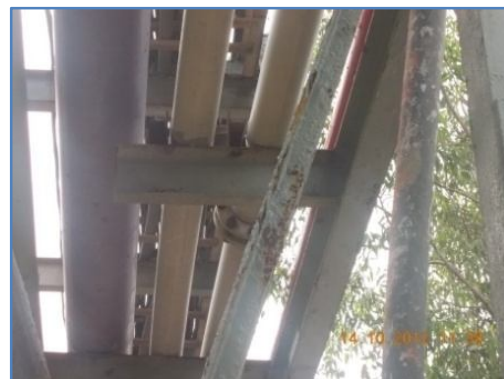
- Severe corrosion, scaling, pitting and peeling of paint noted on vertical steel member, side gusset plate, seat and cleat angle of longitudinal and horizontal steel members at some locations as shown in the typical photographs below.
