INSPECTION REPORT

**Health Survey of Existing Structure at
Ammonia Plant**

**Of
IFFCO, Paradeep
Orissa**

**INDIAN FARMERS FERTILISER COOPERATIVE
LTD, PARADEEP, ORISSA**

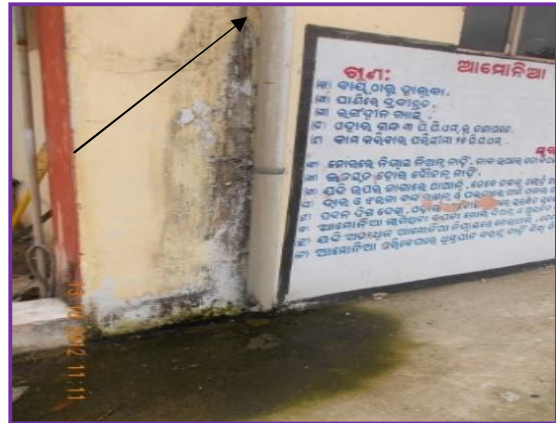
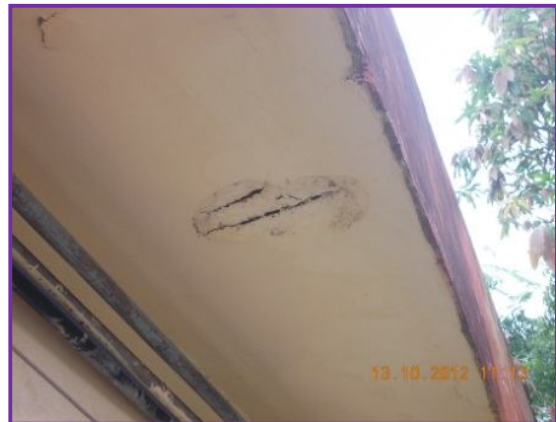
South side external observations:-

- This area reveal distresses like leakage / seepage marks & moss growth due to damaged/missing rain water pipes, localized spalling of cover concrete thereby exposed reinforcement at the soffit of RCC chajja etc.

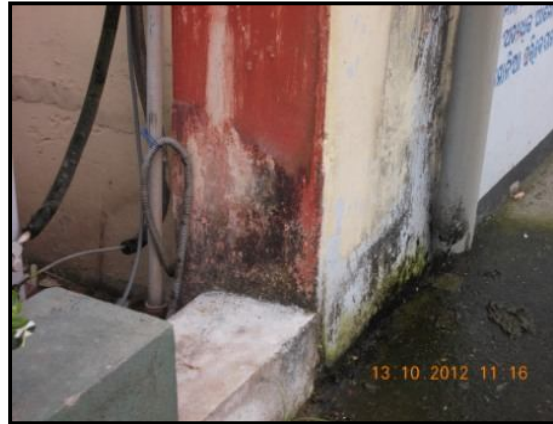
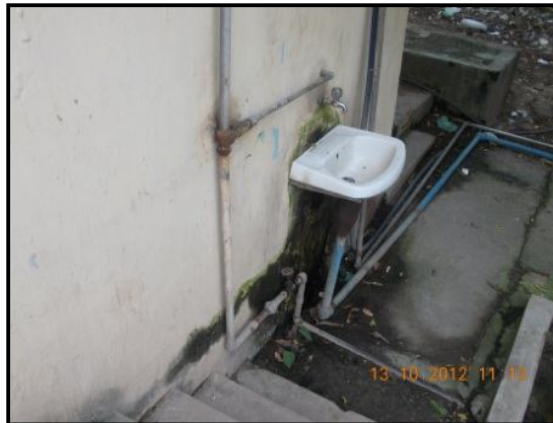
East side external observations:-

- This are reveal with distresses like vegetation growth, moss growth due to leakage/seepage, discoloration of paint and weathered surfaces etc.

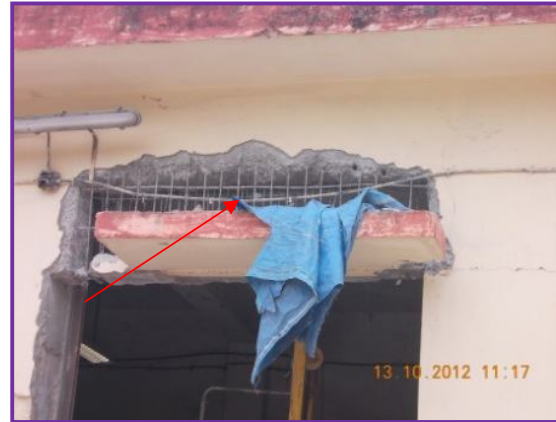
West side external observations:-

- Damaged and broken RCC beam and chajja noted on West side due to new opening arrangements made, as per requirement. However, the area left without any treatment is a cause of concern. Also, Separation crack noted at the junction of RCC and masonry wall.

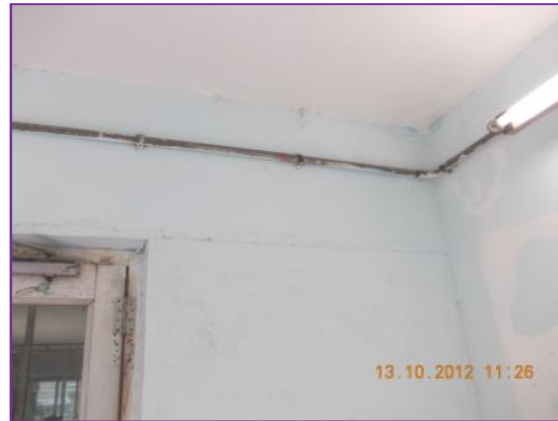
Control room-

- Separation crack noted between RCC beam and masonry wall. Also noted diagonal cracks on wall and unfinished cut-out made to masonry wall for passing cable line. Slab area inspection could not be possible due to false ceiling.

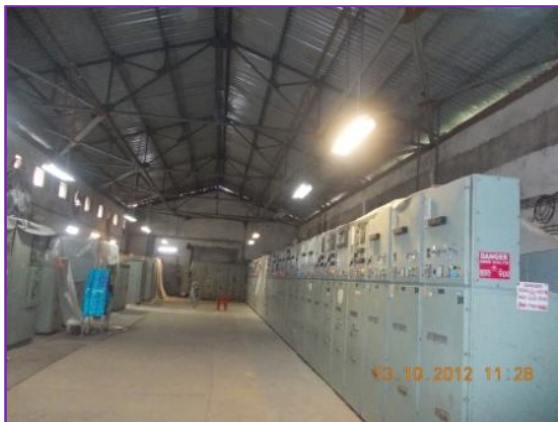
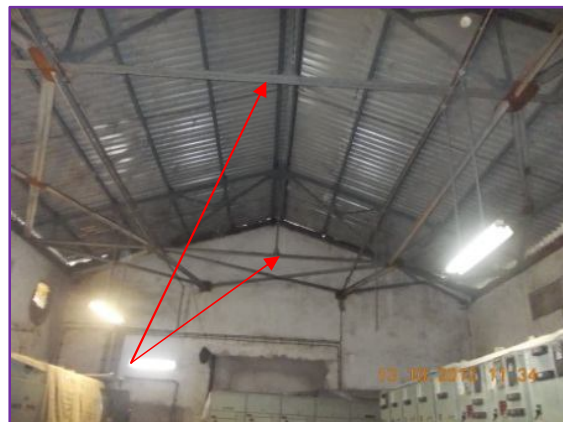
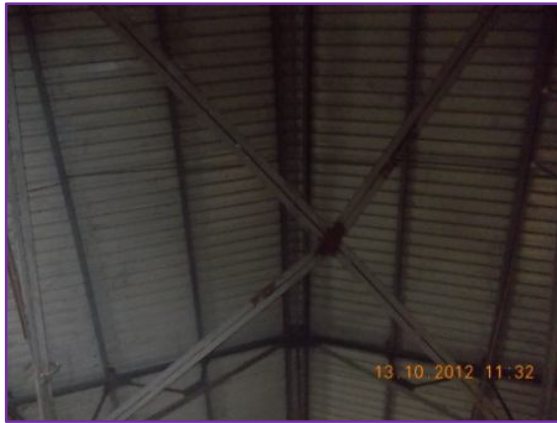
- As a matter of critical observation; deflection noted in the King post truss and roof purlins at some locations. Also, corrosion, scaling and pitting noted in the steel members of roof system.

- Localized replacement of the steel elements of truss system which noted deflected; shall be done according to the design.
- Most of the distresses related to the inadequate connection details need be re-done with providing ideal connection details as can be best designed with improved specifications.
- Few General distresses like Existing corrosion of the steel members shall be removed as per standard method and all the Structural Steel members shall be treated with application of 3 coats of 'SUNPUGUARD' (a high quality Anti corrosive two component Polyurethane coating) or equivalent as per Manufacturer's recommendations. Proper surface preparation of all Structural Steel members shall be done before application of SUNPUGUARD or equivalent, as per manufacturer's recommendations.

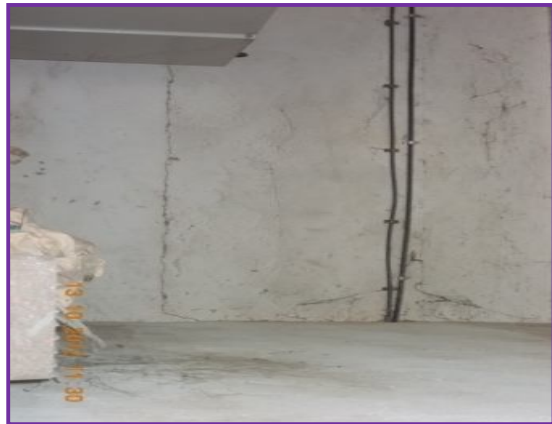
- Separation crack noted in between the RCC and masonry wall at some locations.

- Open the separation cracks with 'V' groove up to 15mm to 20mm depth.
- Clean the 'V' groove surface with water.
- Then apply the polymer mortar with metal embedded on it.
- This metal embedded mortar should be covered with proper chicken wire mesh with over lapping of 6 inch over brick work / Block work and 6 inch overlap to the R.C.C member (beam / Column).
- Apply the plaster according to the manufacturer's specification.

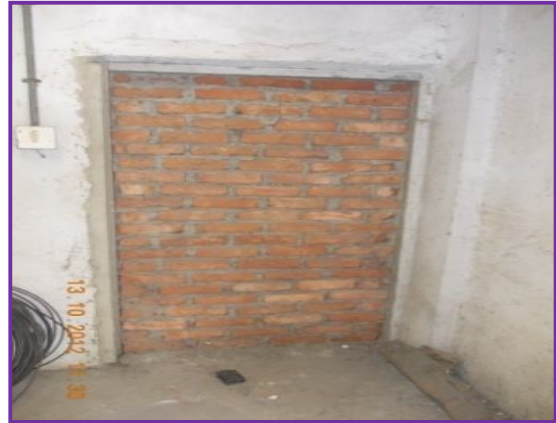
- Unfinished plaster noted on the brick masonry wall on West and North side wall as shown in the photographs below.

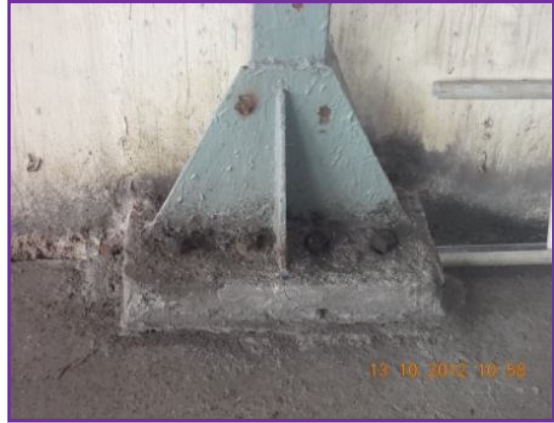
- Severe corrosion, scaling noted in base plates & foundation nut bolts of steel columns at many locations.

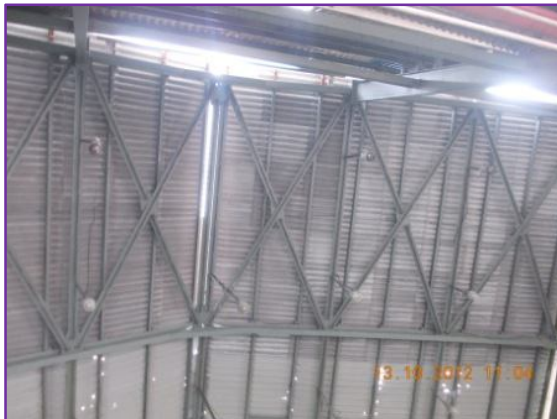
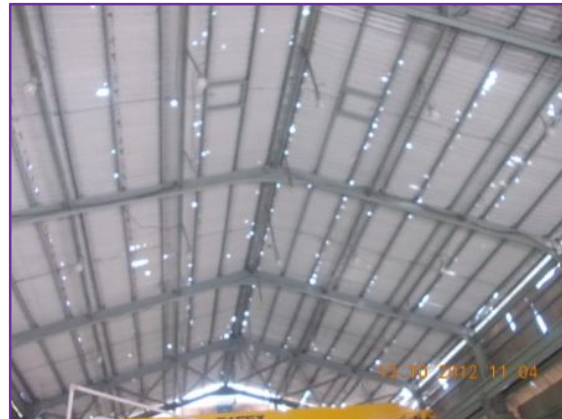
- Light corrosion and pitting noted in the steel elements of roof system like purlins, trusses, cross bracings etc. Also noted nut bolts missing in cross bracings and damaged pre coated sheets in the roofing system.

- Damaged sheets at roof & cladding shall be removed; locally; and replaced with similar type of materials.
- This is the broad assessment of the structural health at this stage.

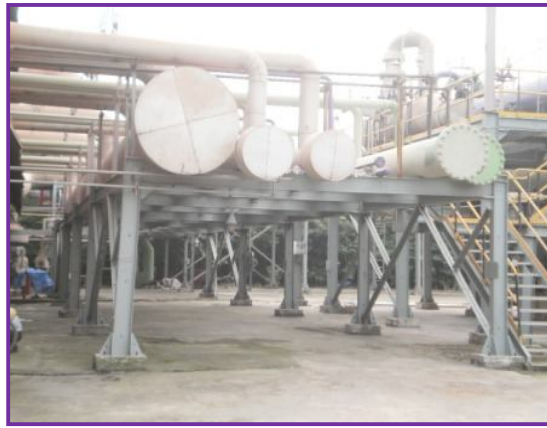
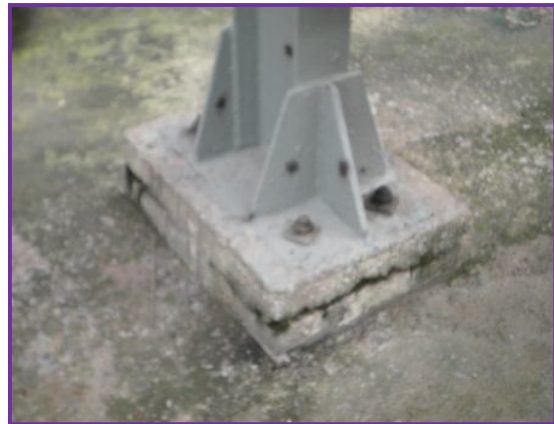
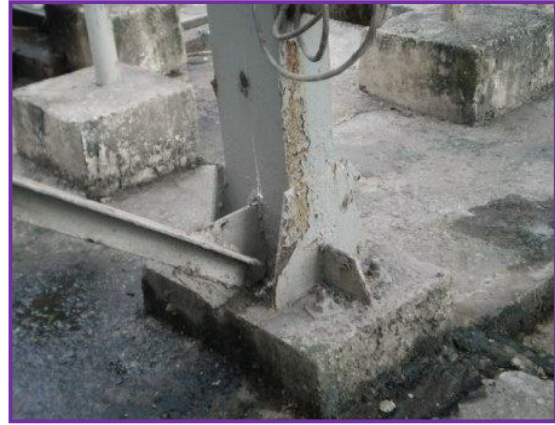
- Cracks noted on top finishing layer of RCC pedestals. Also, corrosion, scaling and pitting noted in the steel elements (of connection system) like nut bolts, base plate, and gusset plates etc. at many locations. Corrosion also noted in the main steel members like columns, beams, cross bracings and tie beams etc. Please refer typical photographs below.

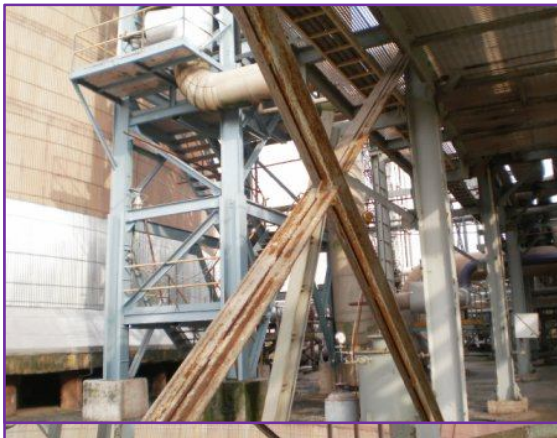
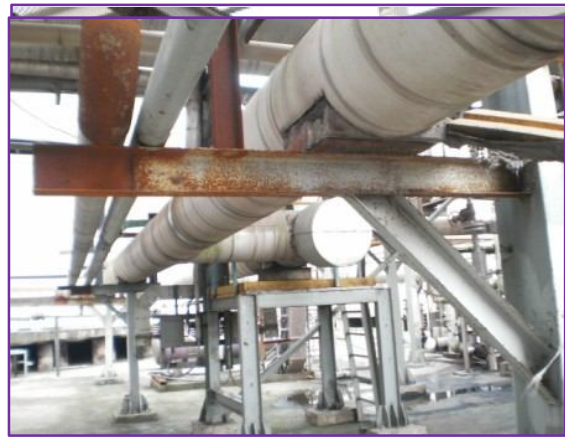
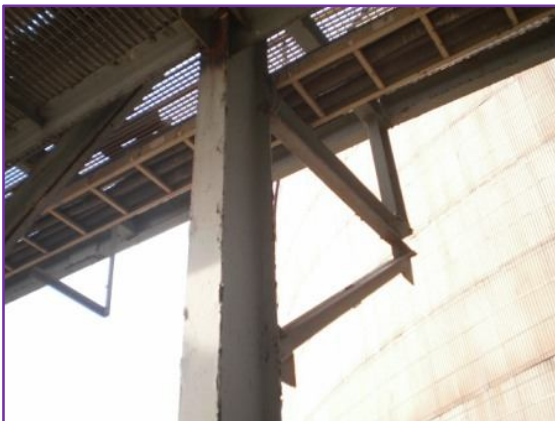
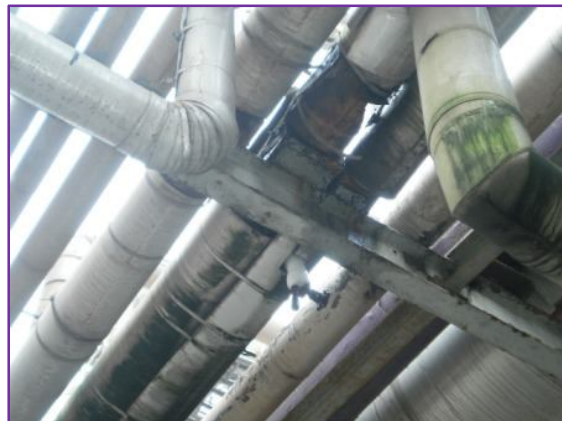
- Inadequate connections in the form of cleat angles missing in one side noted at every connection. Please refer typical photographs below.

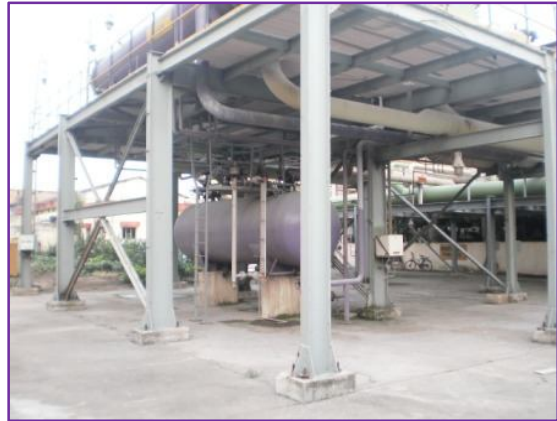
Ammonia condensate structure-

- Structural steel elements of this structure noted with corrosion at some locations. However, severe corrosion and scaling noted on base plate, foundation nut bolts at almost all locations. Please refer typical photographs below.

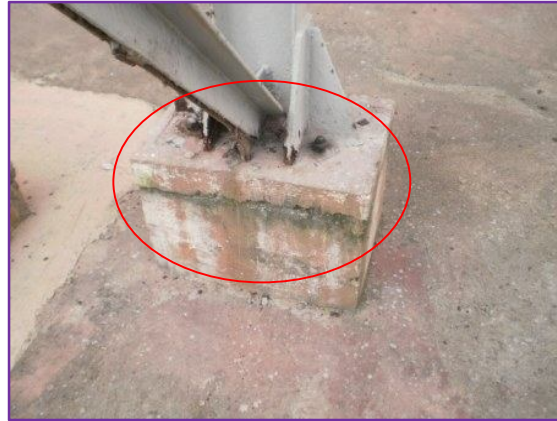
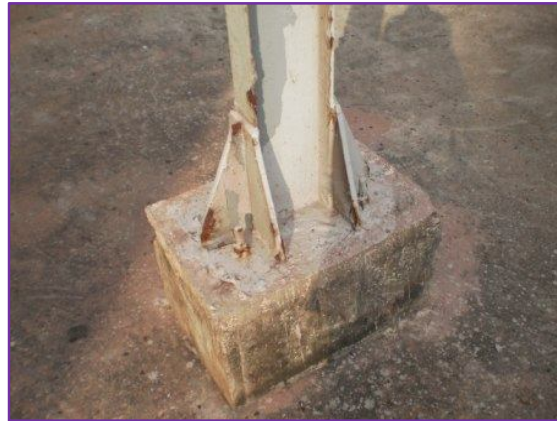
- Severe corrosion noted in the steel elements like base plate, foundation nut bolts, central gusset plate and cross bracings etc.

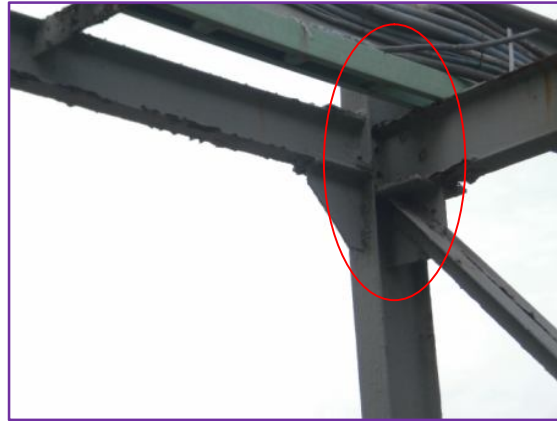
- Inadequate connections in the form of cleat angles missing in one side noted at every connection. Please refer typical photographs below.

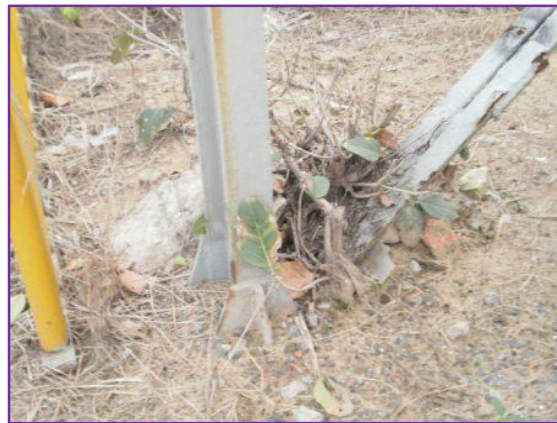
- Vegetation growth noted at junction of the steel column and RCC pedestal as seen in the photographs below.

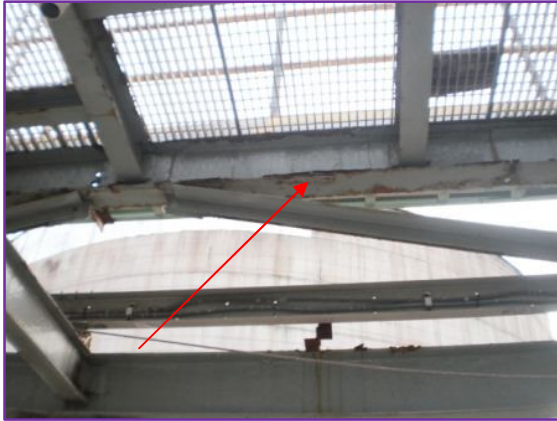
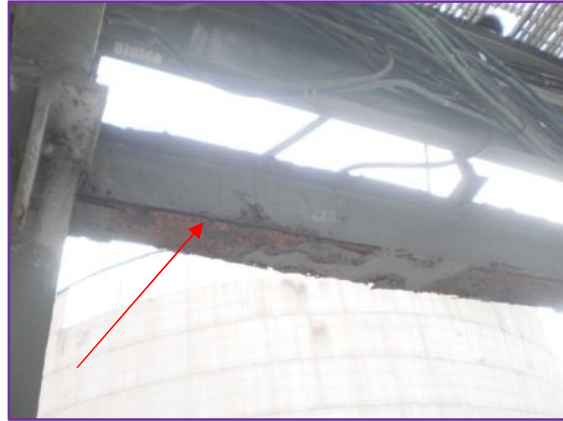
- Severe corrosion and scaling noted on the longitudinal and horizontal members of steel beams as seen in the photographs below.

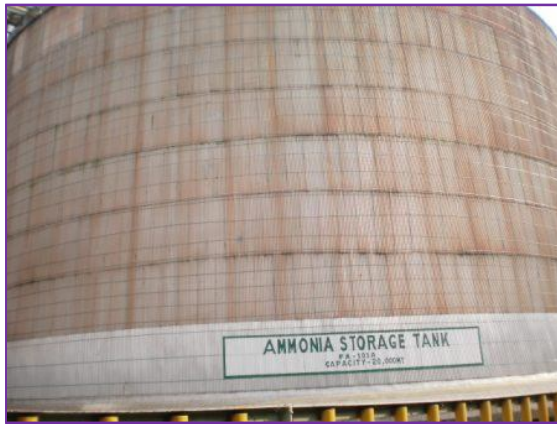
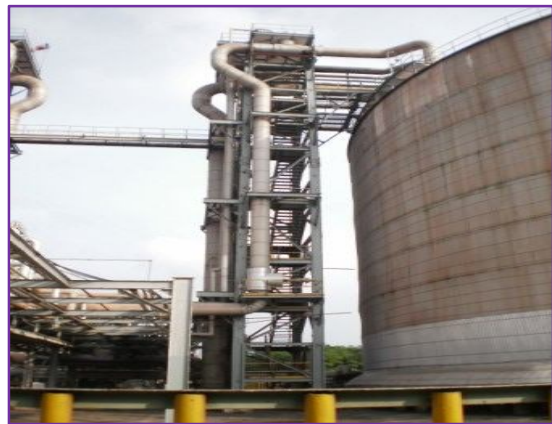
- The staircase near the above said tank reveal distresses like corrosion in all the steel elements like columns, beams, cross – bracings, stringer beams, base plates, gusset plates, foundation nut – bolts etc; inadequate connections in the form of missing cleat angles, missing nut – bolts as also insufficient welding done etc. Please refer typical photographs below.
- [Ammonia tank - 20000 MT \(FA.101A\)-](#)

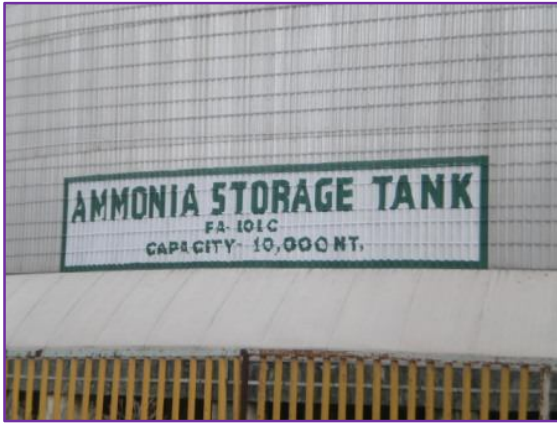
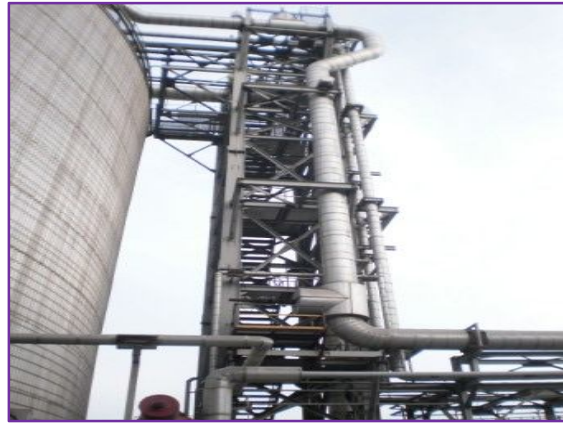
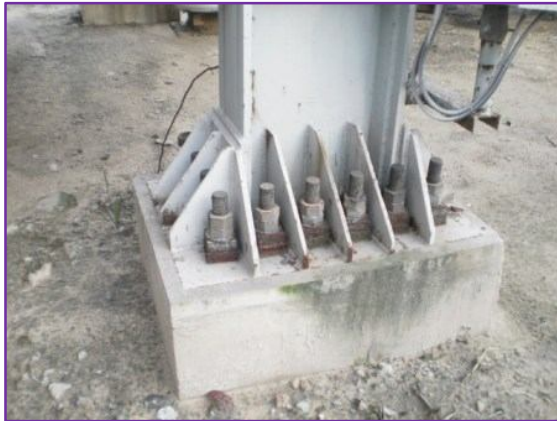
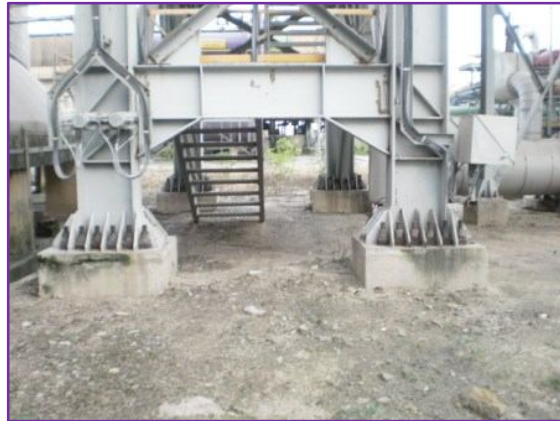
Ammonia tank - 10000 MT (FA.101C)-

Corrosion, scaling and pitting

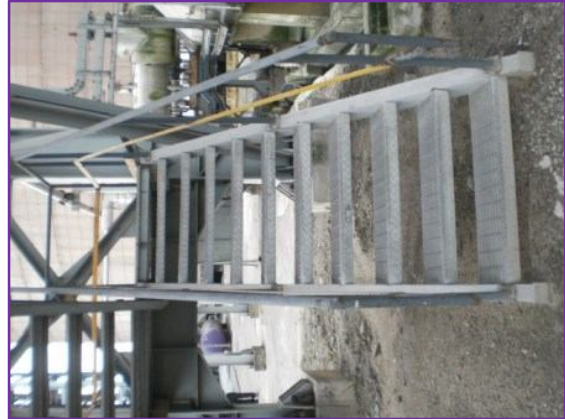
Corrosion, scaling and pitting on weld connection and steel members

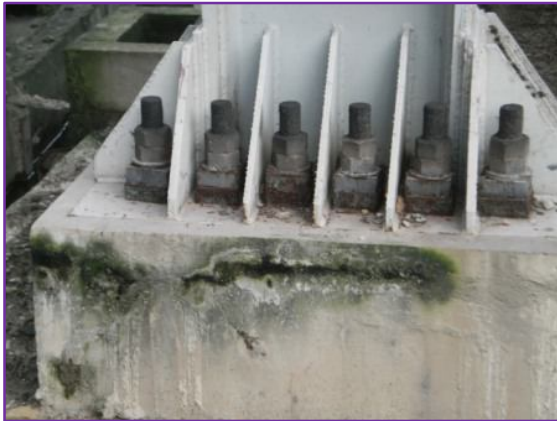
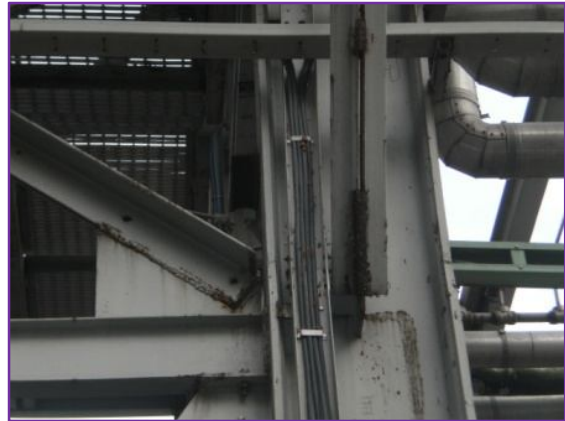
Crack on top layer of RCC pedestal / Nut bolt missing and insufficient welding

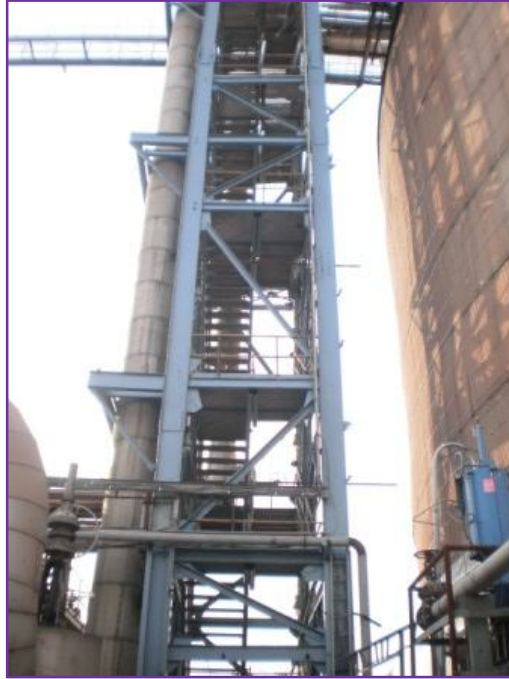
Ammonia tank - 20000 MT (FA.101B)-

- Staircase seems painted recently hence all the visible distresses are covered.

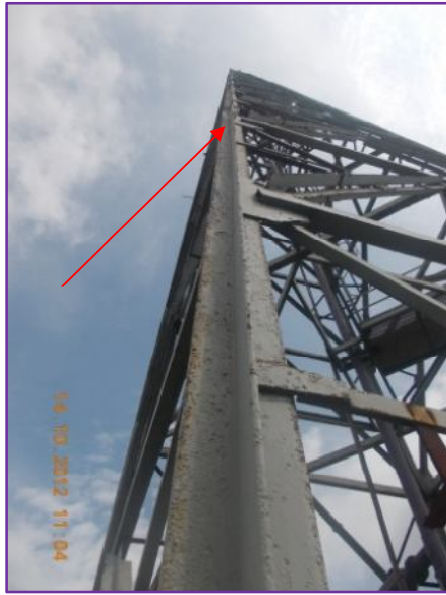
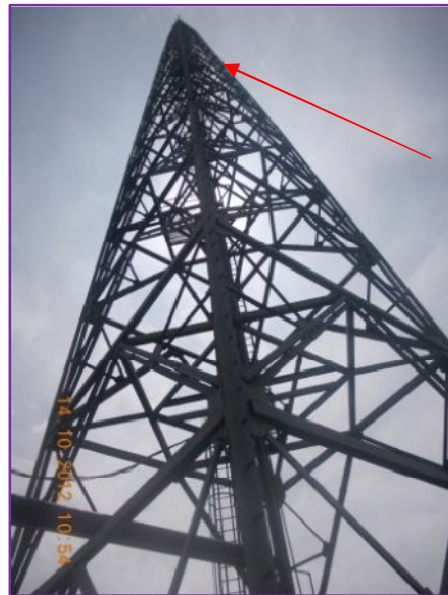
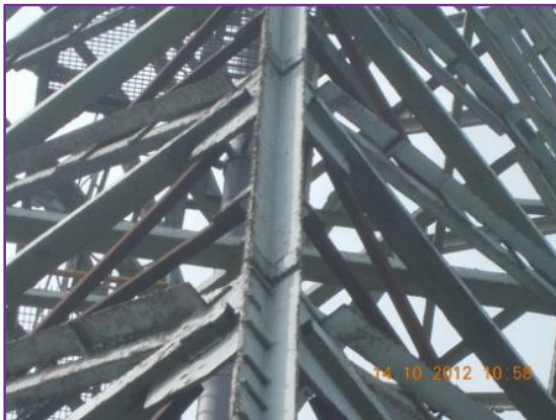
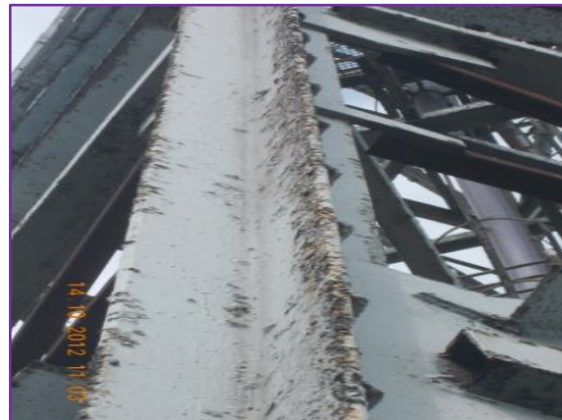
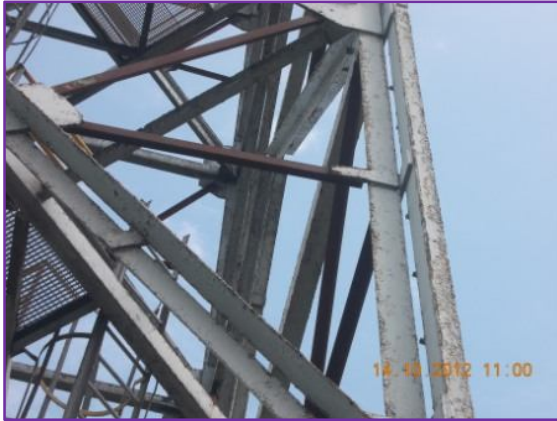
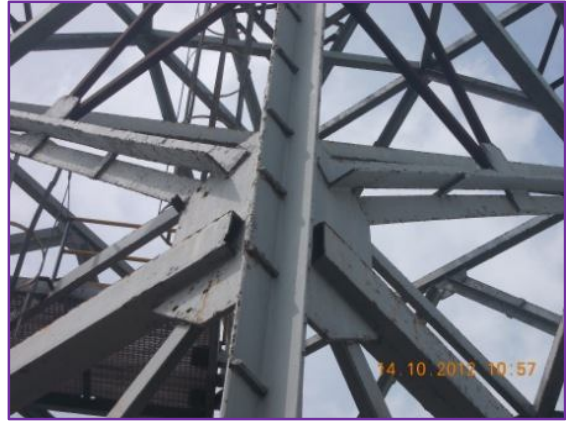
- The main members of steel framing system i.e. steel columns, tie beams, cross bracings etc. noted with corrosion, scaling and pitting at many locations as shown in the photographs below.

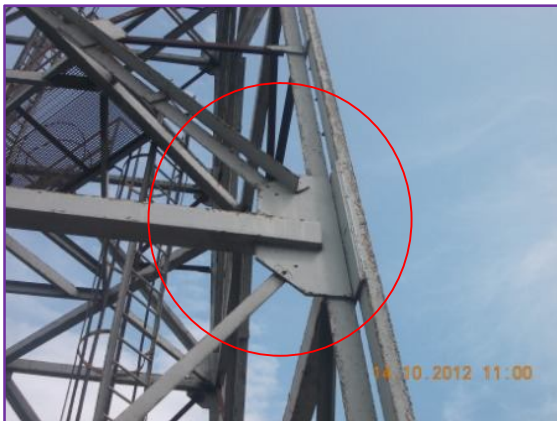
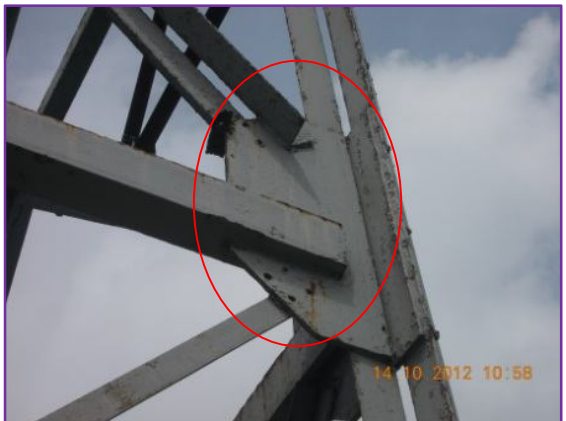
- Nut bolts missing noted on cross bracings and horizontal members at many locations as shown in the typical photographs below.

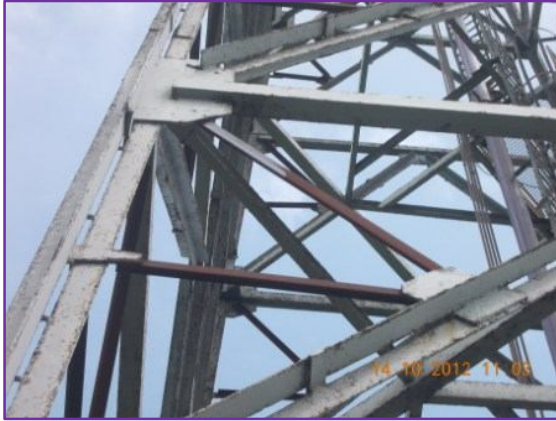
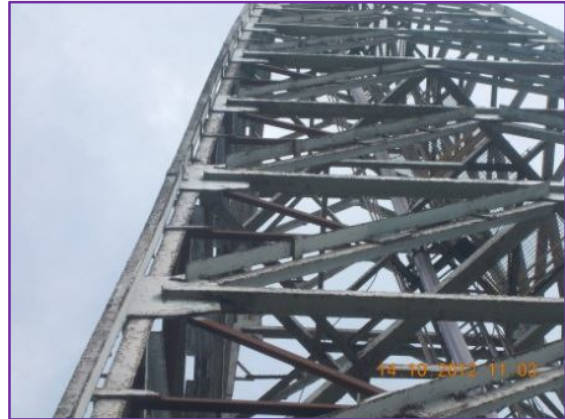
- Structural framing system noted updated in the form of removal of damaged cross bracings and replaced with new member, at some locations as shown in the typical photographs below.

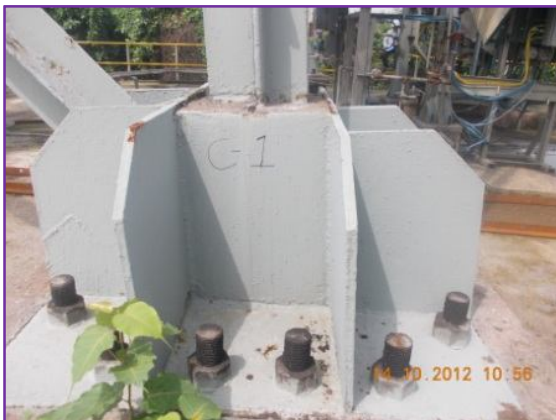
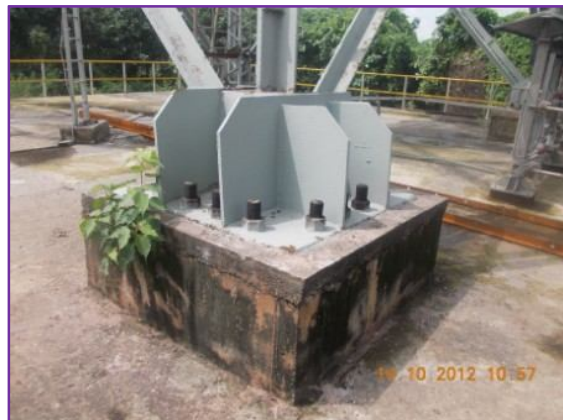
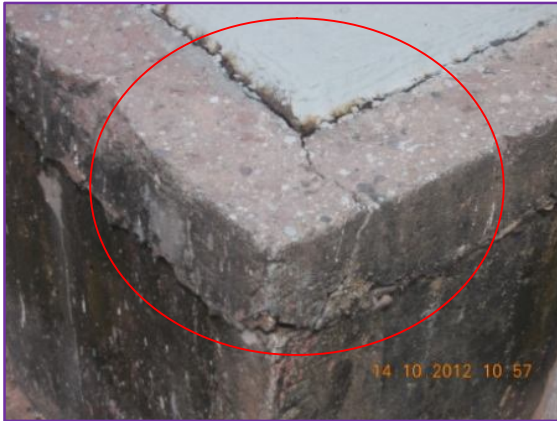
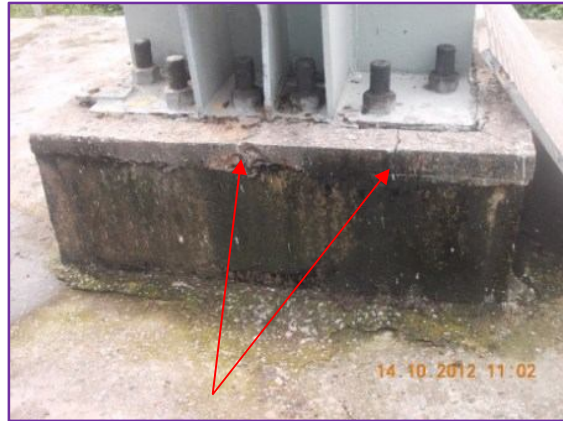
- Vegetation growth, moss growth and crack on top finishing layer noted in the RCC pedestals. Also scaling and pitting on base plate, side gusset plate and vertical steel members noted as shown in the photographs below.

- The gap between concrete and top finishing layer (in RCC pedestals) shall be finished with suitable grouting as per existing system/method.
- Most of the distresses related to the inadequate connection details need be re-done with providing ideal connection details as can be best designed with improved specifications.

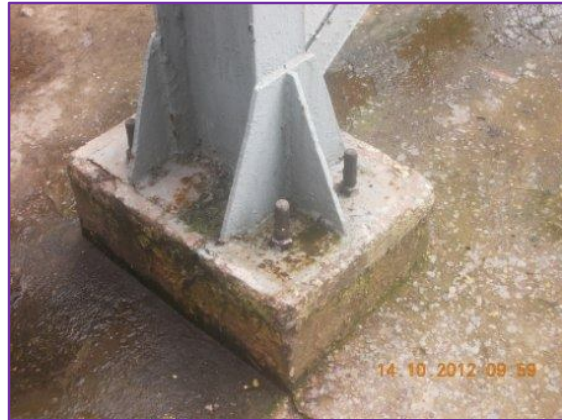
- Severe corrosion, scaling and pitting noted in the base plate, stiffener plate and steel column at some locations as shown in the photographs below.

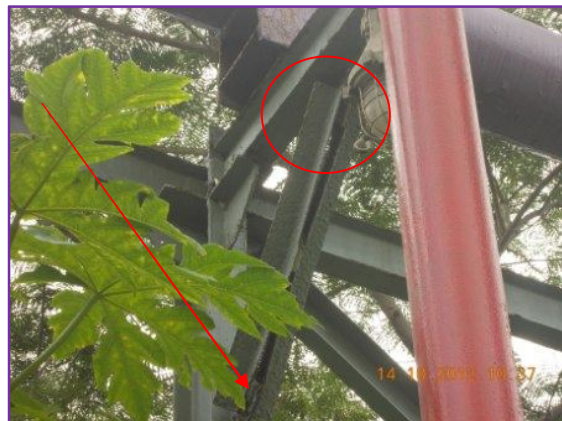
- Weld joint opened out noted on the cross bracings at few locations due to severe corrosion and scaling as shown in the photographs below.

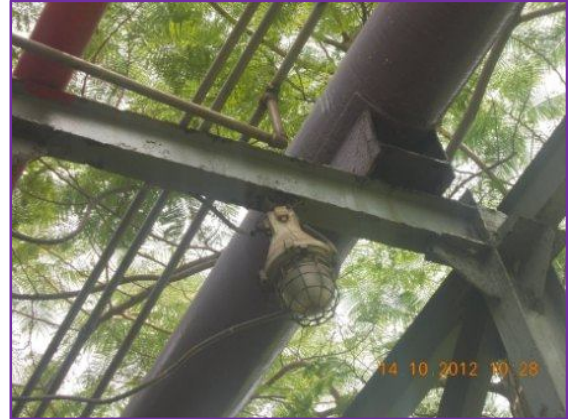
- Corrosion noted in the steel elements like longitudinal, horizontal, vertical members of the supporting system of pipes at many locations as shown in the typical photographs below.

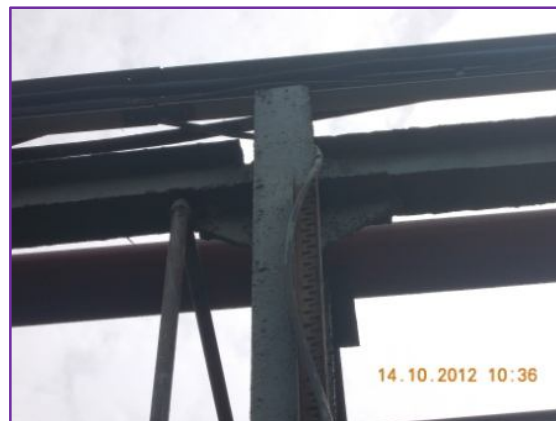
- Inadequate connections noted in the form of longitudinal members did not reached to steel columns properly as seen in the typical photograph below.

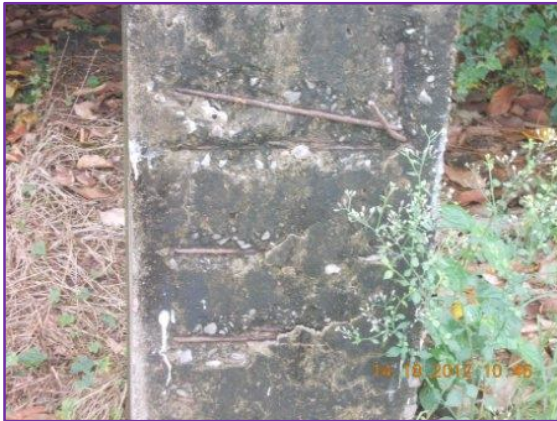
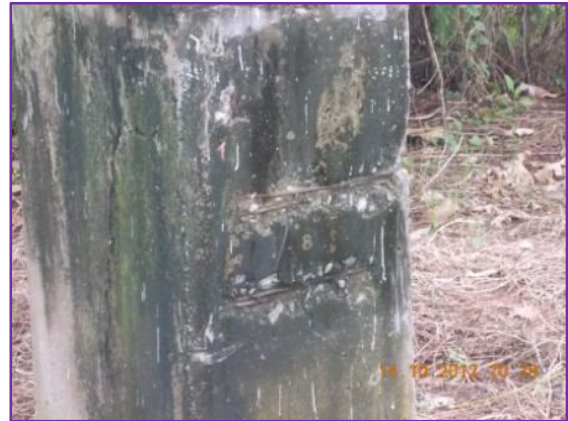
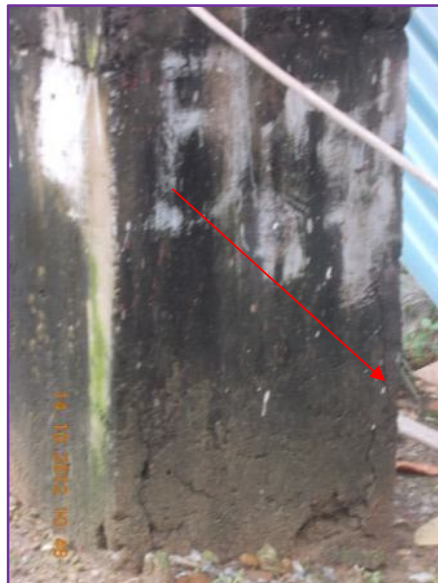
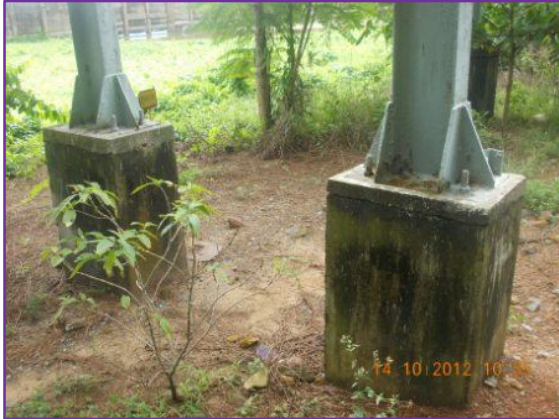
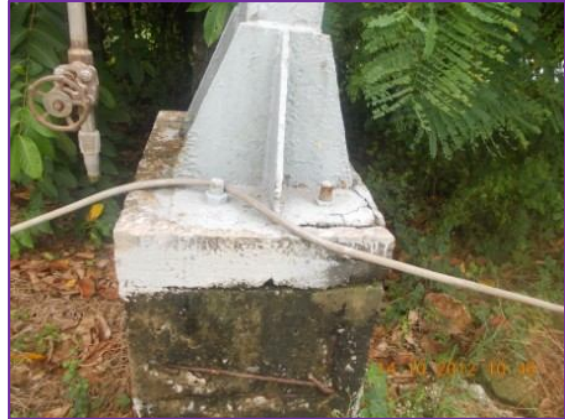
- RCC pedestals provided to support the steel framing system of pipe rack noted with distresses like exposed reinforcement (actually it is original construction defect i.e. reinforcement laid without sufficient cover of concrete), localized bulging of cover concrete & cracks due to corrosion of reinforcement, moss growth and cracks in the top finishing layer etc. as shown in the photographs below.

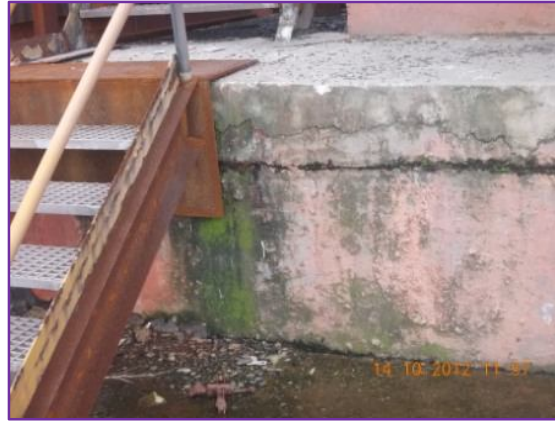
- Moss growth on entire structure, vegetation growth, crack / gap between RCC wall and slab noted as seen the photographs below. Also, note corrosion in the steel elements of staircase.

Moss growth and corrosion in steel elements of staircase

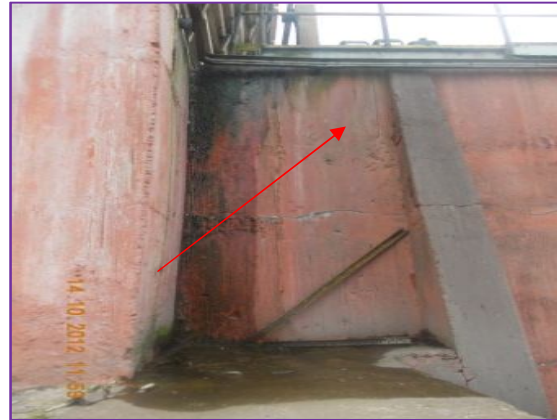
- Bulging of concrete noted at some locations especially at the construction joints/subsequent concrete pours as seen in the photographs below.

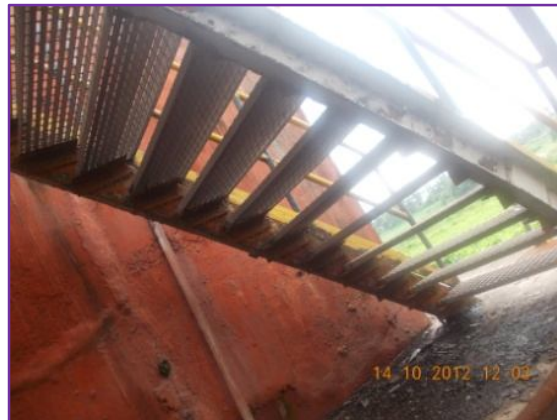
- Severe corrosion, scaling and pitting noted in the steel elements of staircase as shown in the photographs below.

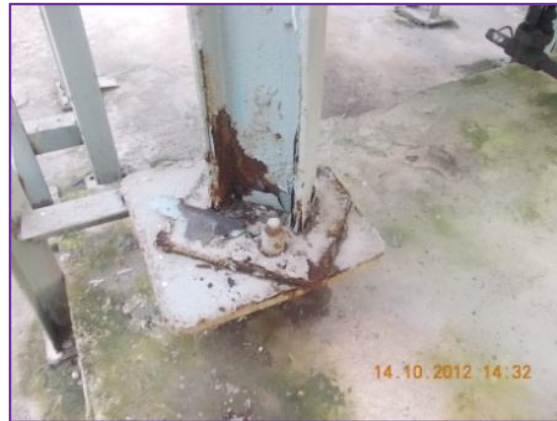
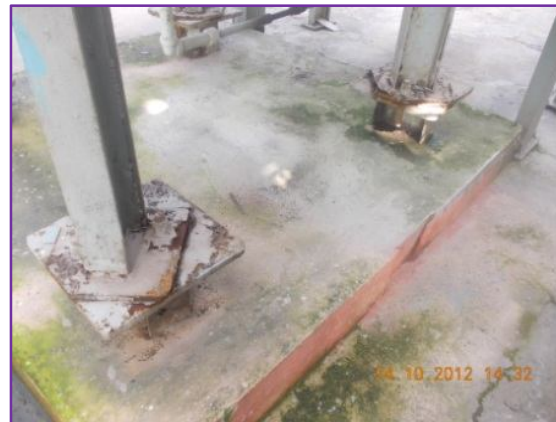
AIR RECEIVER TANK-

- Severe corrosion, scaling and pitting noted on the structural steel column, base plate and foundation nut bolts of air receiver tank near the ammonia cooling tower. Also, two vertical columns directly rest on steel plate without any fixtures as shown in the photographs below.

Severe corrosion and scaling on base plate and nut bolts / vertical steel column directly rest on steel plate.

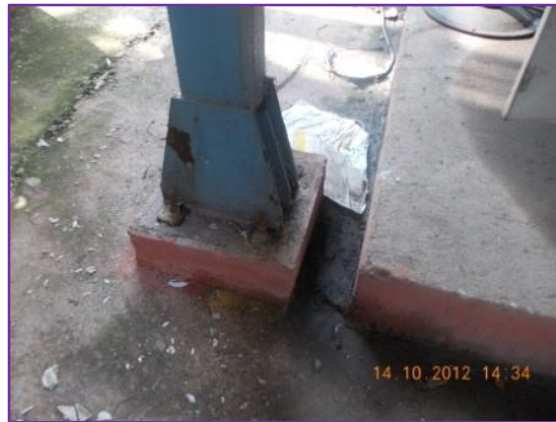
PIPE RACK-

- Severe corrosion, scaling and pitting noted on the structural steel column, base plate; horizontal and vertical steel members etc. as shown in the photographs below.

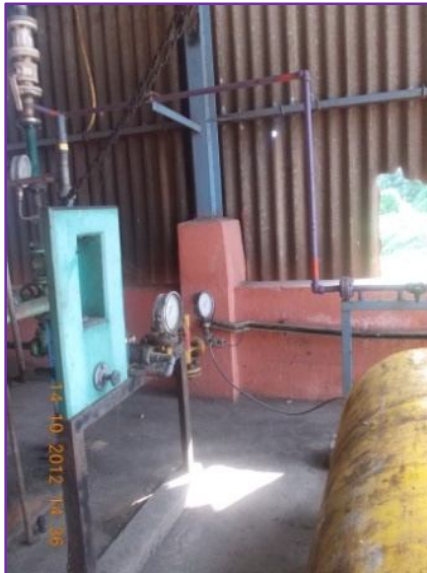
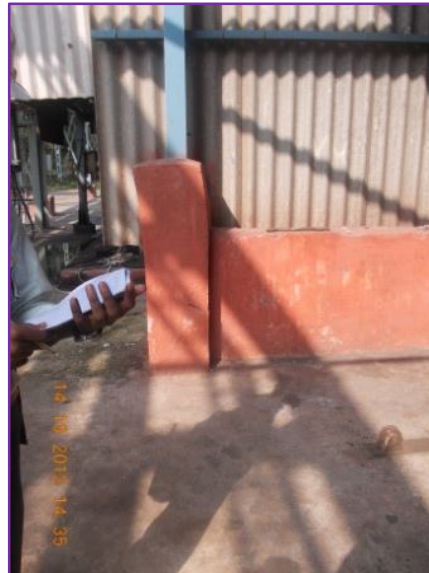
STEEL STRUCTURE NEAR THE AIR RECEIVER TANK-

- Structure seems recently painted hence visible distresses are covered.
