# Low Temperature—II

## Compressor explosion

C. W. GIBBS  
*Ingersoll-Rand Company*

Investigation of damage caused by an explosion during a routine test warns compressor operators against explosive oil-air mixtures.

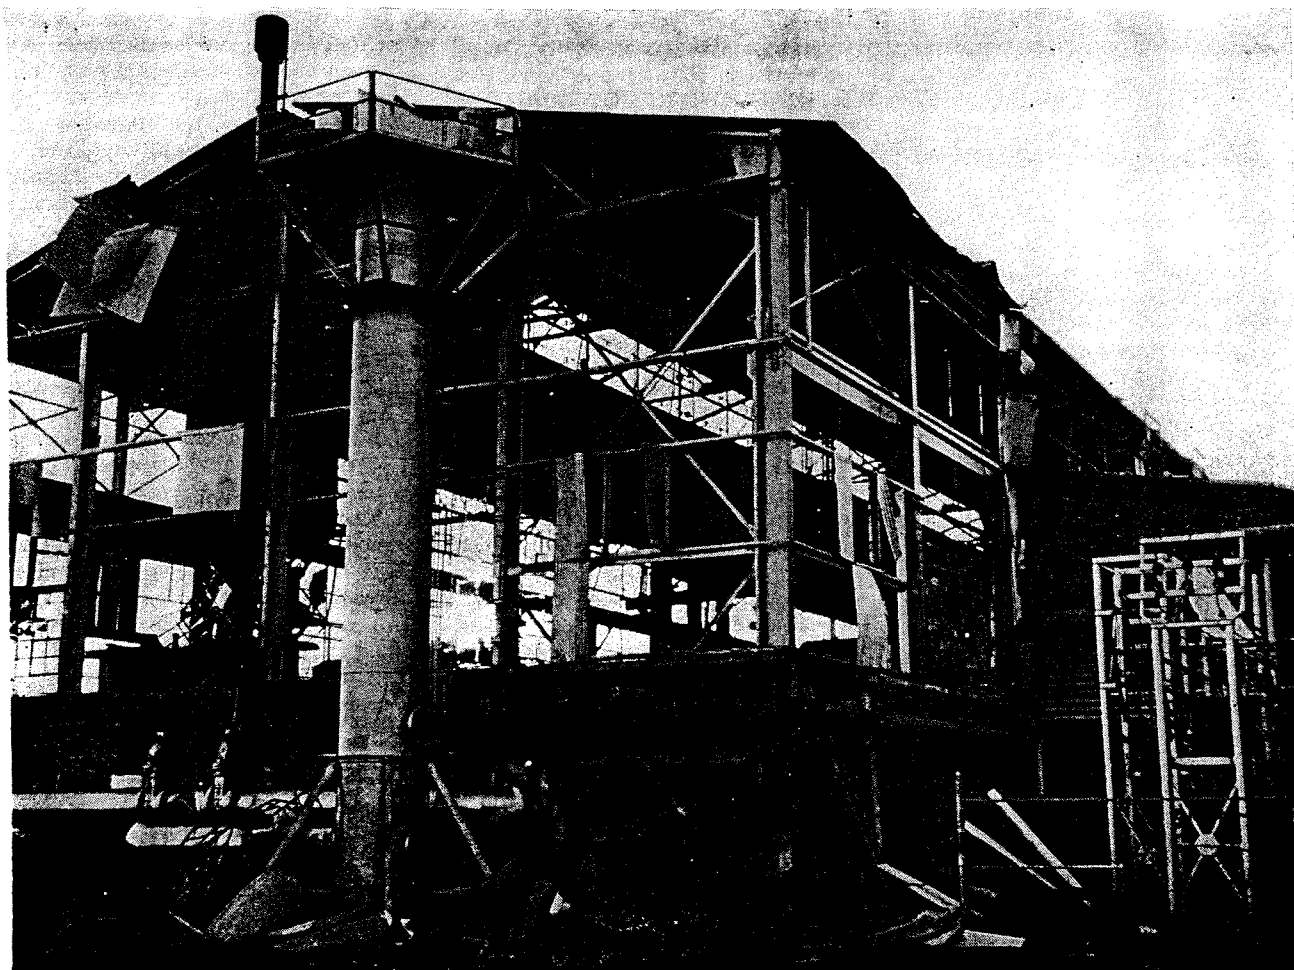
Damage to building housing the compressor testing facilities where accident occurred.

An external view of the building shown in the introductory photograph will give you an idea of the damage done. Figure 3 shows the area where the test loop had been beneath the platform.

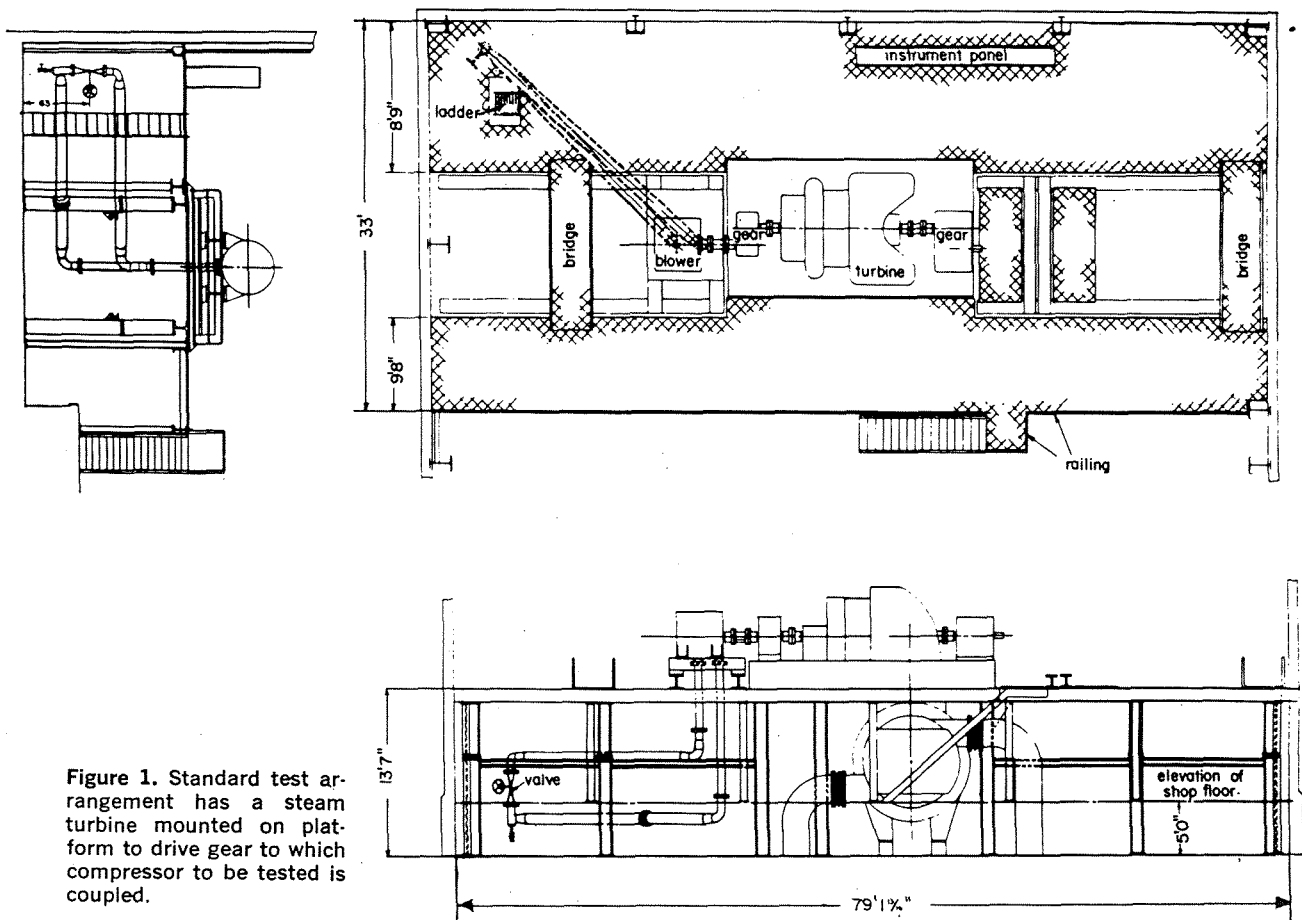
The test setup which is of interest is shown in Figure 1. Testing is done on a platform on which a special 22,000 hp steam turbine driver was permanently mounted, and served by a condenser located beneath the platform. A speed-up gear is driven by the turbine and the compressor on test is coupled to the gear output shaft.

Figure 1. Standard test arrangement has a steam turbine mounted on platform to drive gear to which compressor to be tested is coupled.

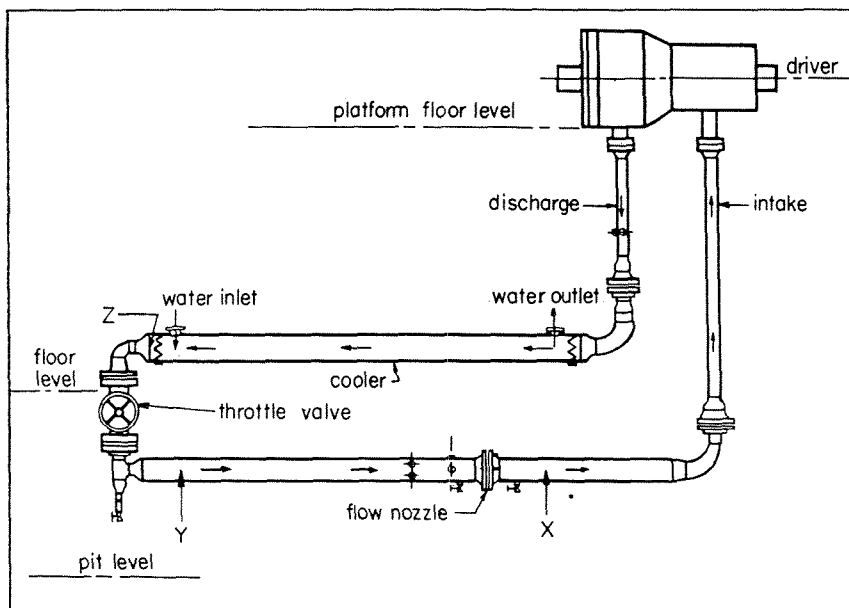
All physical damage in the area resulted from the ruptures caused by detonations within the cool low pressure piping at two points in the horizontal run at the bottom of the test loop. The approximate locations of the ruptures are indicated on the diagram at points "X" and "Y". A third failure occurred at point "Z", but this was due to the severe bending force imposed by the detonations at "X" and "Y" rather than a local detonation.

The committee assembled all of the parts that could be retrieved and studied them exhaustively. At point "X" on the diagram the heavy 12-in. pipe had been ruptured so that it was opened up like a banana peel. A detonation or explosion pressure of extreme intensity undoubtedly occurred in this region. Evidence of soot supported the conclusion that oil was

present and had combined with the compressed air to form a combustible mixture.

At point "Y" in the diagram a second severe rupture occurred giving a similar banana peel appearance to the exploded pipe. In between the two ruptures a long section of pipe was intact. This condition is typical of ruptures caused by detonation waves. They create a region of very high pressure, ignite and explode, and then travel at relatively low speed to a new region where this is repeated. This may be followed by successive waves of pressure at intervals along the pipe.

In studying the reassembled parts positive evidence was found that the detonation wave had traveled from right to left on the diagram. This, of course, is opposite to the direction of the normal flow of air in the loop system. The findings also localized the damaging detonations in the cooled low pressure part of the loop system.

It is known that the low pressure air in the system at 600 lb./sq. in. was at a temperature of 85°F. Fires in compressed air systems occur occasionally and are practically always associated with the high temperature region at the discharge of a compressor. This fact is well known to the industry. Here, however, the ruptures and damaging detonations occurred in low temperature regions and not in high temperature regions. In view of the direction in which the pressure wave apparently traveled, it could only be concluded that a fire occurred somewhere in the compressor and the resultant shock wave traveled down the low pressure piping, gathering momentum until it detonated at the first point of rupture marked "X" on the diagram.

Figure 2. Flow diagram of compressor piping indicating sections where explosion damage occurred.

The investigating committee was also instructed to make recommendations to insure against a recurrence of this accident. The recommendation was made and immediately put into effect that an inert gas, which will not support combustion, be used in place of air in all future testing of centrifugal compressors where it is possible for combustible materials to enter the closed loop. This we feel certain will prevent a recurrence.
