the operators
report on
SAFETY
in air
and ammonia
plants

*
The fourth and final
part of CEP's
exclusive report on
the informal
roundtable session
takes up, in detail,
the direct problems
involved in actual
explosions experienced
by the companies
represented at
the session.

BOLLEN, Dow (Canada): On December 13, 1957 at about 4:15 p.m. an explosion and fire occurred at the ammonia plant of the Dow Chemical of Canada Ltd., in Sarnia, Ont., which destroyed the hydrogen purification unit. Two men were fatally injured and one man was seriously burned.

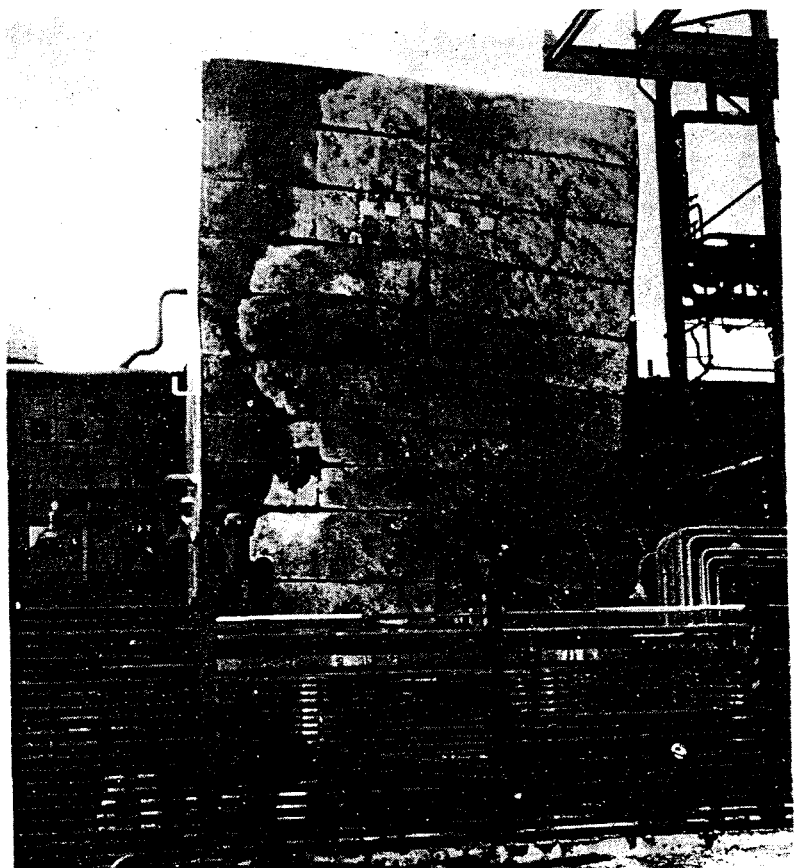
General view of the cold box from the north side after the fire had been extinguished.

All evidence indicated that the explosion had been inside the cold box casing, but outside the equipment. Careful examination of all the pipe and vessels revealed no evidence of rupture by internal pressure or explosion, or any

evidence of mechanical failure. The center of force, although not too clearly defined, was in the general area of the liquid nitrogen scrubbing column at an elevation of approximately 13 feet. The force of the explosion tore the top head off the cold exchanger and collapsed and tore loose the bottom head of the reflux condenser. Support legs under other nearby units were shattered allowing the vessels to drop, causing separation of numerous lines.

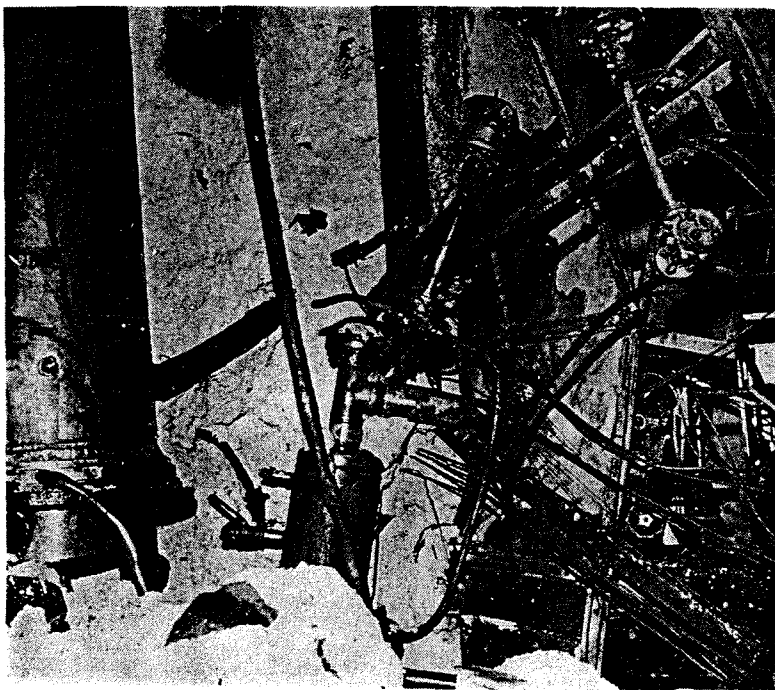
Close-up of cold box from inside the building, showing extent of damage to lower southwest corner.
