Oxygen plant vaporizer explosion

An analysis of the causes led to plant changes for improving safe operation.

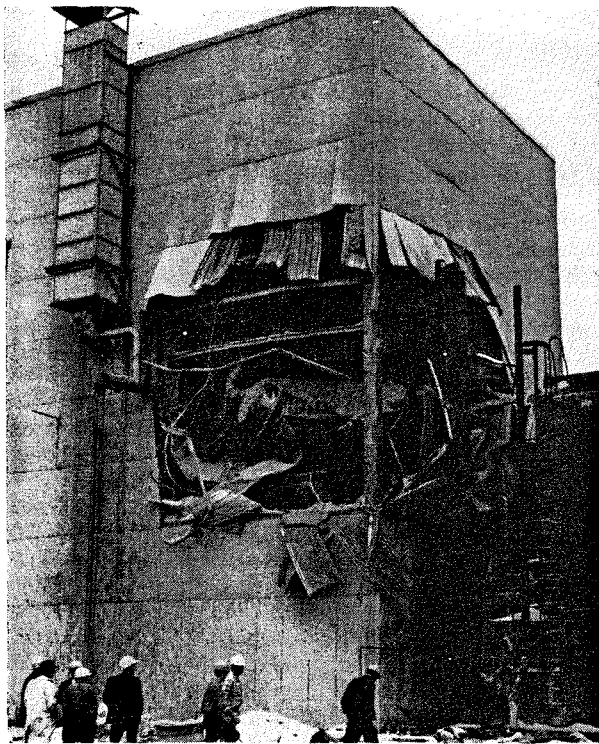
HIGH PURITY OXYGEN SUPPLIED by three units with a total capacity of 350 tons/day is required by the Dominion Foundries and Steel, Ltd. for producing steel. At 8:10 P.M., September 30, 1959, the vaporizer in No. 2 unit exploded, wrecking the vaporizer and surrounding parts of the cold box, Figures 1 and 2. No one was injured and production loss was minimized because the No. 3 spare 150 ton unit had gone on stream three weeks earlier.

Figure 1. Damage to plant before any repair work was started. Vaporizer displaced from normal position can be seen in foreground.

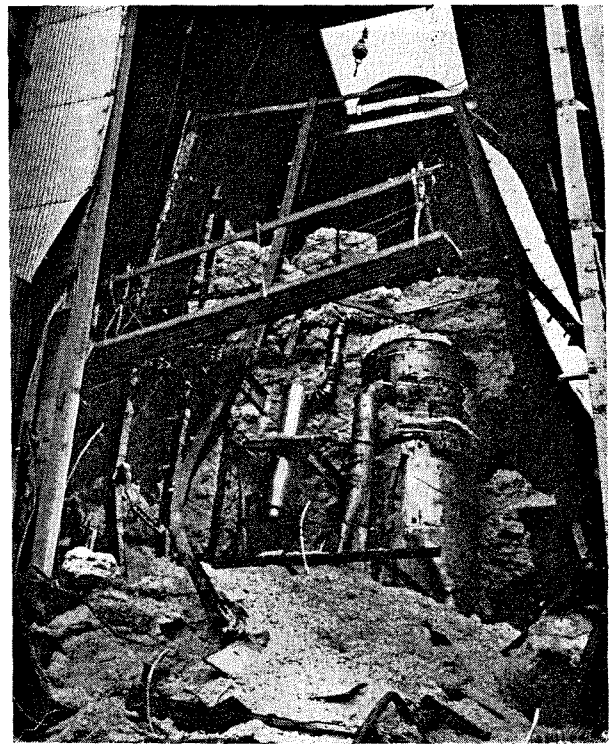
Figure 2. View of plant after cleanup commenced shows the low pressure vessel (dented) in the foreground.

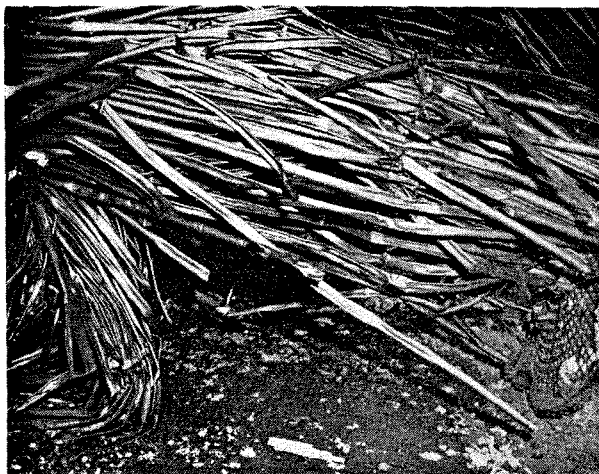
Figure 3. Close-up of tubes in vaporizer and bottom tube sheet at right. The line of detonation can be seen to be approx. 6-8 in. above the tube sheet.

Approximately 30 tubes in the vaporizer burst 6 to 8 in. above the bottom tube sheet, Figure 3. The force of the explosion ruptured the stainless steel outer shell and blew out the side of the cold box and building closest to the vaporizer.

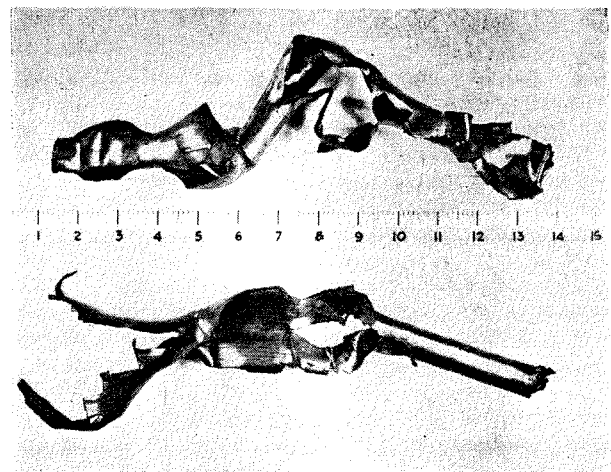
Figure 4. A close-up of an individual tube shows a fracture characteristic of acetylene explosions.

Judging from the appearance of the fracture of the tubes, Figure 4, the explosion was apparently caused by an accumulation of hydrocarbons in the vaporizer, probably C₂H₂, which was triggered by the warm up of the plant.

WRIGHT: That might be possible. The reason for blaming C₂H₂ in spite of the fact that we had no positive test, was Ontario Research Foundation's statement that this fracture was definitely characteristic of C₂H₂. Certainly, we have no proof that there were not other contaminants in there—in fact, we are fairly certain that there were.

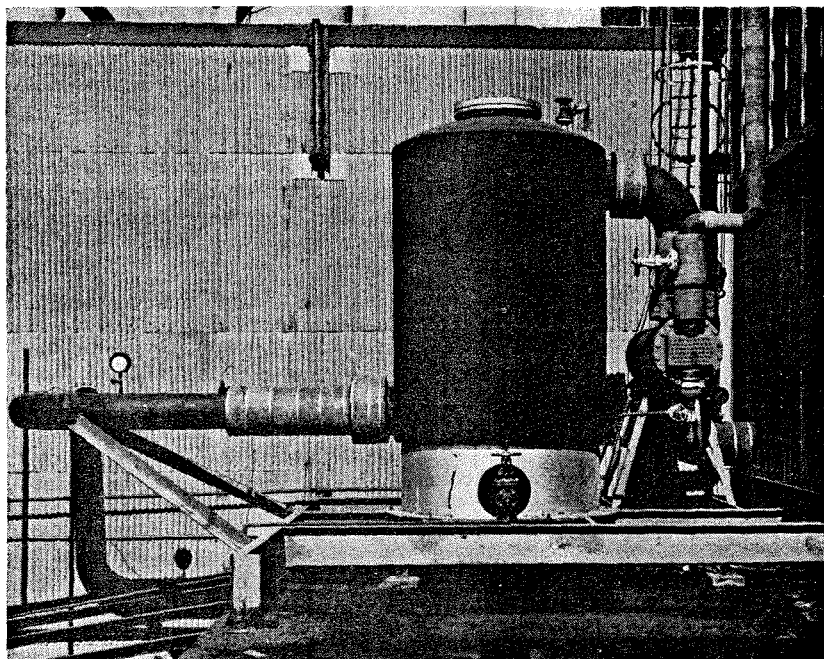
Figure 5. Catalytic filter installed on No. 2 plant. Air is heated 320° by the steam heat exchanger at the right.

5. M.S.A. catalytic filters have been installed on all three plants, Figure 5.
