# *Heat exchanger explosion at a nitrogen-wash unit*

AN UNEXPECTED EXPLOSION IN THE VICINITY of the  $-130^{\circ}$  to  $-145^{\circ}\text{C}$  section of the second heat exchanger at the Mekog nitrogen-wash unit occurred on July 13, 1959, causing severe damage. The explosion occurred while the unit was working under full load after being in normal service for 42 days. Prior to this, the unit had been completely thawed and washed with caustic solution. Despite the great damage, there were fortunately no personnel injuries.

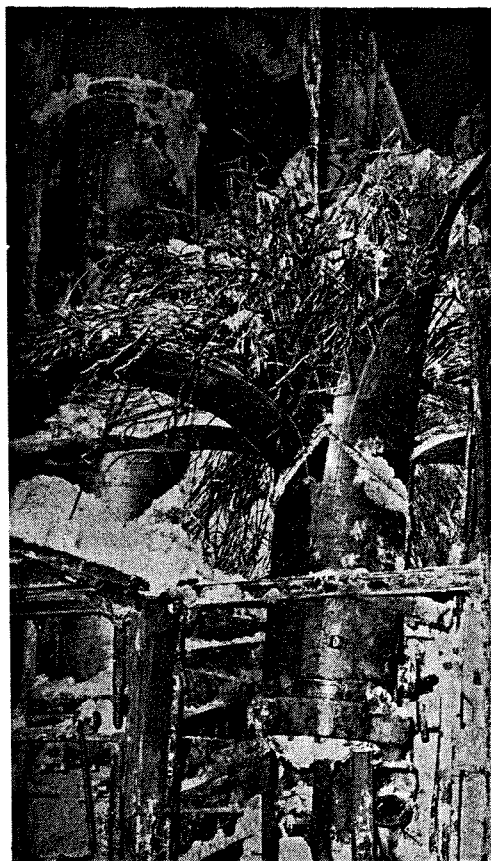
The heat exchanger, which was 8.0 m. long, was torn apart laterally and snapped off. The tubes burst apart

Exploded heat exchanger showing where shell was torn apart laterally and snapped off and where tubes burst.

and were thrown out of the shell, as shown in the introductory photograph. The twisted part was about 1.5 m. long. At the break, the tubes were pressed together lengthwise, indicating an explosion in the space for the incoming gas.

According to an explosions expert, the general picture indicated the rapid explosive combustion, perhaps lasting 0.1 to 1 sec., of some 3-5 kg. of explosive material. At the time of the explosion, 5 kg. of NO had accumulated in the unit, the accumulation having been unexpectedly rapid.

The following steps were immediately taken to prevent explosions:

1.  $Na_2Cr_2O_7$  was added to the  $CO_2$  wash-water circuit until about 10 mg. of dichromate per liter was present. In this way the amount of NO in the gas was reduced from 0.6 to less than 0.1 ppm in 24 hr. By continuing this, in the winter months NO contents of 0.005 ppm and lower were attained in the gas.

2. The sludge was cleaned from the water tank of the  $CO_2$  washing unit.

3. NO accumulation was limited to 1000 liters; alternately, as a temporary measure, the equipment was thawed and flushed with caustic every three months.

4. A maximum permissible NO content of 0.1 ppm was fixed and it was arranged that production should be stopped if this limit was exceeded.

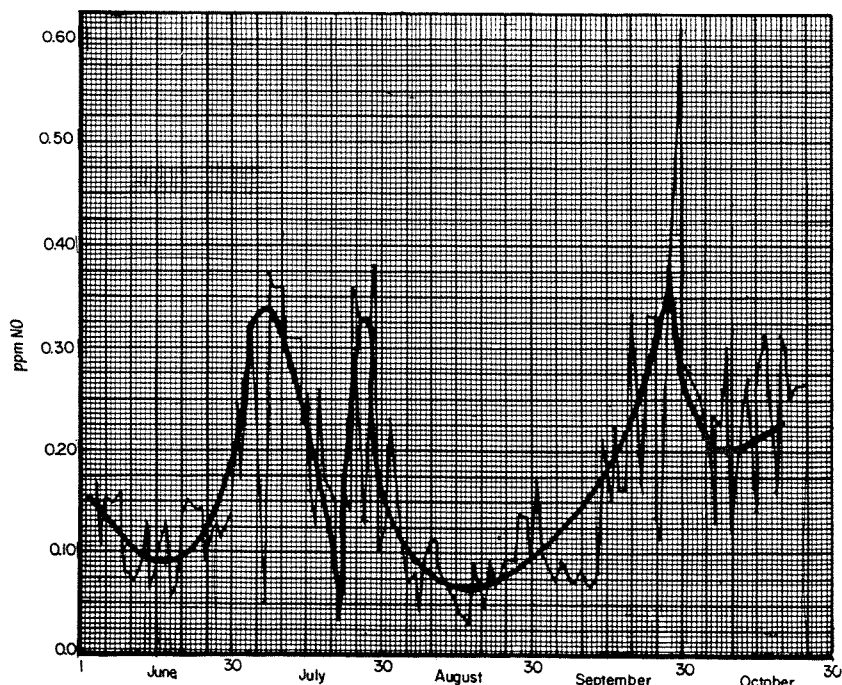
Figure 2. NO concentrations after water washing during summer months.

It had been found that on warm summer days the gas desorbed an unusually large amount of NO from the scrubbing water (*i.e.*, 0.4 to 0.6 ppm) as shown in Figure 2. The

The fact that NO accumulation in warm weather does not fluctuate markedly with the temperature of the  $H_2O$ , but fluctuates in periods of a few weeks, is a clear indication that the most pronounced NO-peaks in summer are attributable mainly to mi-
