Air fractionation plant explosion

Investigations of the causes indicate wooden structures may be rendered dangerous by liquid oxygen. Plant modifications are suggested; also, interim safety measures are proposed.

HERE IS A DETAILED REPORT ON the causes of an explosion in an air fractionation plant and the lessons learned from the accident.

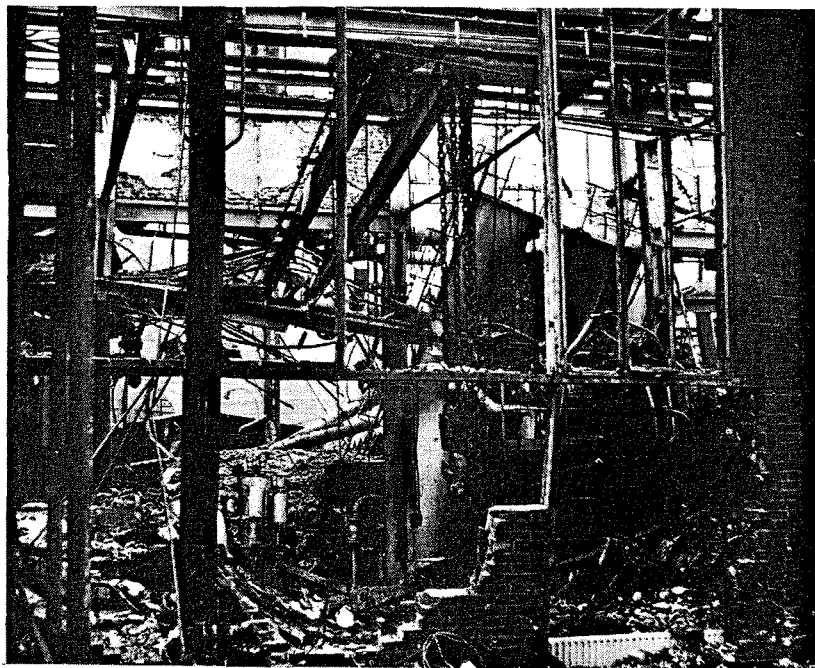
Figure 1. View of the plant after the explosion as seen from the engine-room end.

and the steel beams were appreciably distorted outwards. The upper section of the coldbox shell was tilted in the direction of the machine shop. Altogether, the destruction caused was so widespread that it was at first thought that the entire shop—and not one individual piece of apparatus—was the seat of the explosion, Figure 1.

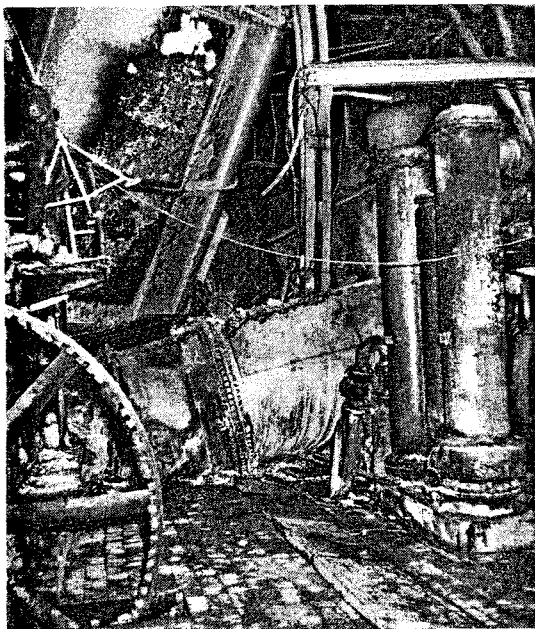
Figure 2. Pressure column with main condenser.

of them being ejected from their normal position in the plant. The lower sections of all pressure shells had burst as shown in the introductory photograph. The pressure column, together with the main condenser which was bolted to it, was torn away from the upper part of the column and was found at a point outside the main shop, *i.e.*, in the engine-room section of the plant at the point where the main control panel had previously been located. This section of the plant, which had a total weight of approximately 15 tons, had obviously been hurled through the air as a result of an impact received from below. It dislocated the crane gantry and another of the main supports of the steelwork structure as it somersaulted through the air, Figure 2. The bottom end of the column shows clear traces of indentation, obviously caused by external impact, Figure 3. The upper column was found within the upper section of the coldbox shell. This latter had obviously fallen down after the lower part of the shell, the pressure column, and the main condenser had been blown away; and it finished up leaning against the steelwork structure of the building, Figure 4.

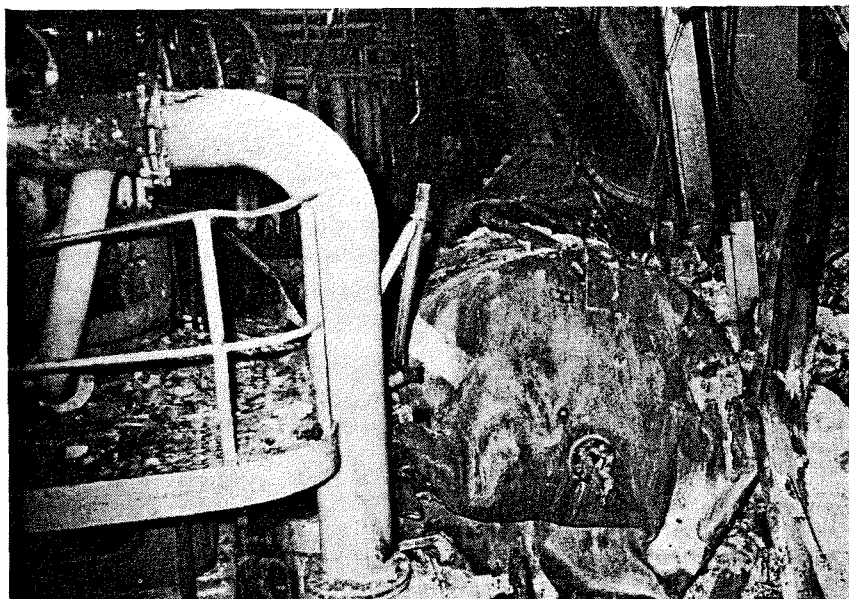
Figure 3. Bottom plate of pressure column showing indentations.

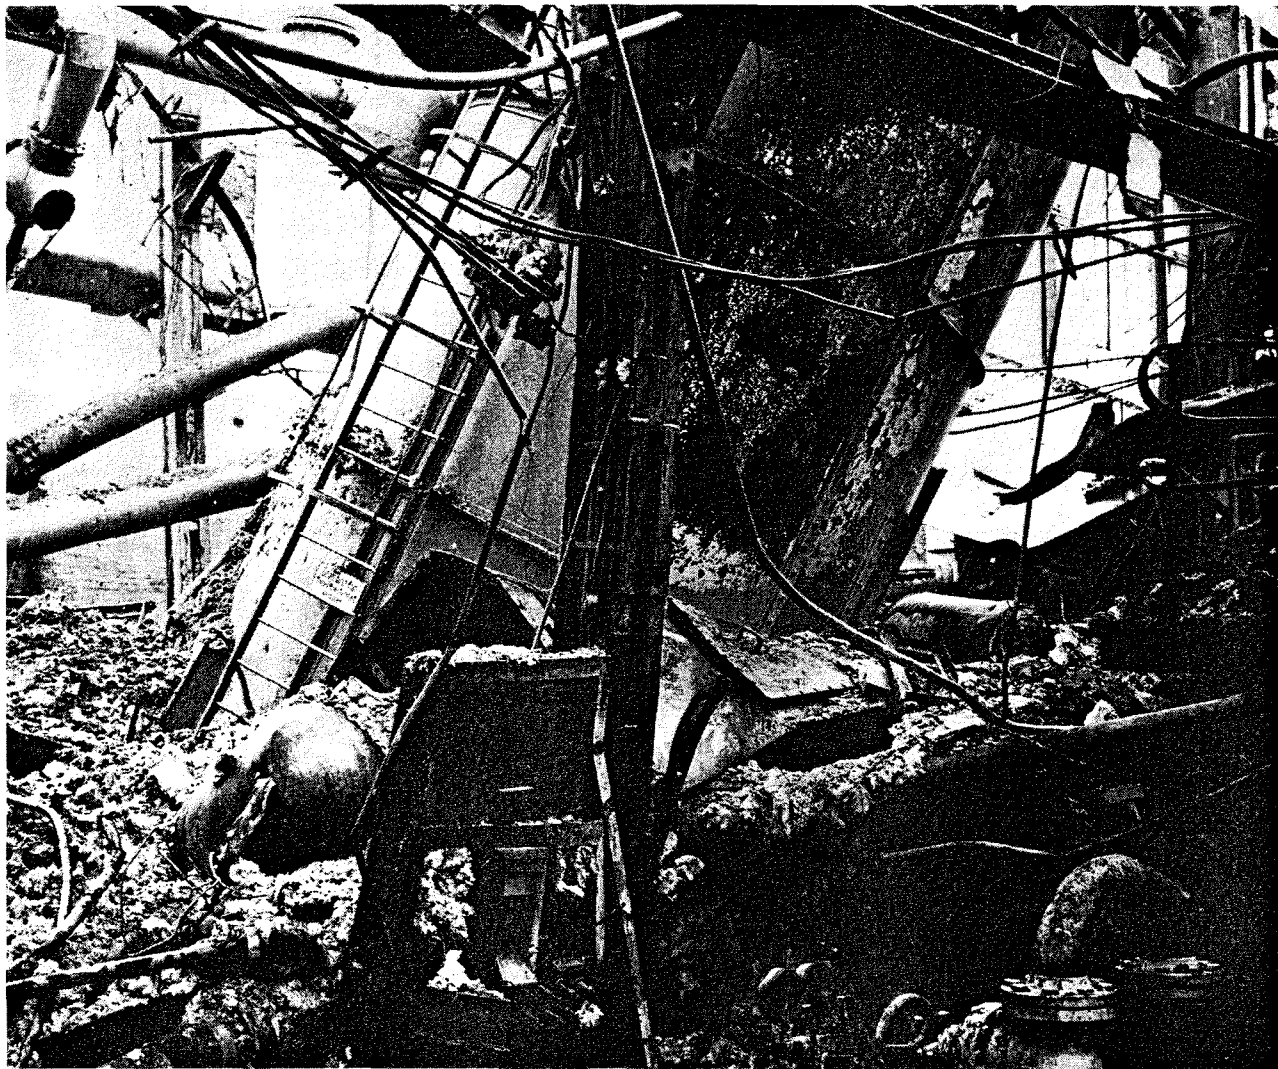
Figure 4. Position of upper section of the coldbox shell after the explosion.

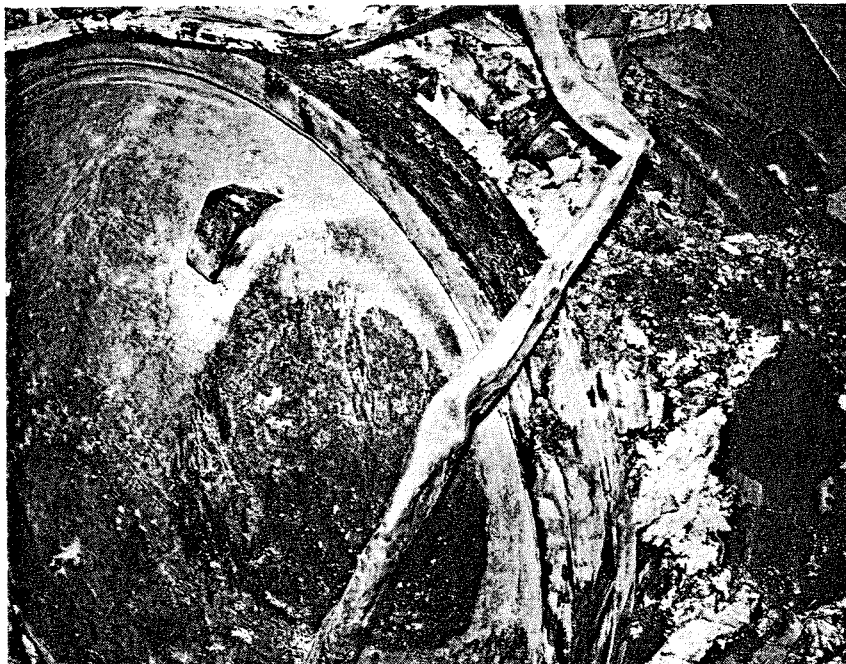
Figure 5. View of the cover (top) of the main condenser.

plosion and then subsequently split apart, was otherwise completely intact, Figure 5. It is thus obvious that no explosion could have taken place at this point. The acetylene adsorbers were also quite undamaged externally. The lower section of the pressure column had obviously been indented from below by some external force, as already mentioned. The lower sections of the regenerators, all of which were burst open, furnished no evidence pointing to a possible explosion within these vessels. Thus, there appeared to be little possibility that the explosion had actually taken place within the apparatus itself.

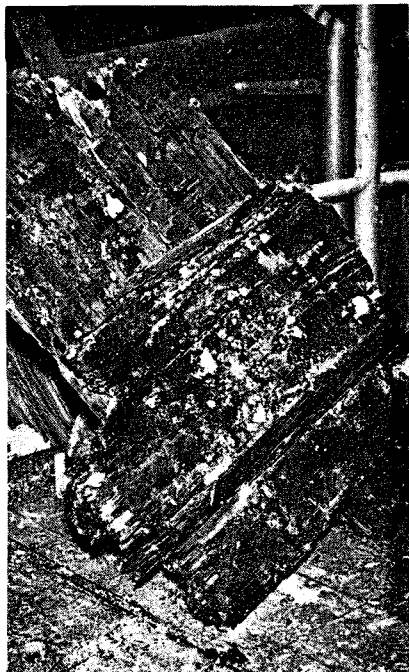
Figure 6. Remaining section of the partly-charred wooden floor.

On the other hand, wood in the form either of chips or larger pieces of various sizes, which were either totally or partly charred, were found in the ruins. Figure 6 shows the largest of the remaining sections of the wooden floor—partly charred—which has yet come to light.

Any wooden floors or foundations present in existing plants should be replaced by non-inflammable materials as soon as possible. Suitable substitutes for wooden pads for plant frame bases are, for instance, asbestos cement sheets. Asbestos cement is perfectly adequate for this job from the point of view of compressive strength and resistance to frost. The quantity of organic constituents in the pure, safe material is so low that this structural material even remains non-explosive when soaked with liquid oxygen. It should, however, be pointed out that asbestos cement manufactured outside Germany does not exhibit similar properties and the latter should always be examined before being used.

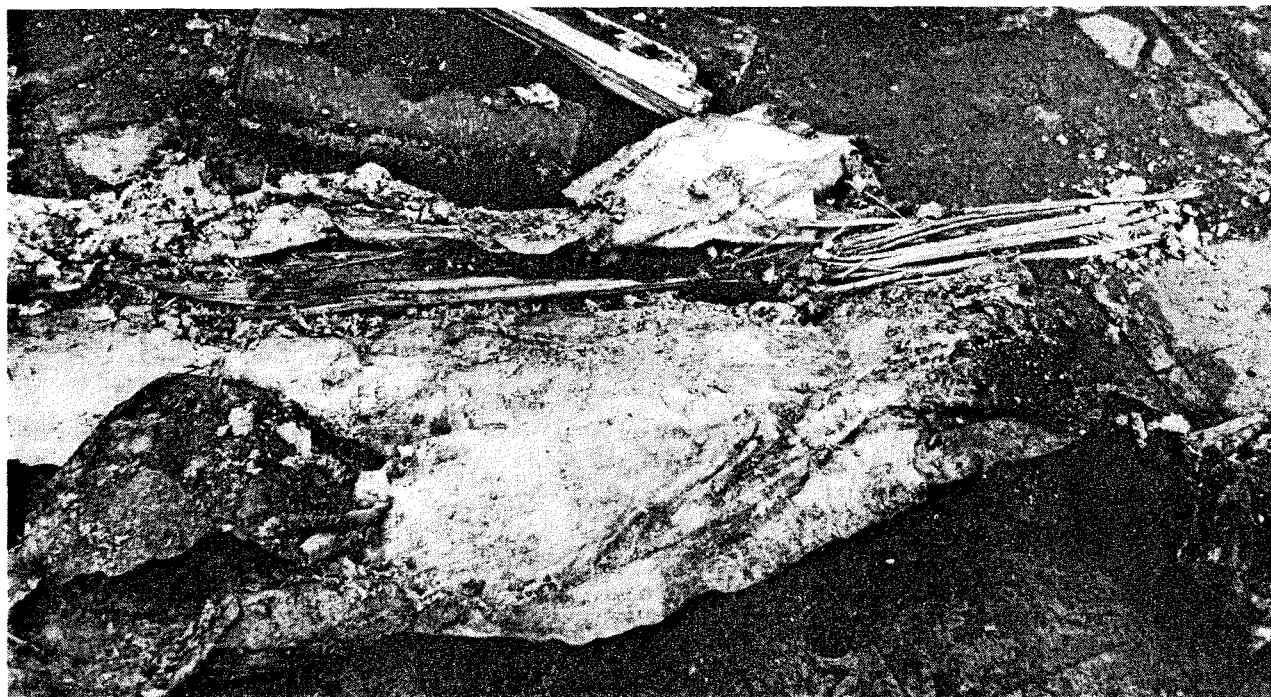
Figure 7 shows the splintered wood. Several pieces of wood were found which were considerably charred on the outside surface but certain surfaces of which were not blackened and which must therefore have been split open after the explosion. From this evidence, the examining experts gained the impression that a charring process must have preceded the actual explosion itself. Statements were made by eyewitnesses showing that in the course of repair work carried out before the start-up of the plant, certain work had been undertaken within the coldbox shell. In the course of this work a copper pipe had been welded at a point close to the surface of the floor. This at first gave rise to the assumption that the wooden floor (which was covered with galvanized iron and thus was unrecognizable to the personnel concerned as a wooden floor) had been caused to smoulder by the dropping of incandescent globules of metal or even by contact with the welding torch itself.

Figure 7. Splintered remains of the wooden floor.

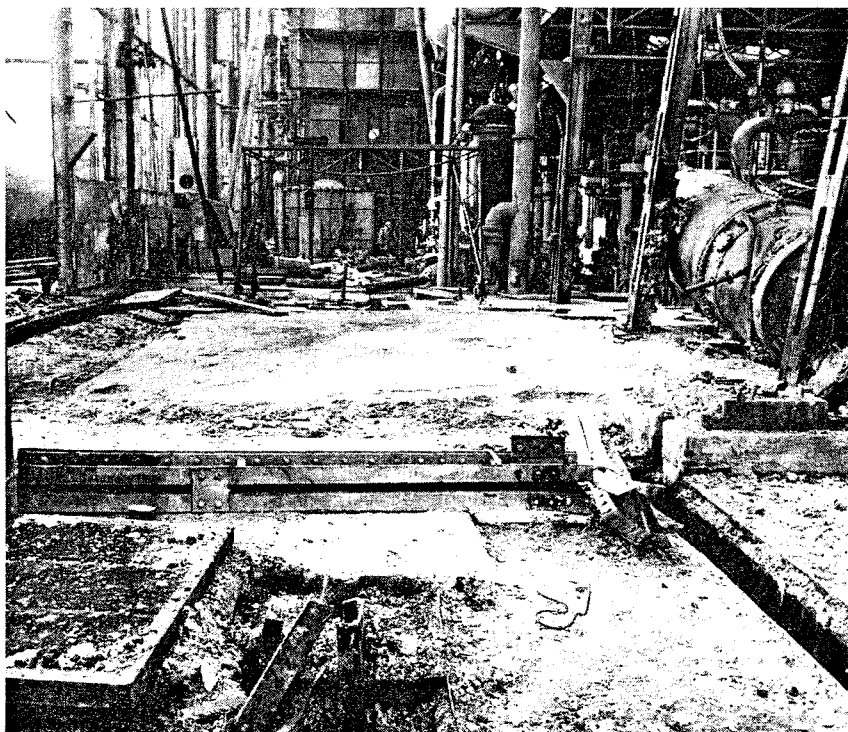
When the rubble-clearance work had been completed, however, it was discovered that the surface concreting of the foundation was relatively undamaged and that it was not possible to pin-point any actual place as the center of the explosion, Figure 8. It became quite clear that the explosion must have actually taken place over the whole surface area of the foundations.

Figure 8. Apparatus base-plate after rubble clearance.

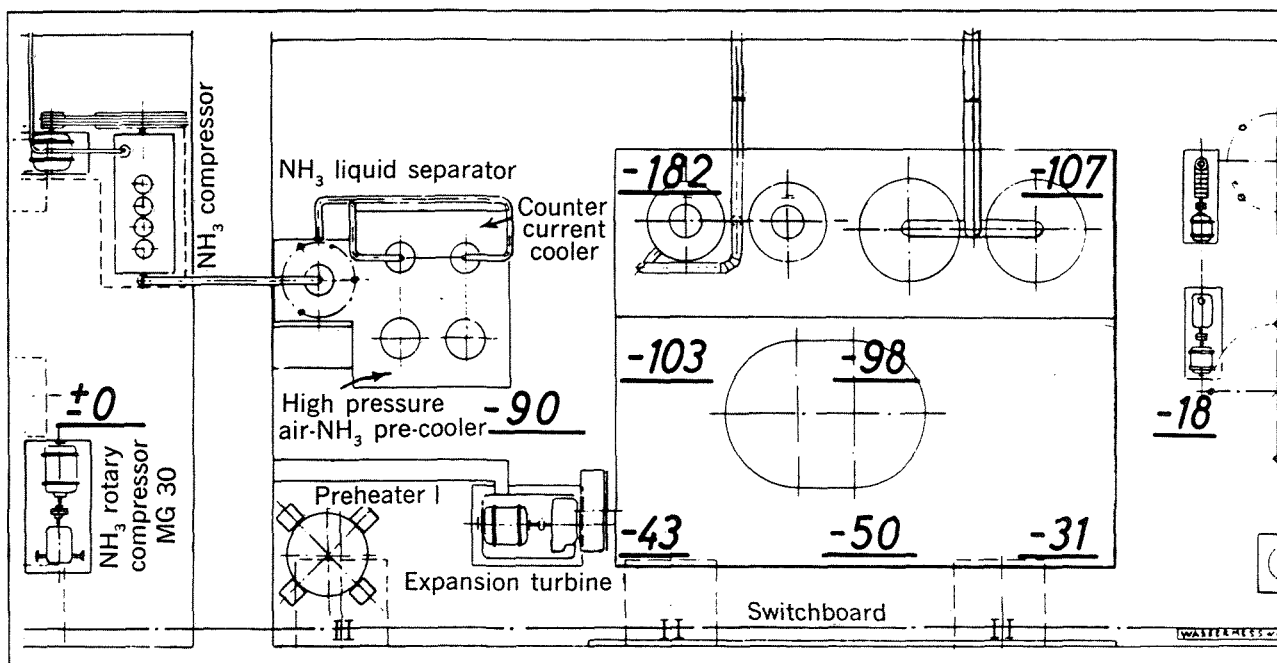
The base-plate was forced into the footings at a slight angle by the explosion. Figure 9 shows the amount

of subsidence of the base-plate after the explosion, as compared with its original position (measurements were taken after completion of the clearance work). This irregular sinking of the base-plate leads to the assumption that the center of the explosion was on the floor between the pressure column and the oxygen regenerators. This opinion is reinforced by the position of the individual vessels after the explosion as shown in Figure 10.

Figure 9. Base-plate settling resulting from the impact of the detonation.

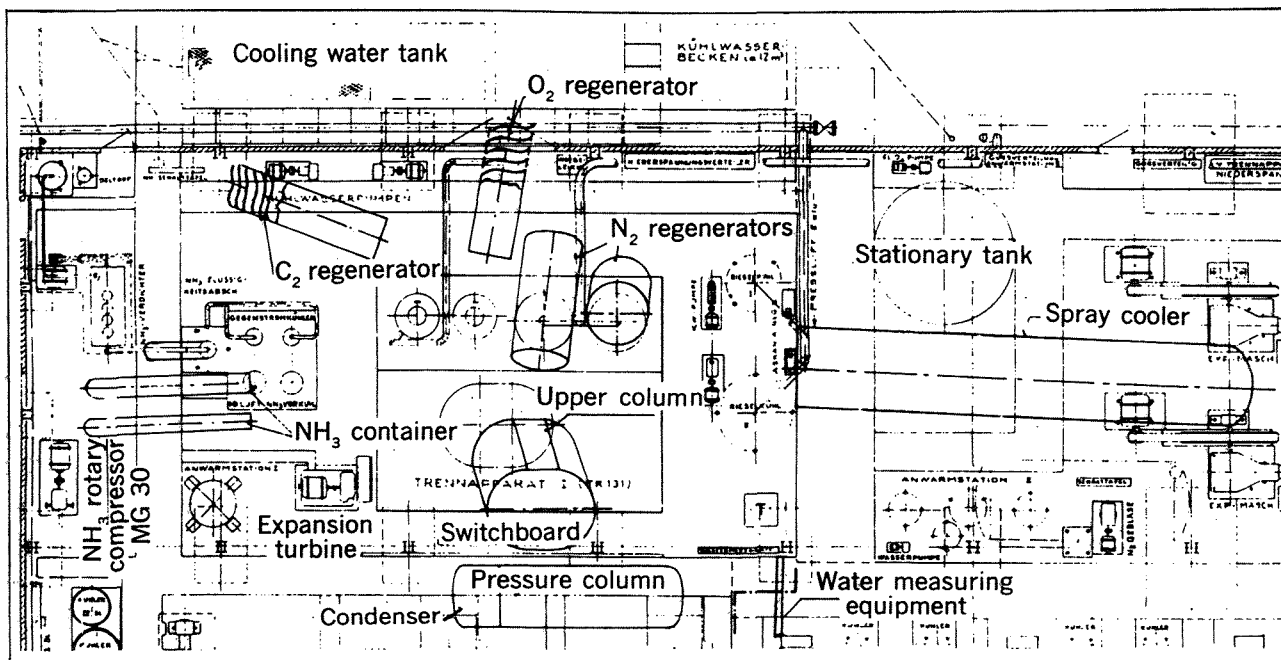
Figure 10. Position of the containers after the explosion.
