OIL SEPARATOR EXPLOSION IN AN AIR-SEPARATION PLANT

John J. Rendos
Air Reduction Sales Co.
Plainfield, N. J.

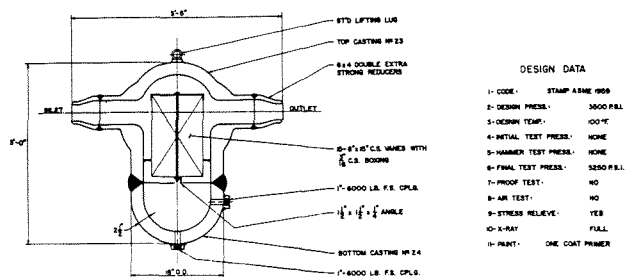
This ruptured vessel was built according to code requirements. Calculations for this cast steel separator indicated it could be expected to rupture at 10,700 lbs./sq. in. Before details are given to show the preventative steps taken to avoid a recurrence of such an accident, a few brief words on the function of this equipment are pertinent.

Figure 2. Drawing of Cast Steel Separator.

6. Plate Weldment or Forged Steel Equipment. The cast steel separator was replaced by a plate weldment steel vessel. In all our plants, the cast steel vessels are being replaced. In the future, purchased equipment for this type of service and operation will be either plate weldment or forged steel. However, no inference should be drawn that tougher materials would have withstood this explosion without rupture.

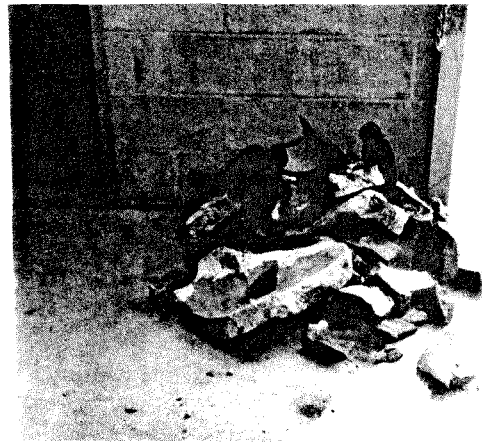
Downstream of the oil collection in the sixth stage aftercooler separator end, the nitrogen oil separator bottle was the first point in the discharge piping where appreciably large quantities of oil and vapor could collect. The explosion wave, upon reaching the separator, ignited the vapors with explosive violence and shattered the separator bottle into more than 25 pieces. Of the several pipes and vessels downstream of the compressor sixth stage, the separator had the lowest rupture strength. In the aftercooler and the chiller, the tubes were bulged and ruptured. Possibly, the "explosion wave" also caused local detonations at locations where there were lube oil collections. The internal damage to the high-pressure nitrogen system is attributed to the explosion in the separator. It should be noted that some difference of viewpoint exists on whether a pool of oil is needed as a fuel source. Some are of the opinion that an explosion can occur if only a film of oil or oil vapor is present.

Figure 3. Remains of cast steel vessel, N-160 focal point of the explosion.

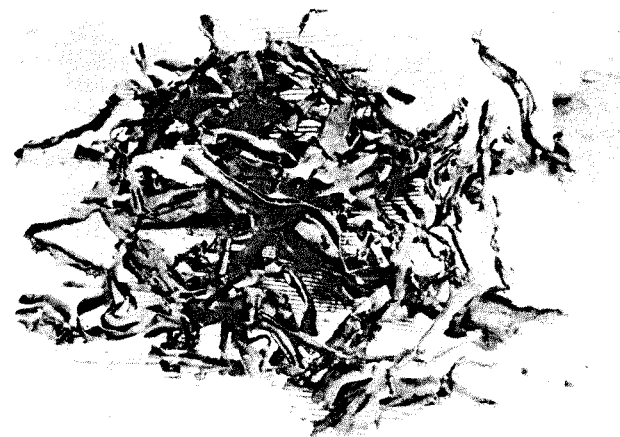
Figure 4. Remains of internal separator of vessel N-160.
