Nitrogen compression system explosion

Electrical failure initiated events leading to explosion. An oxygen analyzer, improved valving and alarm systems are new devices incorporated to increase operating safety.

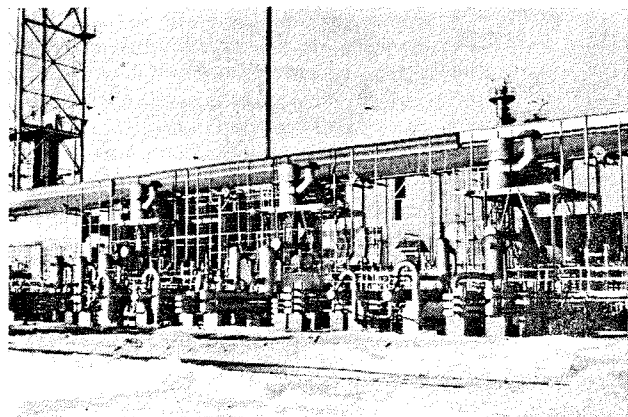
Figure 2. A broad view of the blast area, it being centered between and below the left two of the three air filters along the roof-line. Note the window and building siding blast damage extending clear to the end of the building at the right side of the photograph.

Extensive damage was caused by the explosive burning and shock wave which had an estimated intensity of 2,000-3,000 lb./sq. in. There was also considerable damage due to concussion and shrapnel. Small fires were extinguished by plant personnel on the air-nitrogen compressor and an inter-cooler. The compressor operator suffered multiple face lacerations by flying glass; he has since recovered and returned to work.

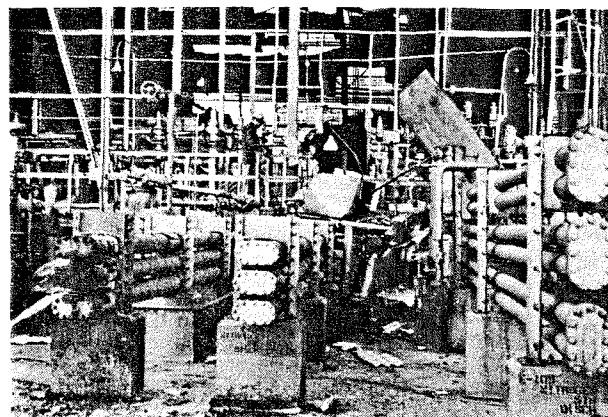
Figure 3. A closer view of the blast area, its center being just beyond the end of the exchanger in the center. Note the building siding and roof damage visible at the upper center, also the bent-upward steel plate beyond the exchangers on the right, such being part of an elevated walkway along the side of the building above the destroyed piping.

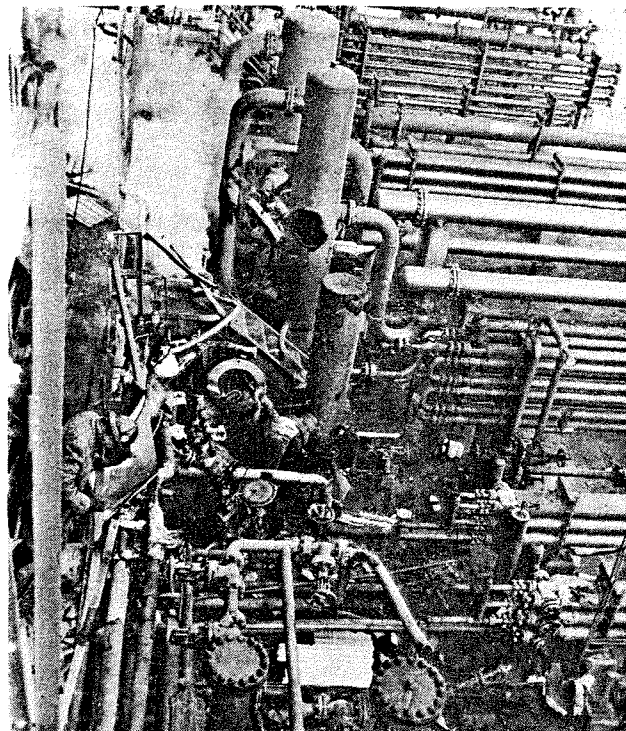
Figure 4. Overhead view of the blast area, the up-ended base of the destroyed drum is visible to the left of center. Most of the piping damage was from shock wave or concussion, with some shrapnel effects on it and on adjacent vessels, e.g. the punctured drum in the upper center.

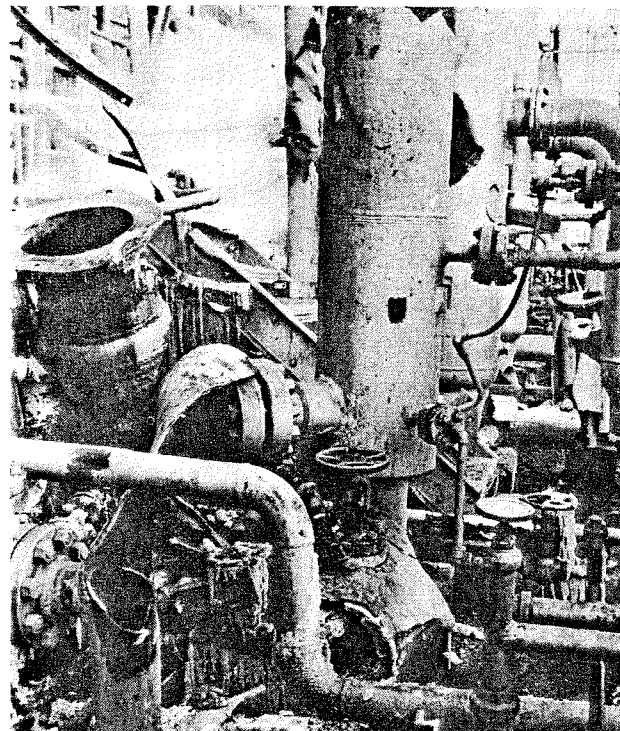
Figure 5. A close-up of the position of the up-ended base of the destroyed drum, seen in Figure 4. Its foundation had been the raised concrete section to the left of center at the bottom of the view, from which anchor bolts had been sheared.

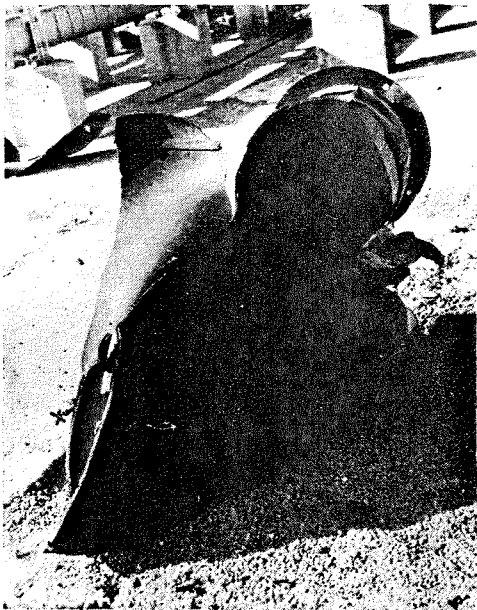
Figure 6. The base and part of the torn body of the destroyed drum, it having been removed to a clear area by this time. Its dimensions had been 20-in. O.D. by 8-ft. long, the wall thickness being 0.50 in. Although walls showed evidence of coked oil, there was still gummy oil in the base where the oily layer would have probably been thicker.

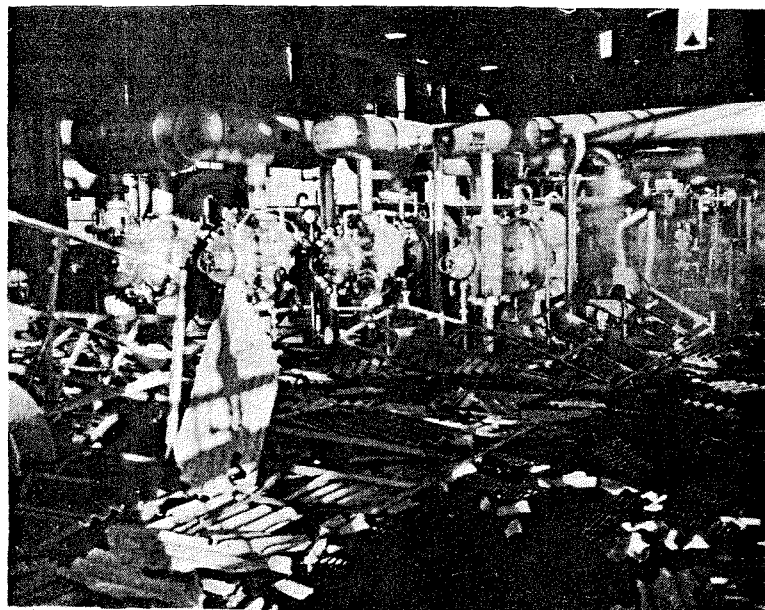
Figure 7. A view of the inside of the building, the center of the blast area having been just outside from the right side of the picture. Note the bent subway floor grating to the right of center, from the piping below the floor. Wire-glass windows immediately adjacent to the blast area were largely pulverized and as such were responsible for many of the face lacerations of the compressor man, who was standing just about at the right edge of the view, starting to open the compressor vent valve.

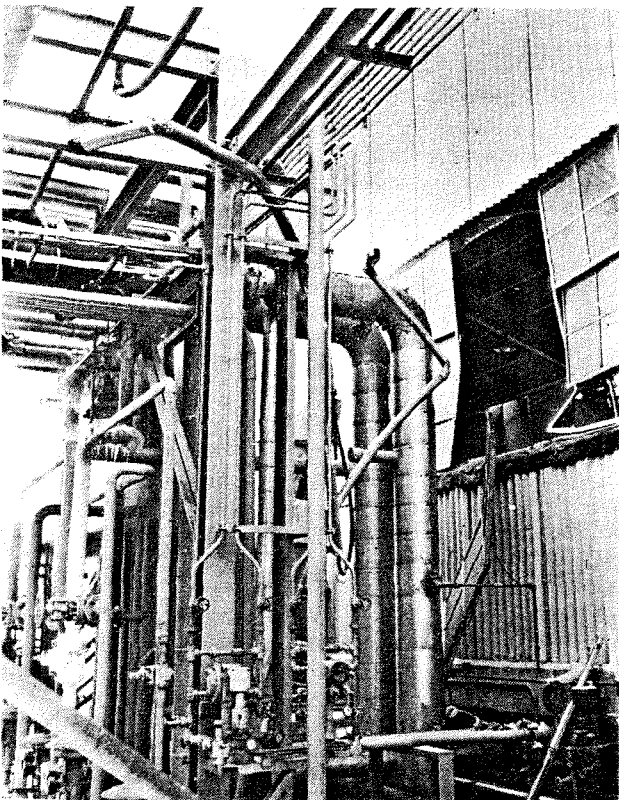
Figure 8. The typical damage in a 2 in., Schedule 40, carbon steel line from the destroyed drum, some 100 ft. away, the line damaged being the elbowed section in the right center. The upper end of the line had been connected by the ruptured 90° elbow to the horizontal run at the top which is bent backward over the I-beam support steel. The other bent, insulated, line is a steam line which got in the way of the other flailing piping.

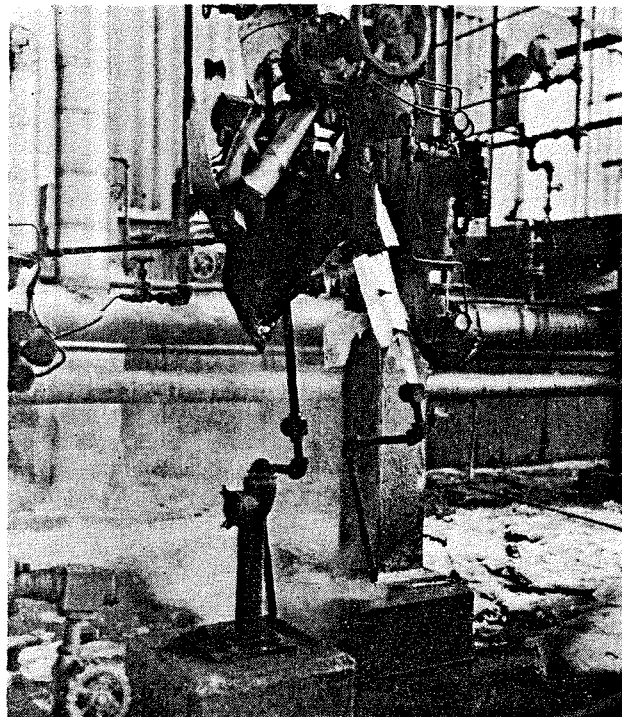
Figure 9. Another view of the damaged 2-in. line, some 80 ft. and the third elbow downstream. It was Schedule 40 stainless steel at this point, having been joined by a recycle nitrogen line from the low temperature unit. Note the flared, split, damage to the piping in the upper center, which had broken off the top of the elbow sitting on the pedestal below, as well as the line snapped off of the other side of the elbow. The furthest pipe breakage was a snapped-off nipple off the insulated 6 in. line in the right background, some 40 ft. still further downstream.

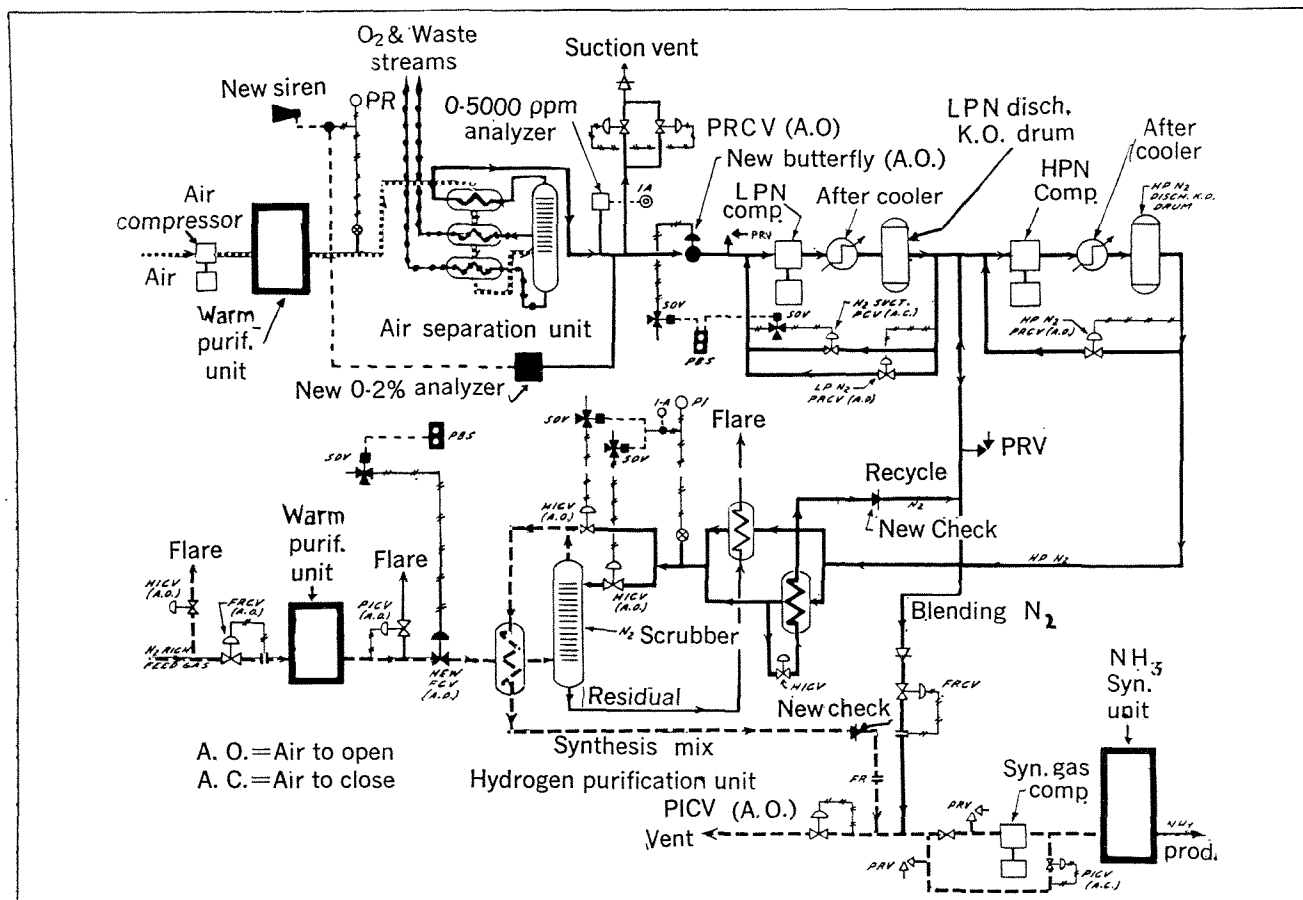
Figure 10. Final simplified-flow diagram of the anhydrous ammonia plant. The five new operating safety features added are indicated by the circled numbers which correspond to the description in the text.

Various additional safety devices have been incorporated into the process since the explosion. These have been added-in on the final flow diagram, Figure 10. The new safety devices incorporated are:

1. In the event that nitrogen pressure is lost, such as occurred prior to the explosion, the two air-operated valves which admit liquid nitrogen into the hydrogen system in the hydrogen purification unit would be closed. An alarm light would be activated to show the closing of these valves.

2. A new oxygen analyzer has been installed on the product nitrogen from the air separation unit. The original analyzer is a low range instrument normally used on the 0-1000 ppm scale although it also has a 0-5000 ppm high range. At an oxygen concentration of 2% the new analyzer will energize a new siren. The siren will also be sounded when the air pressure to the air separation unit drops below 100 lb./sq. in. gauge. Abnormally low air inlet pressure is a prelude to fractionation difficulties and oxygen contamination.

3. Upon hearing the siren or observing process instability, the controlman will close a new butterfly valve in the nitrogen suction line to the compressors, thereby diverting the air separation unit production to the vent.

At the same time a kickback valve will open, permitting the intermediate nitrogen compression stages to recycle back to the suction. Installation of the butterfly valve isolated the compressor suction header from its normal relief valves and therefore new pressure relief valves were required between the butterfly valve and the compressors.

4. To provide a quick and positive shut-off of hydrogen feed gas in the event of a pipe or vessel rupture in the hydrogen purification unit, an air-operated valve has been installed in the feed gas line to this unit. This valve is closed from a push-button station in the control room.

5. To minimize the effects of a compressor system explosion on the hydrogen purification unit internals, check valves were installed in the nitrogen recycle and synthesis mix lines from the unit. It is expected that these check valves would dissipate the shock wave caused by an external explosion. Since the check valve installation in the recycle line permitted its isolation from a protecting relief valve, a new pressure relief valve was installed on the intermediate pressure nitrogen system at the hydrogen purification unit. #
