# AIR SEPARATION PLANT FIRE

J. J. Rendos  
Air Reduction Sales Co.  
Jersey City, N. J.

On Wednesday, March 6, 1963, at 11:08 A.M. an explosion occurred in an oxygen circulating pump and connecting piping. The resulting fire involved refrigerating and associated equipment. This accident was caused by the ignition of combustible contaminants in the oxygen pump and connected piping. The source of ignition is unknown. The violent fragmentation of the cast-bronze pump body and associated equipment caused considerable damage and personal injury. The ruptured pump and associated pipe equipment were built according to code requirements. The violence of the explosion was such, that piping, pump parts, and cold box panels were ruptured.

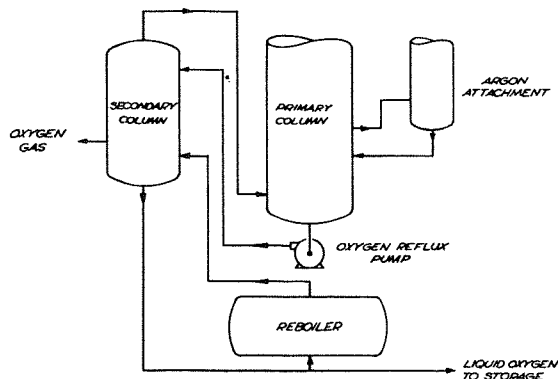
This plant manufactures liquid oxygen, nitrogen, and argon in addition to pipeline oxygen and nitrogen. Due to the increased argon demands, a modification was made to the primary air-separation column of one of the units. This consisted of adding more rectification plates between the argon attachment and the reboiler. This secondary column was so installed that it was necessary to take liquid oxygen from the present (low pressure) primary column and to pump the liquid to the newly installed column, Figure 1.

Figure 1. Simplified flow sheet.

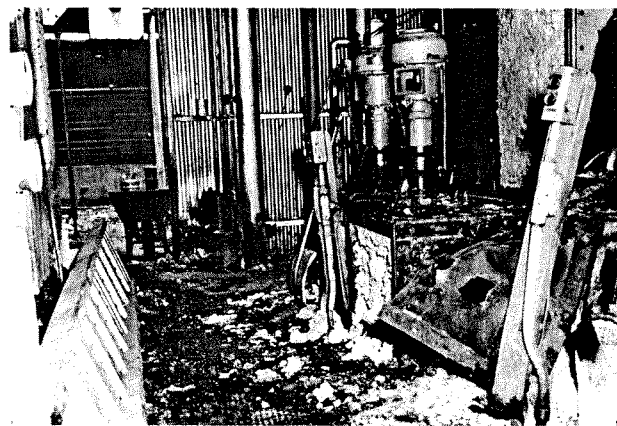
The inlet, outlet, and vent lines within the insulated pump housing, as well as the 4-in. inlet line inside the cold box leading from the bottom of the primary oxygen column to the pump impeller casing, ruptured from an internal explosion. The impeller casing explosion blew several pieces through the end steel insulation panel. The violence of the detonation, Figures 2 to 7, forced the vertical pump shaft upwards with sufficient momentum to break loose the motor and

Figure 2. View from northwest corner of liquid oxygen reflux pump casing-floor level.

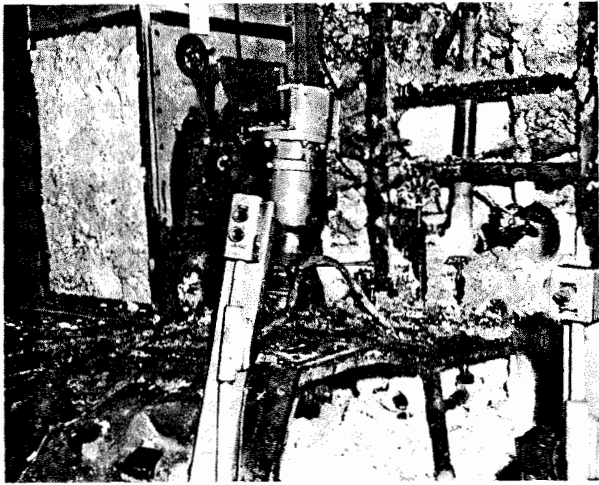
Figure 3. Close-up view of liquid oxygen pump installation.

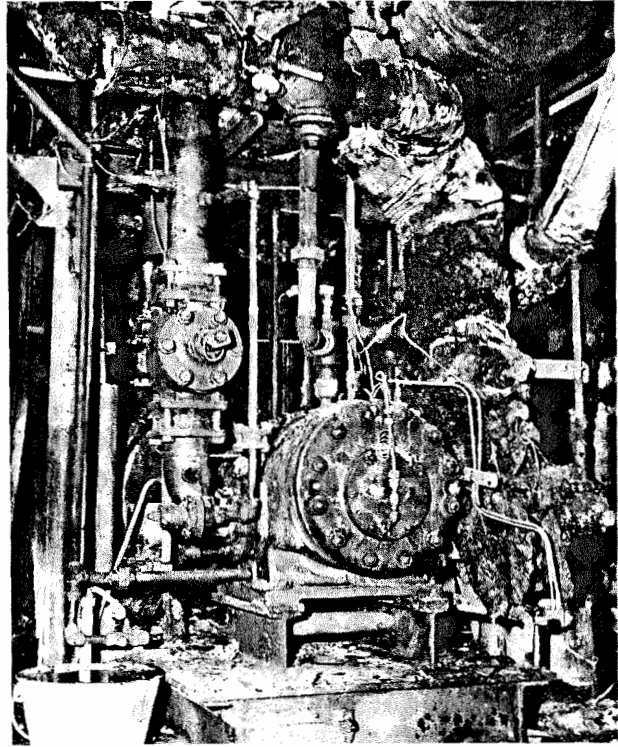
Figure 6. View from southeast corner of Freon system.

4. The combustibility hazard of Freon 12 refrigerating equipment will be examined to determine need for less exposed positions or for automatic sprinkler protection.

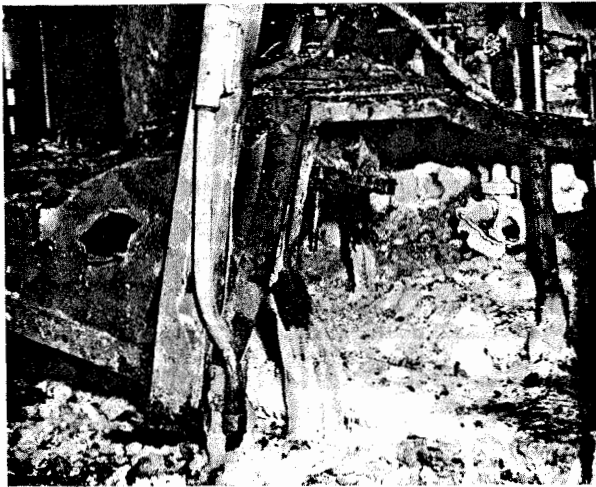
Figure 4. Close-up view of lower section of damaged pump area.

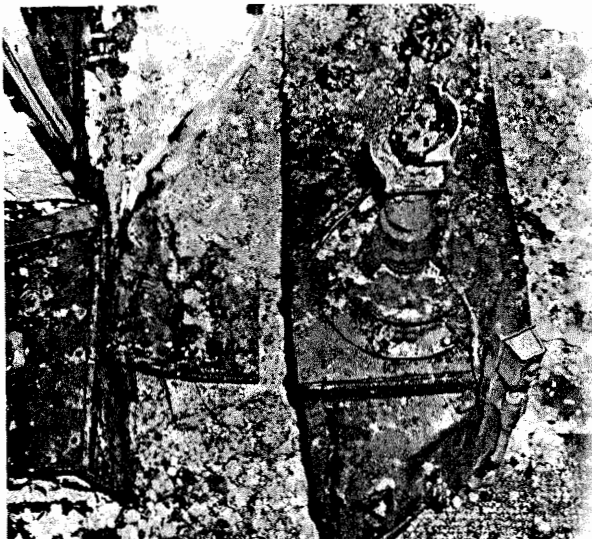
Figure 5. Overhead view taken from catwalk over Freon system of liquid oxygen pump area.

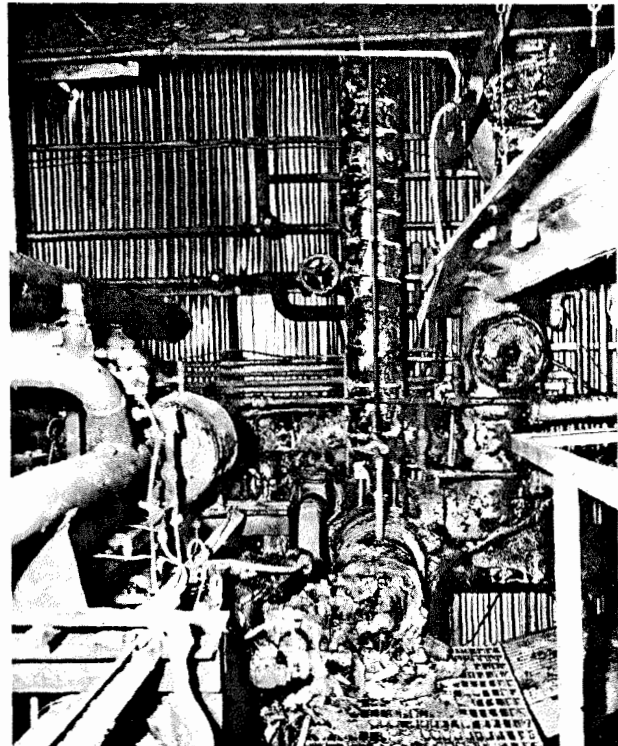
Figure 7. View from catwalk of fire damage to upper section over Freon unit.

The pipeline explosion blew the panels from the east side of the pump housing and from the side of the cold box immediately in front of the pump. It also blew rock wool and fragments of the three pipelines around the area. This started an oxygen-fed fire at the refrigerating equipment several feet in front of the pump. The fuel was a mixture of Freon 12 (dichlorodifluoromethane)  $\text{CCl}_2\text{F}_2$  and lubricating oil. Evidence of burning at the copper braid covering of the ruptured flexible hoses indicated that some combustibles were present in the hose lines.
