EXPLOSION IN NITROGEN GAS COMPRESSORS

Prepared by J. A. Rogers
The Best Fertilizer Co.
Lathrop, Calif.

Presented by F. W. Wilson
Consulting Engineer
St. Paul, Minn.

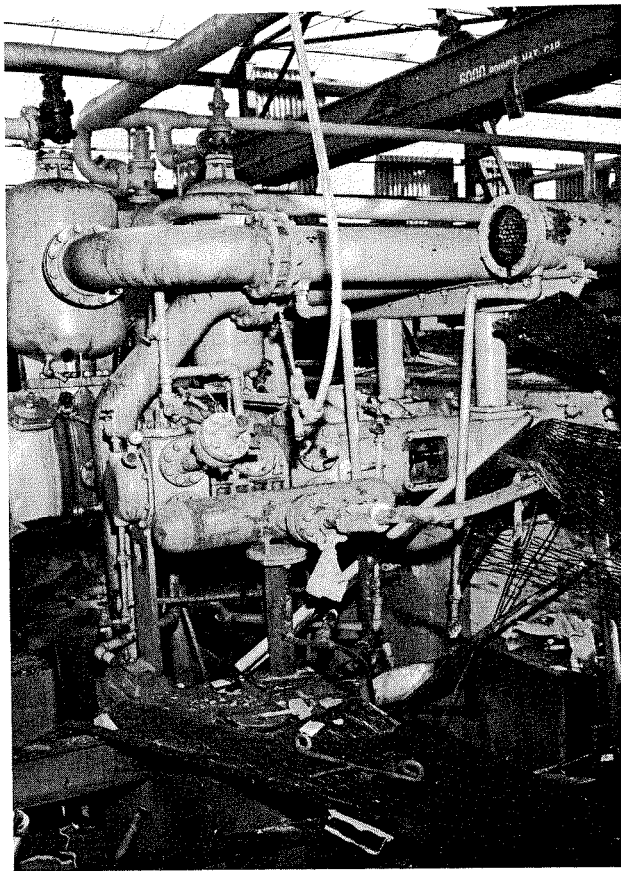
The extent and type of damage would indicate that a detonation apparently took place simultaneously in the fourth stage cylinder and the fifth stage after-coolers and separators of both compressors. The nitrogen section of each compressor was almost a total loss. Four men were in the building, all of whom suffered shock, eardrum damage and varying degrees of cuts and abrasions. One of the four suffered a concussion and required hospitalization for a few days. All have recovered and are back to work.

Figure 4. View of north side of C-301A looking east. Fifth-stage 3,000 lb./sq.in. gauge nitrogen cylinder in foreground.

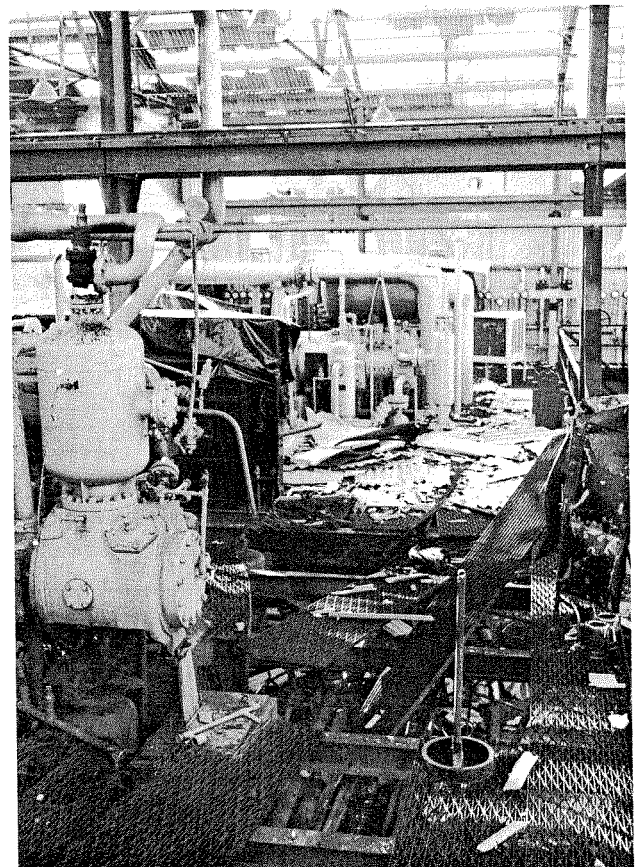
Figure 5. View of north side of C-301A looking east. Second-stage 160 lb./sq.in. gauge nitrogen cylinder in foreground.

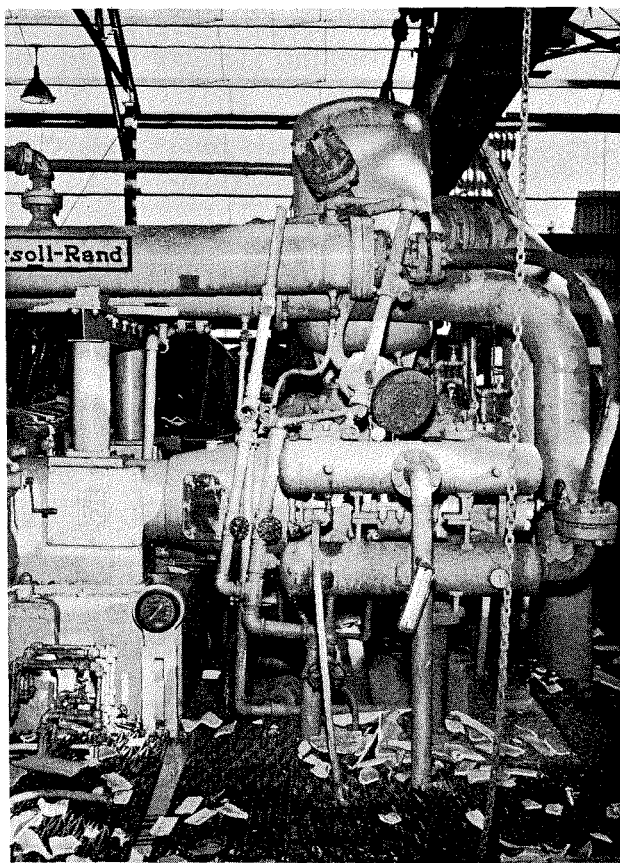
Figure 6. View of the south side of C-301A looking east. Fourth-stage 1,200 lb./sq. in. gauge nitrogen cylinder in foreground.

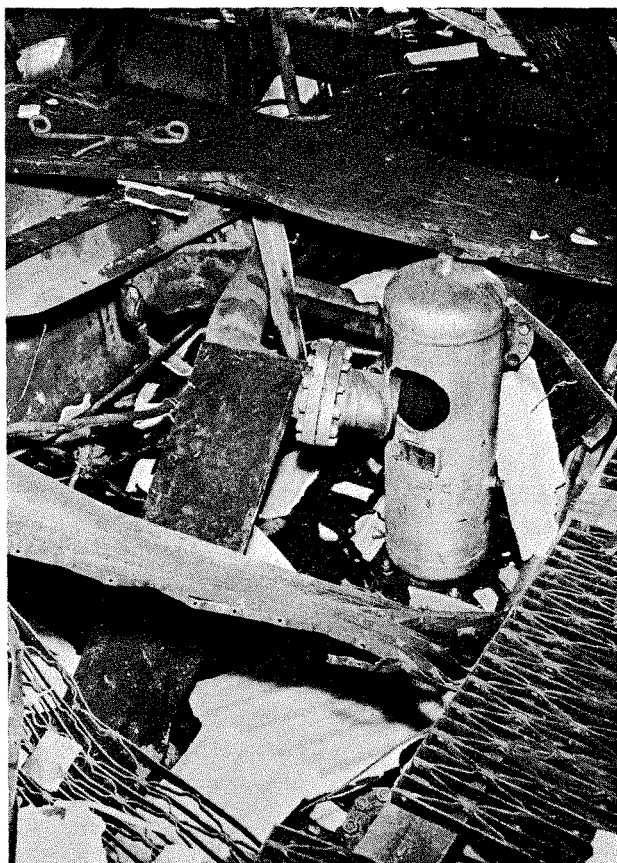
Figure 7. View of 250 lb./sq. in. gauge air separator. Damage to nozzle and outlet line from external force. No internal damage to air system.

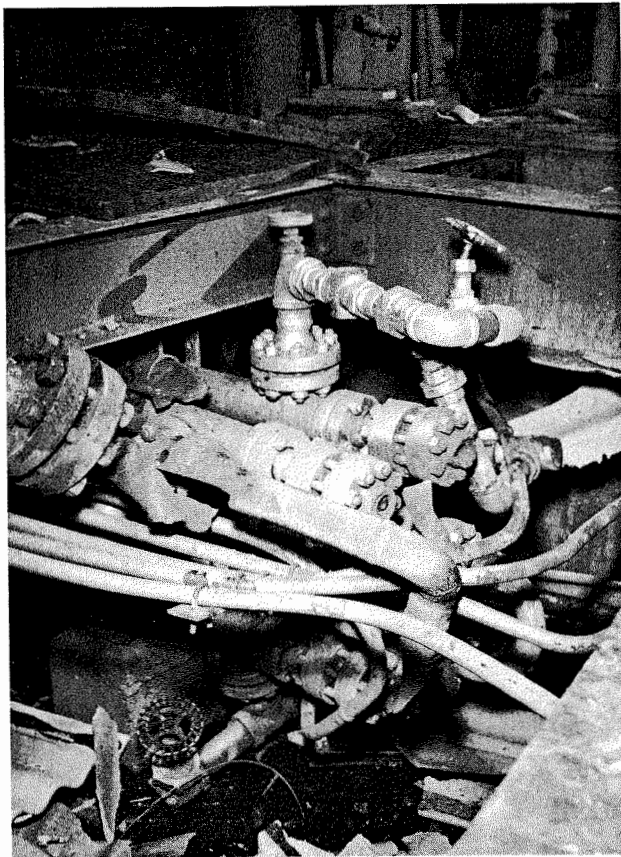
Figure 8. View of fifth-stage 3,000 lb./sq. in. gauge nitrogen aftercooler. Note rupture of 2-in. Schedule 160 line.

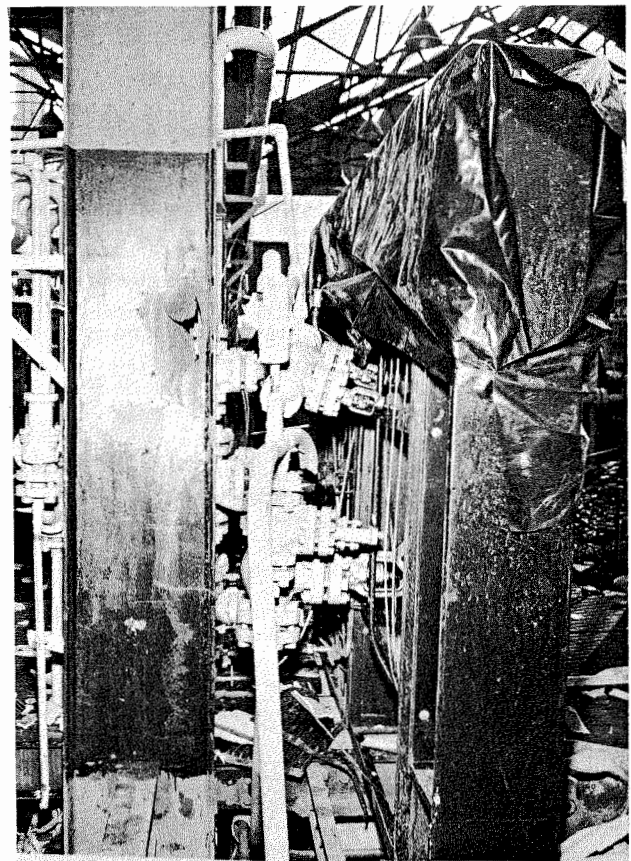
Figure 9. View of piping at control board. Note puncture of building column.

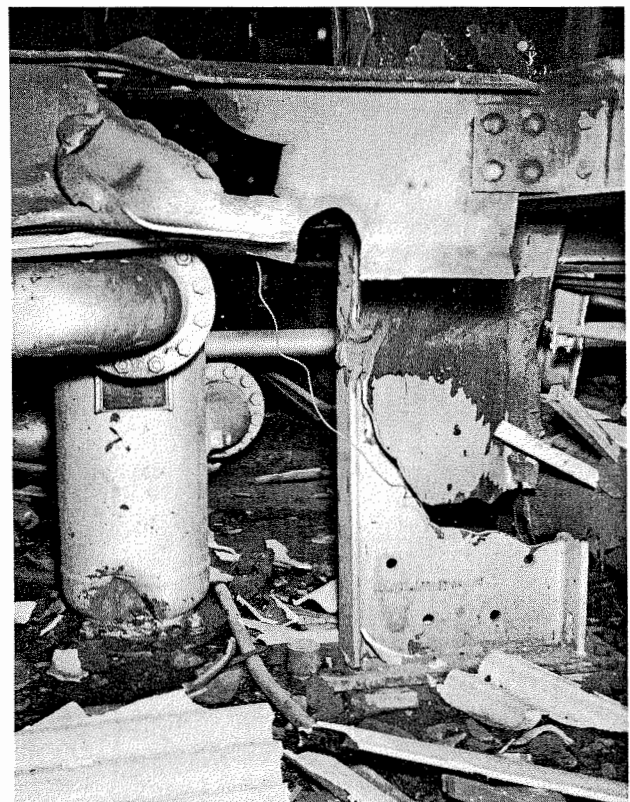
Figure 10. View of building damage.
