Urea-ammonium nitrate solutions: Are they safe?

Explosion in the mixing installation of a fertilizer plant points out the potential hazards. Avoid contamination or conditions of temperature and concentration that result in explosive mixtures.

L. G. CROYSDALE,
W. E. SAMUELS,
and J. A. WAGNER

Farmers Chemical Assoc., Inc.
Tyner, Tenn.

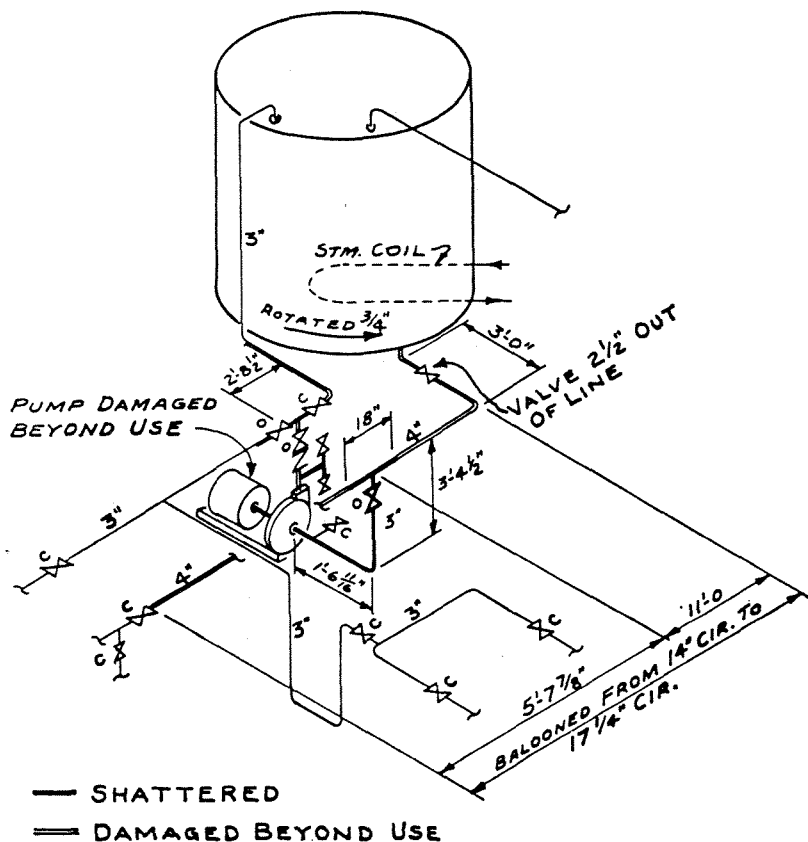
Figure 2. Details of area in which explosion occurred.

Figure 2 shows a schematic of the actual piping and associated equipment. The actual position of each valve is noted with a "C" for being closed and an "O" where the valve was open. The very heavy sections indicate the section of piping and valves which were actually shattered by the force of the explosion. Piping from the original tank to the isolation valve was severely ballooned and distorted from original circumference of 14

in. to a circumference of $17\frac{1}{4}$ in., as was the discharge pipe to the tank isolation discharge valves. The pump, although destroyed beyond further use, did not disintegrate. All studs on the suction flange failed, the pump impeller was bent, the bracket supports and coupling housing cracked, the motor rotor pushed out the rear housing, and the entire unit sheared off the anchor bolts from the foundation. A small drain valve left its impression on the concrete foundation as the entire unit was forced away from the center of the explosion.

The weigh tank was rotated approximately three quarters of an inch and the bottom outlet connection was $2\frac{1}{2}$ -in. out of line. The focal point of the explosion is thought to have been in the 3-in. Aloyco pump suction valve.

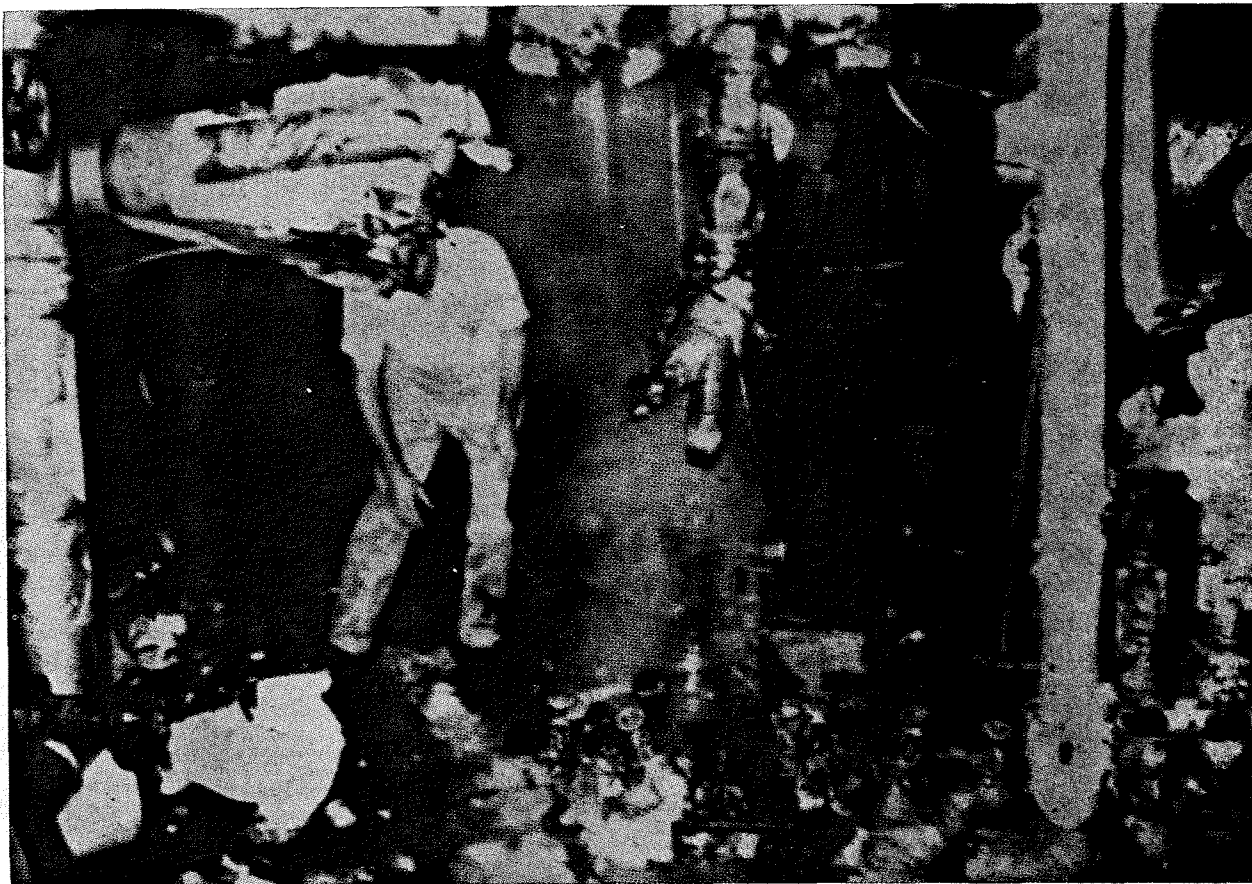
Figure 3. Scene of the explosion approximately one hour later.

Figures 3 and 4 show the scene approximately one hour after the explosion. Figure 5 is a plot plan showing the area involved and marked to show location of major recovered pieces of piping and valves as well as other damaged equipment. Pieces of the valve body and piping penetrated the insula-

tion of all vessels and piping in the area. One hole was knocked in a 4-in. stainless steel line, and all vessels and considerable piping in the area had serious dents and gouges. Electrical conduit and instrument lines in the area sustained severe physical damage. One fragment of piping, approximately 2 by 3 in. was removed from the insulation on the 10,000-ton ammonium nitrate storage tank located 130 ft. away. A pipe flange knocked a hole in a boxcar over 100 ft. away. Numerous holes were knocked in the aluminum siding of the dryer room and several holes in the roof, over three stories high, indicated pieces of material had bounced off the dryer drums and gone out through the aluminum roofing. Undoubtedly, the insulation on numerous vessels and piping in the area greatly reduced the extent of physical damage. A hole was punched in an 8-in. H-beam almost 40-ft. north of the center of explosion.

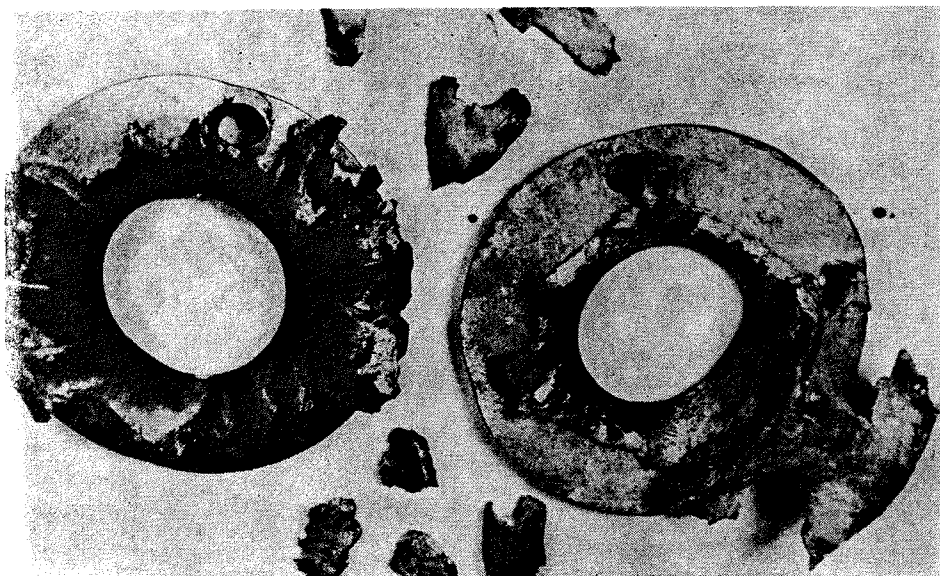
Figure 6. View of the 3-in Aloyco valve body flanges.

Figure 6 shows two views of one of the 3-in. Aloyco valve body flanges. The large section in the lower right-hand corner is part of the valve bonnet flange. The miscel-

laneous small pieces are from the valve body, piping, and flanges. Discoloration showed that carbon was definitely present in some form. Figure 7 shows a photomicrograph of a section where the distortion was at a minimum. Figure 8 shows the pattern from a severely deformed section in which the delta ferrite structure and inclusions were elongated.

Scrapings of the flanges and samples of a standard solution were analyzed. The laboratory report stated that a considerable amount of difficulty was experienced in conducting the spectrographic analysis of the urea (solution). Several small explosions were encountered. It was further found that concentrations of the material, 250 ml. of liquid evaporated to a salt, were highly flammable just prior to completion of the evaporation process. The spectrum was scanned for 66 elements which included the trace elements. It is suspected these were not picked up from the piping. The report did not attempt to reduce the analysis to actual parts per million of the product analyzed; however, traces of Na, Mg, Al, Si, Cr, Mn, Cu, Pb, and numerous addi-

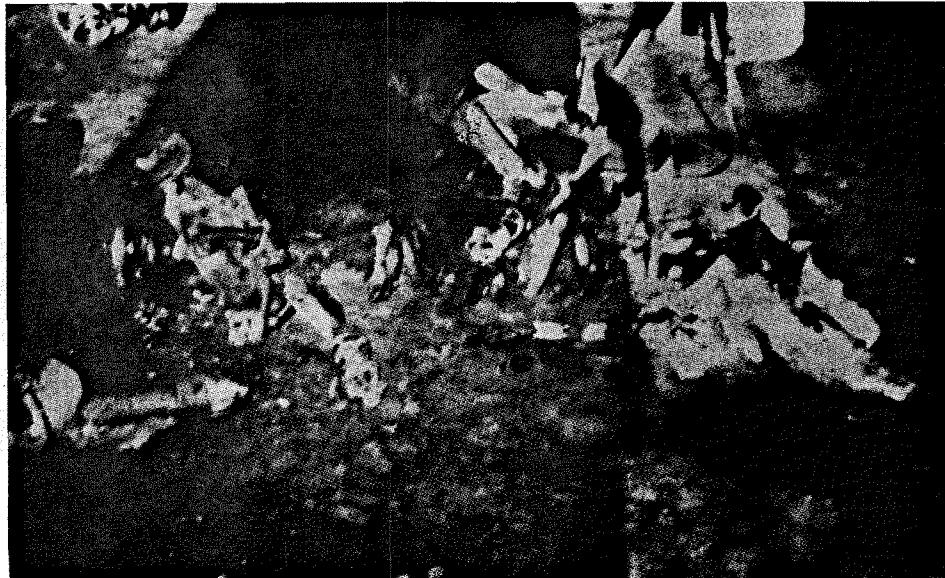
Figure 9. Over-all view of the reassembled parts.

All parts removed from the area were taken into the shop and laid out as closely as possible to the original pattern. Figure 9 shows an over-all view of the reassembled parts. The main header piping was fragmented and actually pulled back along the ballooned section. Stainless steel tubing was flattened into ribbons. The piping flanges were bent and dished. The pump housing and impeller were severely distorted. The 3-in. valve and the 1-in. drain valve, pipe flanges, and valve discs were all discolored. Of particular interest is the disc discoloration which was primarily restricted to the back side; only part of the actual faces were discolored. No discoloration was found on the actual valve stem which, incidentally, still turns freely.
