# EXPLOSION IN EXPANDER DISCHARGE PIPING

W. L. Ball

Air Products and Chemicals, Inc.  
Allentown, Penn.

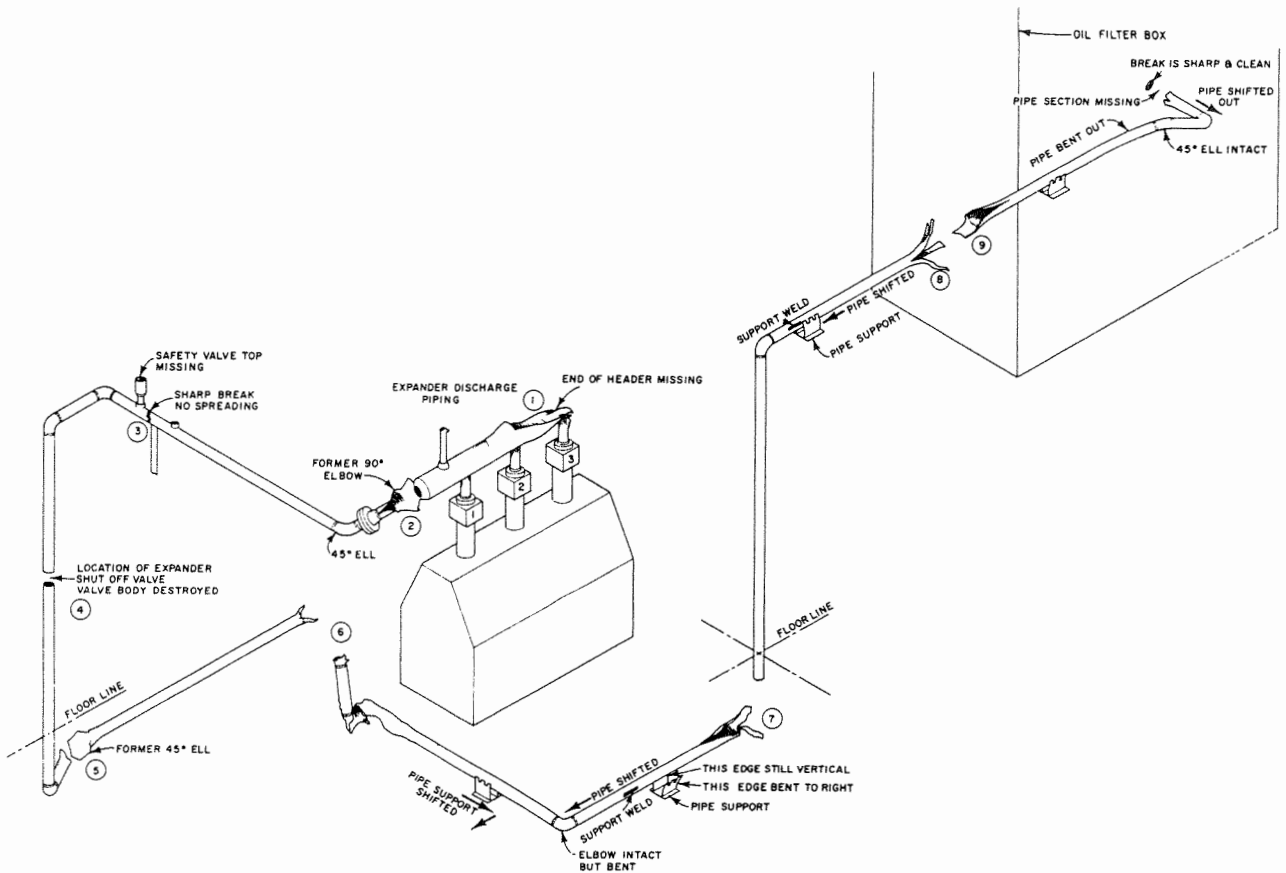
Most of the windows in the east end of the building were broken. Damage by flying debris was not extensive. The major damage was confined to the discharge piping system of the expander, and to a lesser degree the piping in the oil filter. The multiplicity of failures in the discharge pipe is graphically shown in Figures 1 and 2. The encircled numbers on the figures correspond to the numbers on the photographs showing the failures in the pipe.

The piping system had failed or exploded at ten separate locations between the expander and the penetration into the oil filter jacket. With the exception of about 5 ft. of the pipe, just prior to the penetration into the oil filter jacket, all of the pipe had been stressed beyond its elastic limit by internal pressure which had increased the outside diameter by as much as 1/2 in. (The pipe was 3 in., Schedule 40, 304 stainless steel. Stressing to the elastic limit would have required an internal pressure of 8,500 lb./sq.in.) Five of these failures occurred at 90° or 45° ells; eight other ells, although deformed to varying degrees, remained intact.

Figure 1. View of expander discharge piping damage.

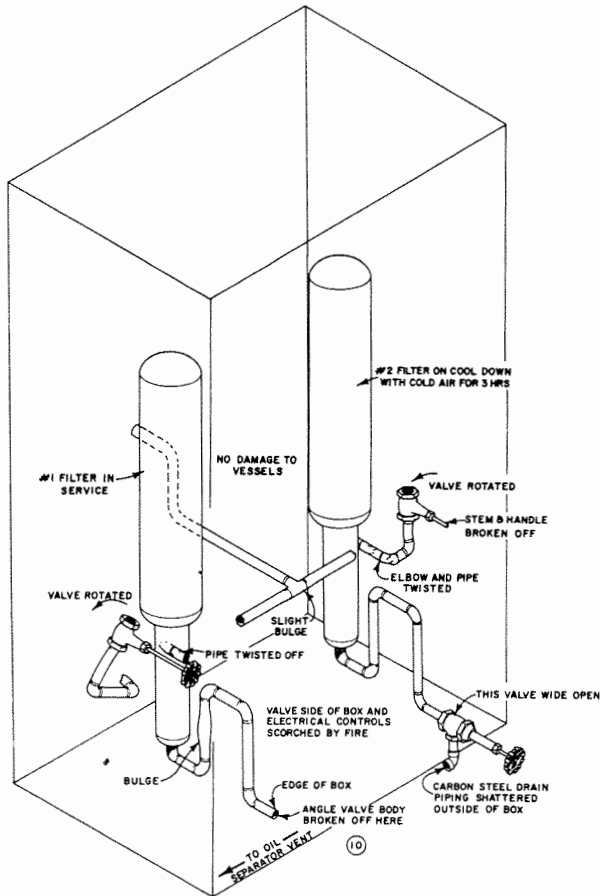
Inside the oil filter box the inlet valves to both filter bottles had blown loose from the inlet piping. This was a mechanical failure of the silver soldered joints caused by a high pressure surge in the piping. The momentum of the valves acting on the pipe as a lever arm twisted and deformed the pipe downstream of the valves; the inlet pipe on the No. 1 filter bottle had twisted completely off. The drain pipe on the No. 1 bottle was bulged from internal pressure.

The jacket of the oil filter box was bulged from the release of high pressure air when the inlet valves pulled loose from the pipe. There was also damage to the heater controls, pressure gauges and temperature gauges on the box.

Figure 2. View of oil filter box damage.

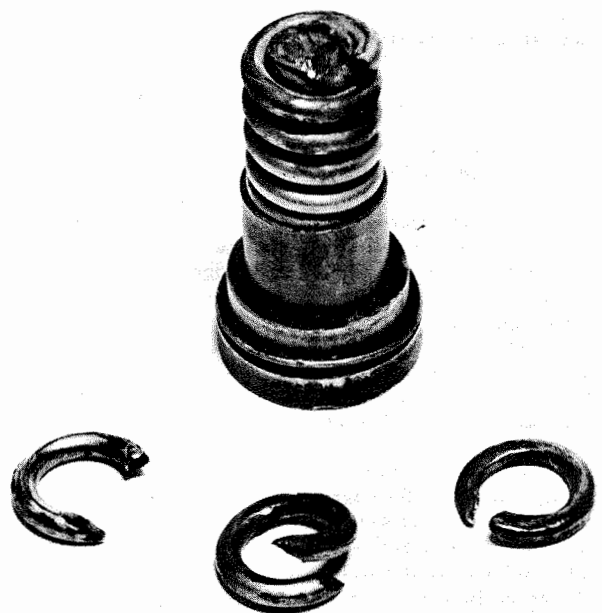
The most significant detail found when the expander cylinders were dismantled was the broken spring on the inlet valve of the No. 1 cylinder, Figure 3. As can also be seen in the picture, the end of the spring guide is heavily marked and deformed. This would indicate that the spring had broken prior to the explosion, as the expander shut itself down at the time of the explosion.

Figure 3. View of broken spring on the inlet valve of the No. 1 cylinder.

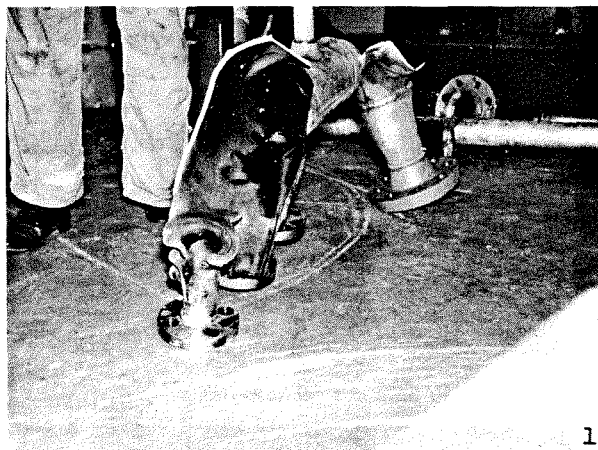
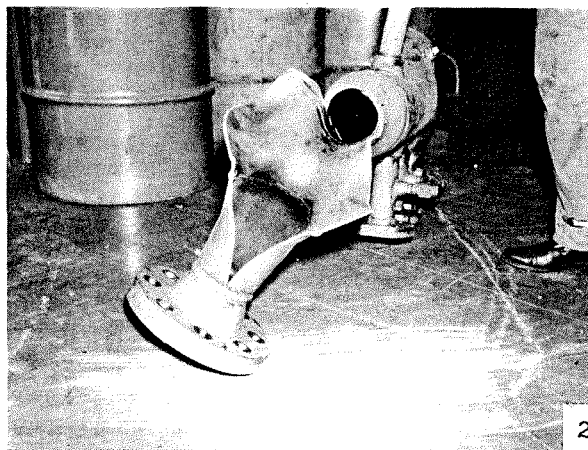
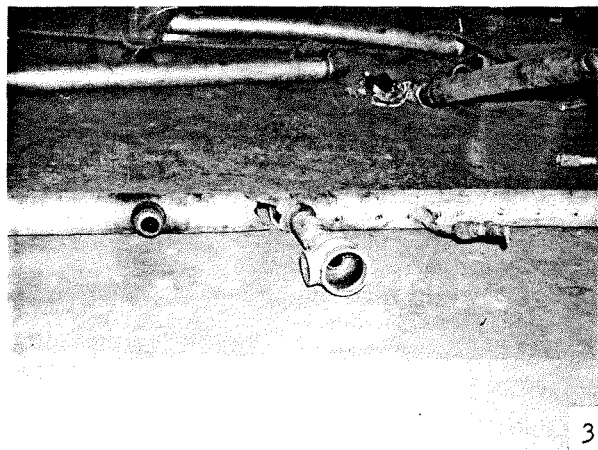
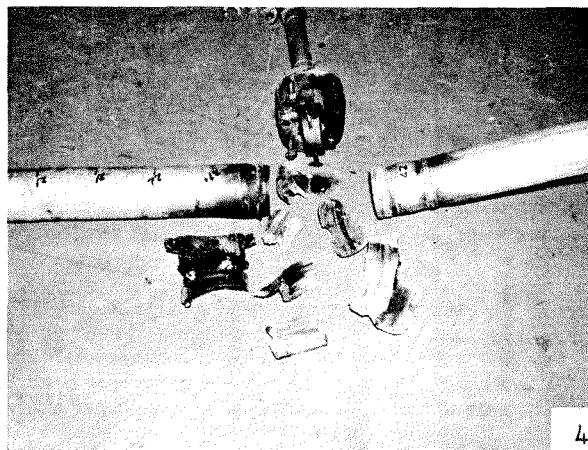
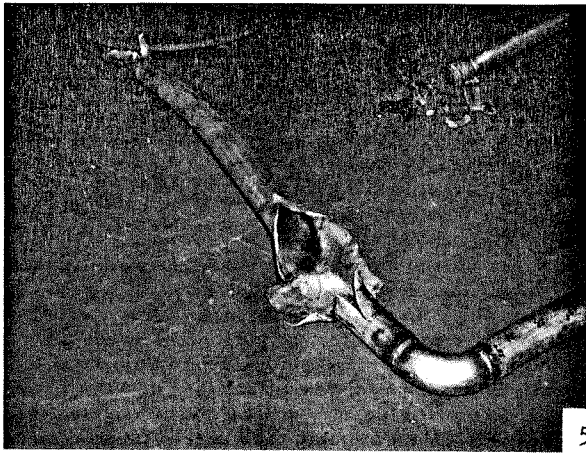
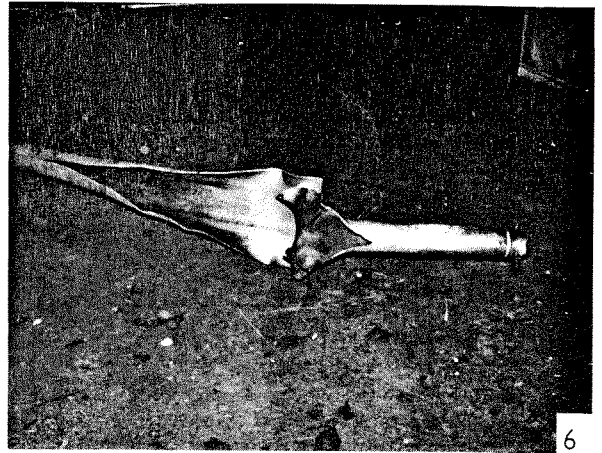
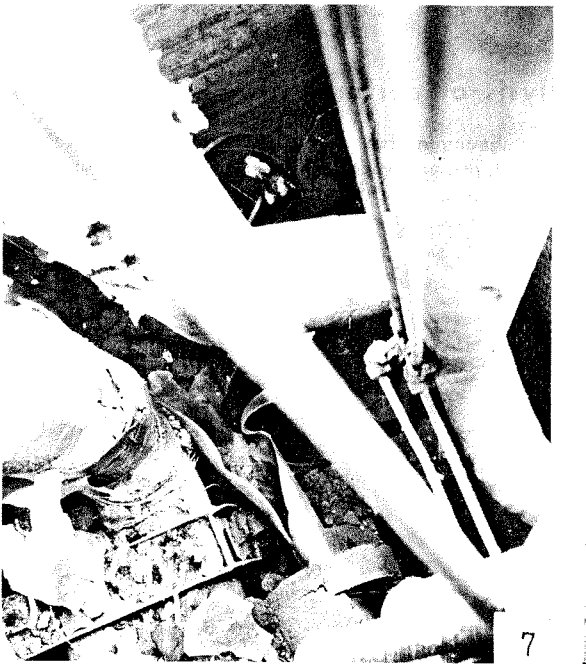
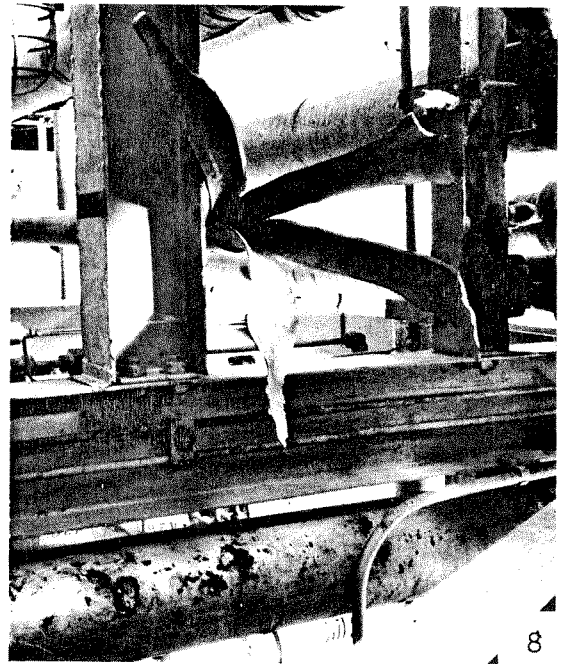
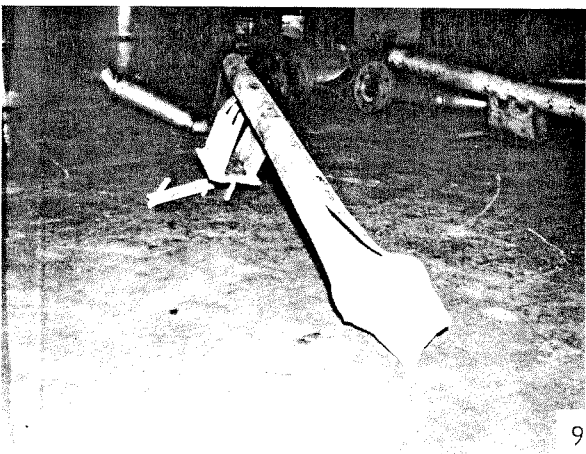
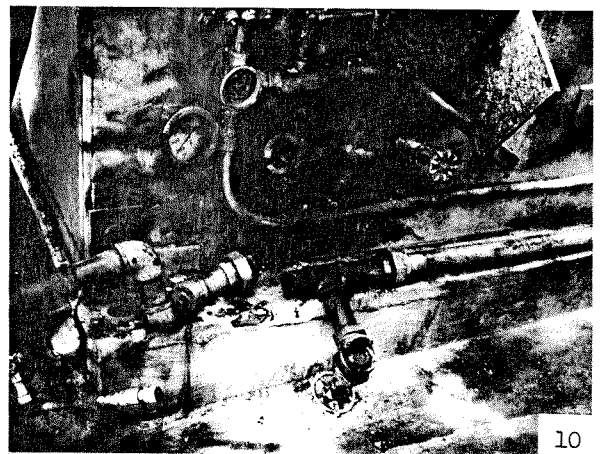
Figure 4. Ten photographs showing specific piping damage.

The quantity of oil that existed in the header is indicated in Picture No. 1. The expander discharge pipe in an identical system at a sister plant was opened

to observe the extent and condition of any oil deposit. It was found that a small rivulet of frozen oil about 1- to 1 1/2-in. wide existed along the bottom of the pipe. The presence of such a deposit in this plant was indicated by dark combustion stains in the bottom of unruptured pipe sections while the sides and tops of the pipe were bright and clean.

It may be noted that most of the failures, Figure 4, occurred where oil would tend to collect, in the header (failures 1 and 2) and at low points (failures 5, 6 and 7). Failures at 8 and at the box penetration may be explained by oil accumulations at weld joints. The drain valve at point 10 would also be a natural point for oil to collect.

BALL: There has not been any change in that particular design. It is now operating exactly as it was before. I think that in future designs we would change the piping system to reduce the number of points where oil can accumulate. The most extensive changes that were made were in the analytical systems and the operating procedures so that we can detect and shut down the system in a matter of a few seconds rather than almost a minute and a half.
