INSULATION FIRE ON A STORAGE SPHERE

Before tank was completed a polyurethane foam insulation caught fire and was completely destroyed

H. L. Darling
Sherritt Gordon Mines, Ltd.
Fort Saskatchewan, Alberta
Canada

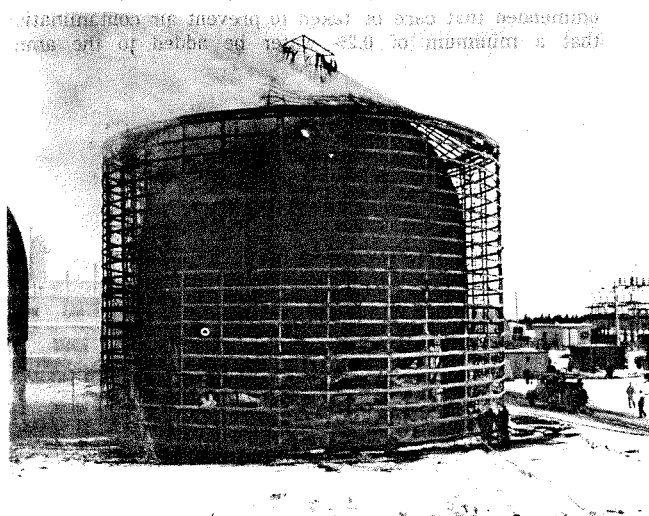
Figure 1. This was taken not more than 10 minutes after the fire started. The framework was all badly charred and had to be torn down.

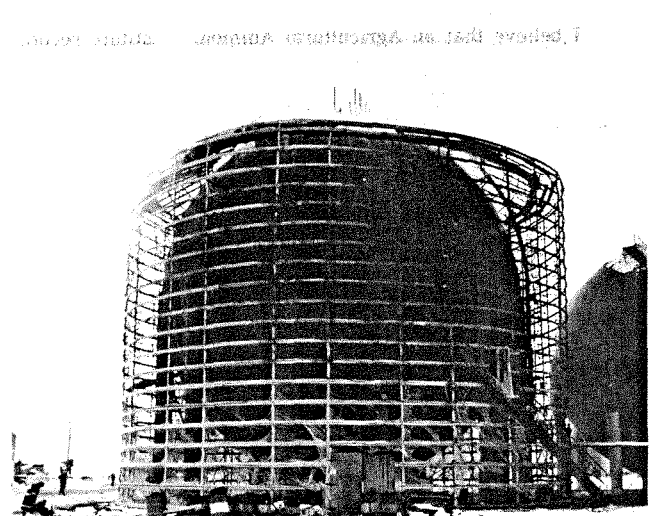
Figure 2. This is a closeup of damage done to the hoarding cover. Escape doors can be seen. Scraps of the polyethylene shelter were all that remained.

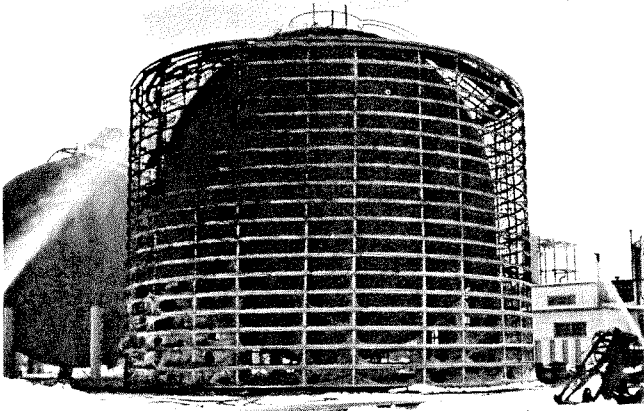
Figure 3. This is an additional view of the tank; nearby 1,000 ton spheres may be seen in background. Fire hoses are still playing upon the sphere.

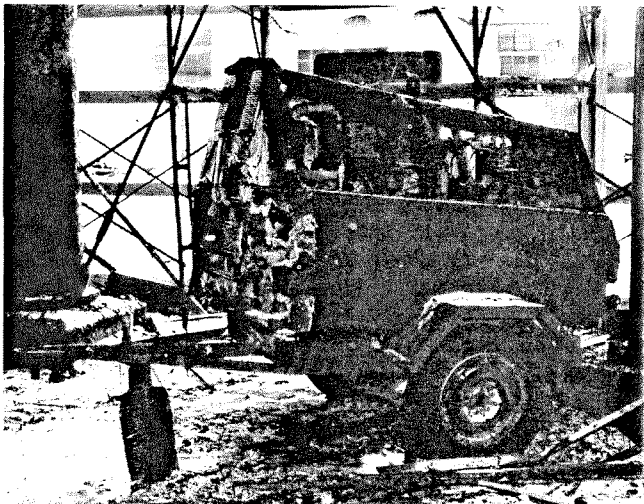
Figure 5. Extent of damage can be seen by this photo of the remains of the contractor's air compressor which was within the framework.

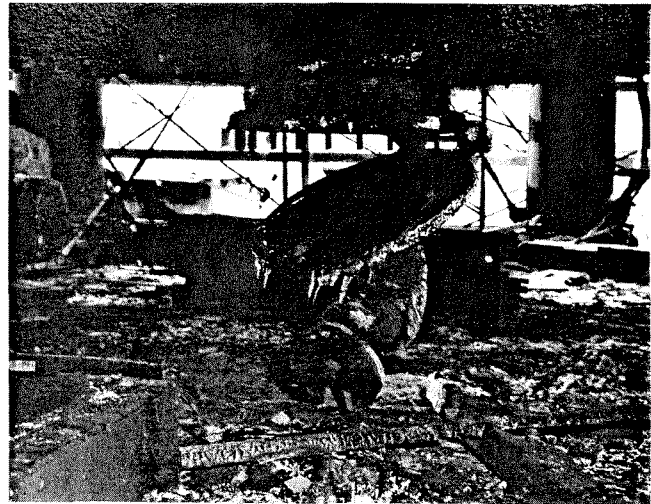
The day after completion of the installation, a mechanic was assigned to prepare the vessel for service, connecting up pipe, etc. He found that the liquid outlet connection which was connected to the bottom manhole cover was completely frozen up. This was from the condensate draining from the sphere. He decided that the quickest way to thaw this out was to use a propane torch.

After a few moments, the bottom of the sphere caught fire. Before the mechanic could reach for the fire extinguisher it had spread beyond his control. He was alone at this point but managed to escape from the area taking the propane tank and torch with him.

The after-fire investigation revealed that the C-29 is based on a coating of asphalt and gilsonite. These are blended with a 100-flash petroleum solvent, asbestos fibers and mica fillers.

The solvent actually oozes out of the insulation until it is cured. This curing period, I am told, can take up to 30 days. This we didn't know.

Figure 4. The fire started here underneath the sphere where a workman attempted to thaw out a frozen nozzle with a propane torch.

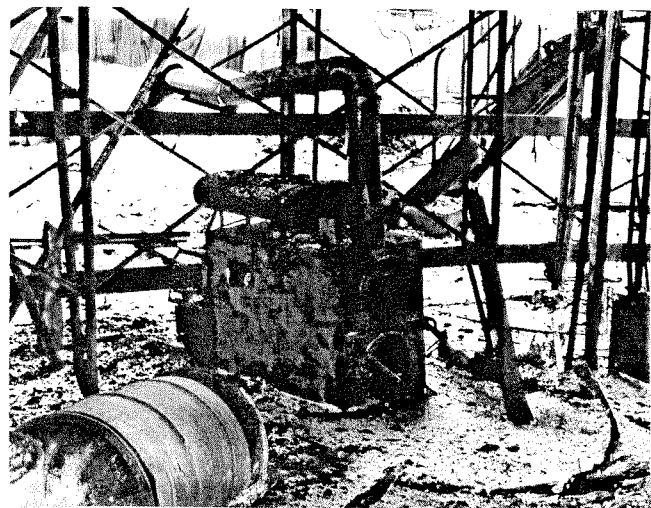
Figure 6. This kerosine space heater was also consumed in the blaze. The heater was used to warm the space within the polyethylene shield.
