FLARE LINE RUPTURE IN AN ETHYLENE PLANT

Trend towards large capacity plants emphasizes the need to adequately guard against brittle fracture risk

C. G. Kevil
Cities Service Oil Co.
Lake Charles, La.

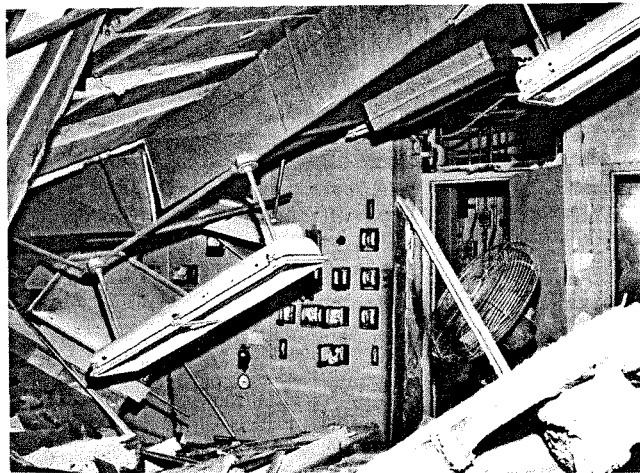
Figure 1 shows the only section of the panel board in that compressor control room that was still standing. The concrete walls had been blown against the panel board and the roof had fallen in. More details on the system damage are in the Feb. 14, 1966. Chemical Engineering article on this particular fire and explosion.

Figure 1. This was the only section of the panel board standing in the compressor control room.

We also put in a better located, more rugged compressor control room. We had none left so we just started over from scratch. It was cheaper that way.

Kevil: Yes, it has a steel frame with steel braces in the walls now. It was designed with steel supports only but we have made it much larger and we have taken it out of the immediate area. It is actually situated almost at the edge of the plant, as the other control room is, so that there will not be the problems occurring. I think we have the structural strength in the walls in the re-design that they won't come in again as they did in this case.

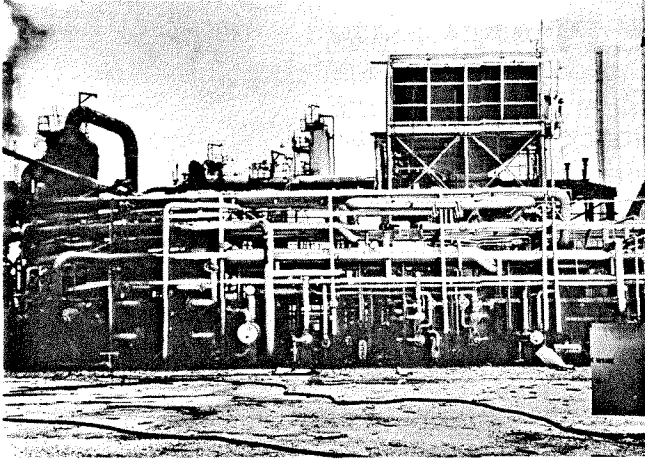
As one man's opinion, I believe we had vented this tower enough times that the line above the heat exchanger which went straight up to a rigid flare line above it, which was held by the cross-members of the pipe rack, had contracted and expanded so many times over the years that it had work-hardened and this stretch was just one time too many.

We know the steel line above the exchanger connecting into the flare line parted circumferentially above the heat exchanger and large volumes of gas flowed out into the plant.

Figure 2 shows the area where the exchanger broke or the line parted with the main gas flow coming from here. Observers from across the road said the fire seemingly originated in this area as

Figure 2. The exchanger broke or the line parted with the main gas flow coming from here.

Third, we went through our system to determine how and where to put in a stainless steel low temperature complete flare header. At the time our plant was built, it was standard to put in steel flare headers, even though everyone knew you couldn't put -255 F. methane or -155 F. ethylene liquids into a line without fear of cracking. Even today there are flare lines being installed in low temperature plants that are made of steel. Maybe you can get away with it in some cases if you don't have it tied down at various points with various entrances from other sources. Of course, in some cases heat exchangers are installed to heat up some of the cold gas or liquids before they hit the steel line. In many cases if you use something such as process gas from a compressor discharge to heat up the exchanger if you have an upset or a utility failure, you don't have the heat to heat up your gas. Also in that case, the plant would be pretty upset, and you probably would be putting out more hydrocarbon into the flare system than normal.

A re-design of the propylene methane heater and piping was made so that there would be no further problem.

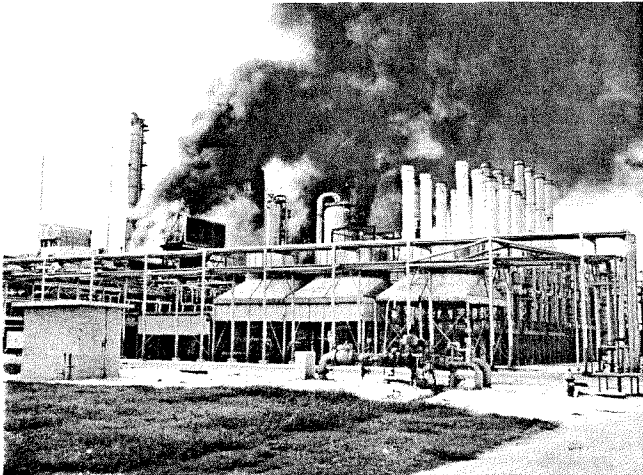
Figure 3. At daylight the next morning the fire was still raging; looking from southeast corner.

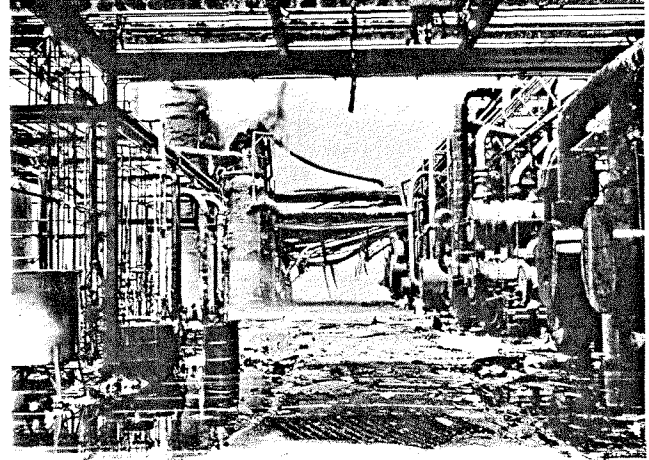
At daylight next day the plant was burning fairly well. Figure 3 is looking from the southeast corner toward the fire, Figure 4, is another view of the damage. You can see all of the piping hanging down and everything just sort of hanging all over. This was over towards the control room. You can see here and here there are pieces of Corrugulux. We had sections of Corrugulux on our compressor buildings plus transit. I will talk about that but the Corrugulux just sort of floated down (like a kite) to the ground. The little sharp pieces lying on the ground like little missiles were transite.

Figure 4. A closer view of the damage shows piping hanging down within process area.

There are three minor items that we would recommend in installations of this sort. That is, replacement of transite with fire retardant fiberglass plastic panels. Transite is dangerous. The fragments become sharp pointed missiles and anybody could be hurt. It was a wonder someone wasn't.

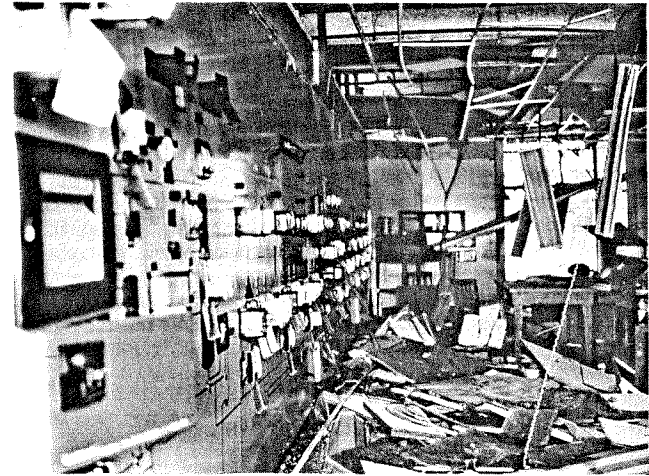
Figure 5 is the main control room with the rubble on the floor and every instrument in the main control room, which was on the far edge of the explosion and fire, had been blown out of its case. You could just see them hanging out.

Figure 5. Every instrument in the main control room had been blown out of its case.

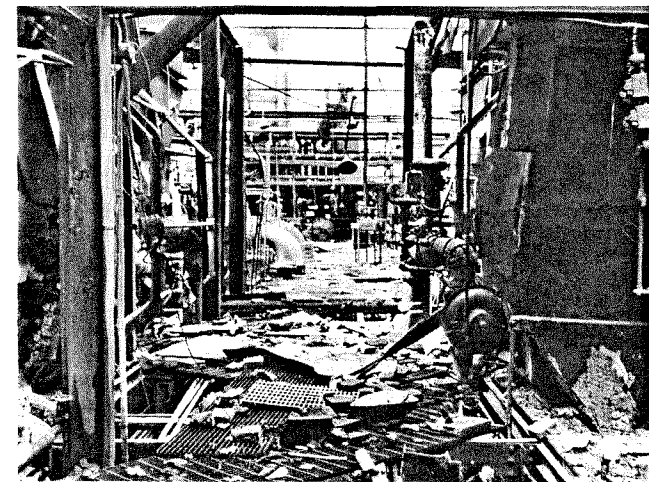
Figure 6 is looking in the northerly direction. There is a gas turbine on either side. This is the compressor floor. It picked up grating, everything, just threw it around indiscriminately. Note evidence of small fires. There was no sprinkler system at this end.

Figure 6. This is the compressor floor looking in a northerly direction.

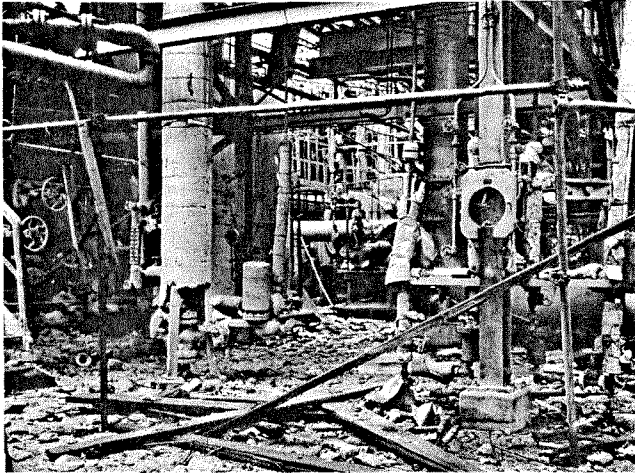
Figure 7 the farthest point from the fire. It was in the south-east corner, with instruments completely damaged, everything around it, the insulation, blown off. The one thing that happened and we found the most intense explosions had taken place on the

periphery because of the lean gas there, whereas closer in, the richer gas didn't explode as much, it just burned fiercely.

Figure 7. This was the farthest point from the fire; most intense explosions were on periphery.

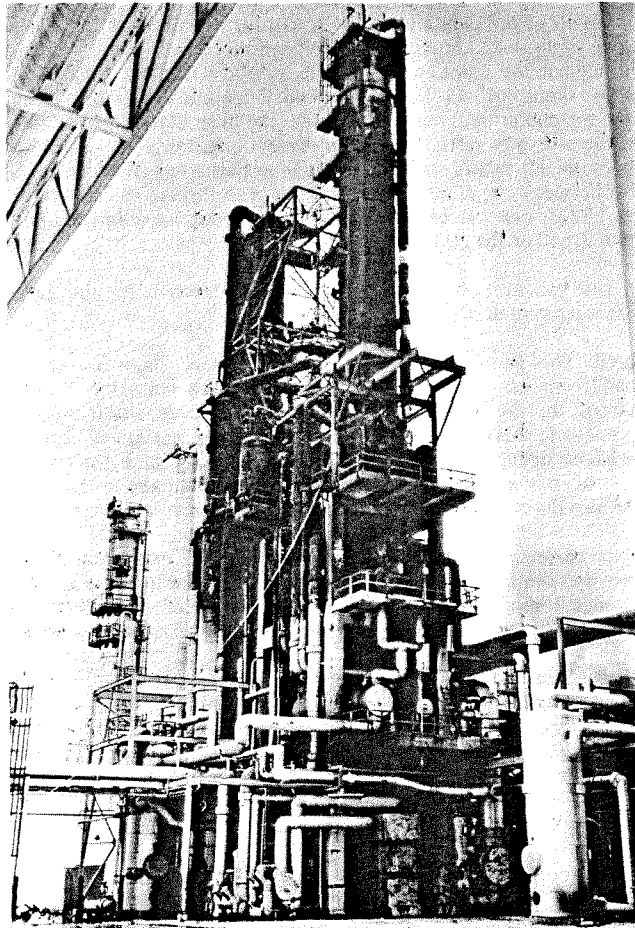
Figure 8 is right next to the fire. The fire was over here and shows what was a 200 foot tower and what we called our cold box. We found several explosions had occurred in there. These are all our low temperature chillers and there was a small tower here

which can't be seen because it was black at this point, behind the ethylene fractionator was the demethanizer which started all the trouble.

Figure 8. This was a 200 ft. tower right next to the fire with cold box adjacent to it.

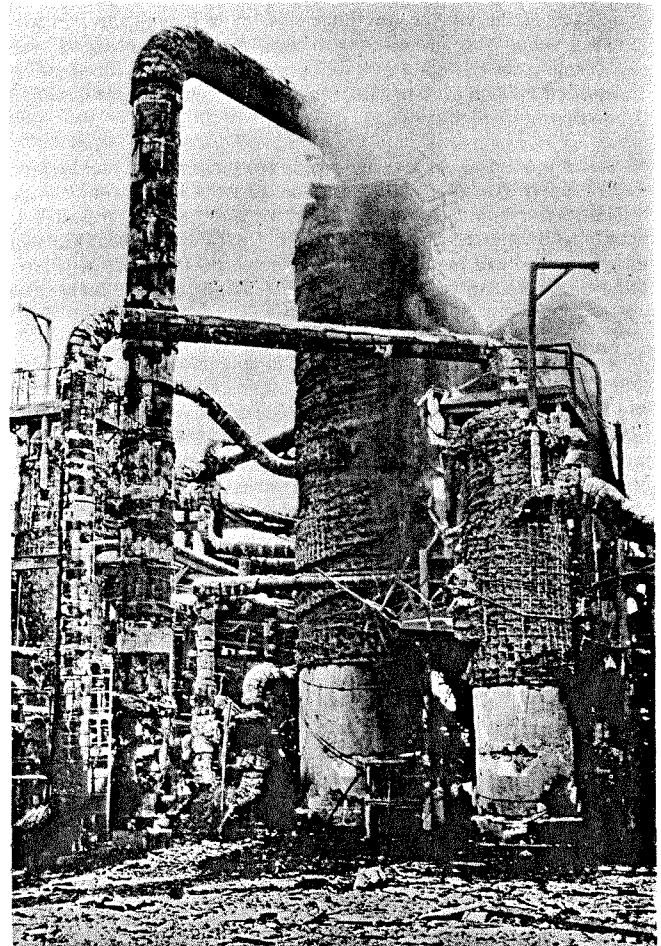
The source of the gas was right behind the drums shown on Figure 9. Note the stainless steel bands were still on the foam glass on these drums and the foam glass was still on all three of the drums except the furthest one and that one had to be replaced.

Figure 9. The source of the gas was right behind the drums shown in this view.

First, we would have been down for better than a year, I imagine, if it had not been for foam glass or equivalent non-flammable insulation on all our towers and drums.

This would have stood up better if it had been covered with thin stainless steel sheeting rather than aluminum jacketing. Aluminum jacketing melted off and allowed some of the foam glass to fail and fall off, thus damaging some of the drums and equipment that might not have been damaged otherwise. I am sure the aluminum people wouldn't like this, but this was the thing that struck me when they were talking earlier about aluminum as a low melting point and it was real obvious in this case.
