METHANOL PLANT EXPLOSION

Rupture of oil blowdown line allowed compressor synthesis loop to depressure in a reverse flow direction; explosion damage was extensive; production resumed in 10 days

J. J. Dorsey, Jr.
Escambia Chemical Corp.

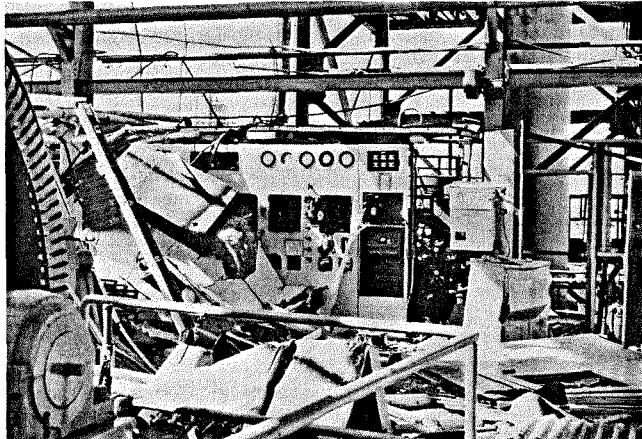
The prompt availability of water in addition to minimizing damage from the flames served to keep structural support members cool and also to keep vessels cool. The heat from the fire damaged all of the electrical wiring and instrument wiring or tubing to the high pressure synthesis area to the west of the compressor building. All control valves in this area suffered damage to the top works and had to be repaired.

Figure 1. All control valves in this area suffered damage to the top works.

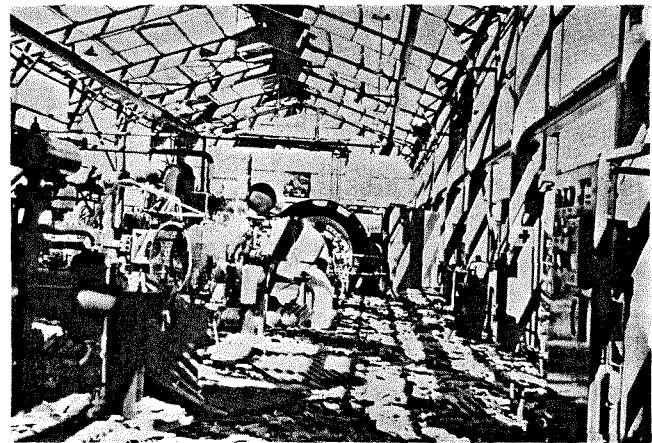
Figure 2. Heat from the fire damaged all of the electrical wiring and instrument wiring or tubing.
