BRITTLE FRACTURE OF CENTRIFUGALLY CAST STAINLESS STEELS

Because of what is now known about causes of stress-corrosion cracking in reformer tubes and brittle fracture in gas collecting manifolds, safety hazards in future naphtha reforming plants will be greatly reduced.

Gordon Harnby, B. Met., A.I.M.
Power-Gas Corp., Ltd.
Stockton-on-Tees, England

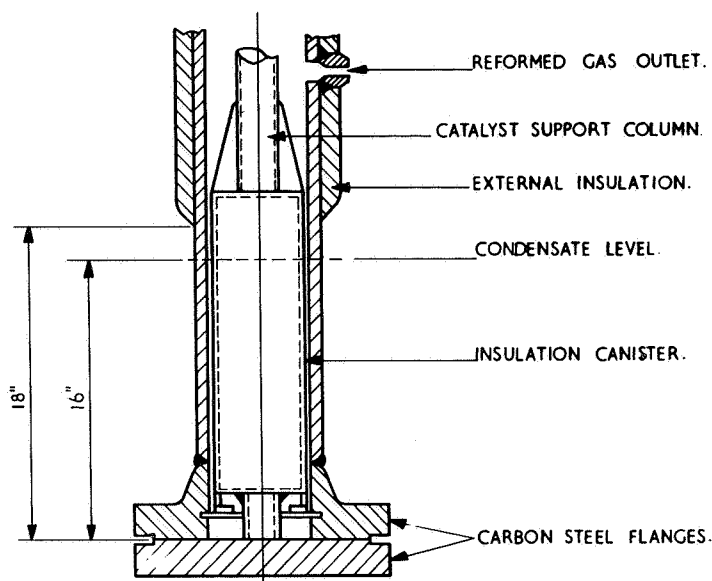
Figure 1 shows the main components of the old type tube base. These include a carbon steel flange, an internal insulation canister, catalyst support column, and external lagging. Such a design resulted in a hand warm temperature at the flange and a steep temperature gradient up to the gas outlet position. Condensate collected in the tube base, and the liquid/gas interface occurred at the height of the tube where the tube wall temperature corresponded to the dew point. In a 400 lb./sq. in. gauge plant this was usually about 180 °C, corresponding to the height of about 16 in. above the base flange.

Figure 1. Principal components of reformer tube "dead leg" section.

The plant was shut down and the subsequent investigation revealed that cracking had propagated through the tube wall of half the tubes in the furnace, and that the remainder were all severely cracked. The cracks had occurred circumferentially, initiating on the tube bore at the wind and water line where it was evident from the water marks that soluble salts had concentrated over a band about 2 in. wide. Fluctuations in operating temperature and pressure had caused the position of the dew point to rise and fall.

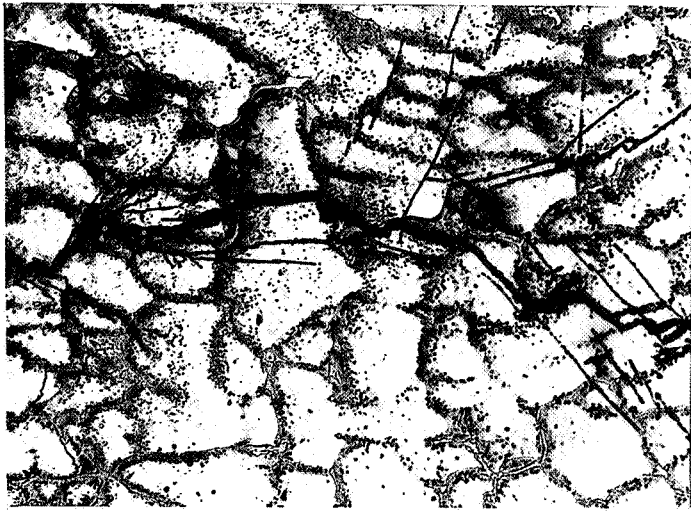
Figure 2, at a magnification of X120, shows the very fine type of cracking which occurred. The transgranular nature of the cracks is very similar to stress-corrosion cracking in wrought stainless steels. Perhaps the only difference of note between the cracks is that the branching characteristics in the cast steel are not quite as marked as in a wrought stainless steel. This is perhaps a reflection of the coarser grain size of the cast material.

The classical conditions for stress-corrosion to occur in stainless steels are: A stress concentration, a temperature in excess of about 80 °C, and the presence of a chloride containing electrolyte or a strong alkali. In the case in point, the stress concentration was provided by a very steep local, thermal gradient across the wind and water line, a temperature of about 180 °C and a chloride concentration of 0.3% in the water line deposit. The

Figure 2. Stress-corrosion cracks in A351 HK alloy.

chloride had gradually accumulated during the previous six months operation from small quantities carried over in the process steam and from the catalyst.

To remedy the situation in the shortest possible time there appeared to be two alternatives. One was to replace the dead leg sections with a material not subject to stress-corrosion cracking in chloride environments. The other was to remove the dead leg altogether and make the tube outlet the bottom extremity of the tube so that the presence of condensate was eliminated, thereby stopping stress-corrosion.

The 1% Cr ½% Mo ferritic steel was chosen as the dead leg material to resist stress-corrosion cracking. The weld between the dead leg and the HK alloy tube was positioned carefully in relation to the external lagging. This was to ensure that the weld operated with a safety factor of 100 °C above dew point but below a nominal 450 °C. Thus on one hand there was no possibility of condensate coinciding with the austenitic steel and on the other hand the ferritic steel was not being extended to the limits of its high temperature properties.

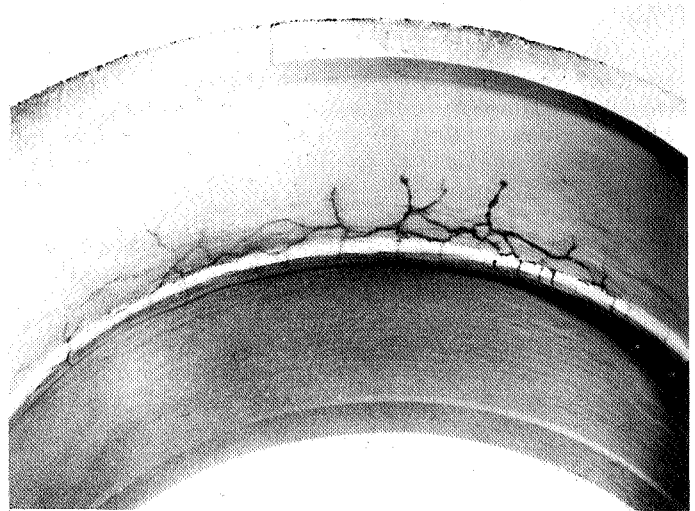
When tubes with ferritic dead legs were put into service the weld temperatures were monitored continuously, to ensure the specified temperature range was being achieved and maintained. It came as a great surprise therefore, when it was found that cracking had again occurred in the HK alloy section of tubes above the ferritic dead leg. The cracking occurred in both the austenitic tube material and the austenitic weld. The ferritic tube was neither corroded nor cracked, Figure 3.

Figure 3. Stress-corrosion cracks at ferritic dead leg in a dissimilar metal weld.

cracking was again of the branching type, transgranular, and in appearance identical to the cracks in Figure 2. They were again identified as stress-corrosion cracks, which by definition require the presence of an aggressive electrolyte to form.

Laboratory experiments simulating conditions in the dead leg had by this time shown that concentrated potassium hydroxide could condense on the tube bore at temperatures up to about 400 °C. The position of the cracking, above the weld, was in fact at a temperature of about 400 °C. This, coupled with the large stresses associated with the weld, indicated that cracking had been caused by caustic potash which had accumulated on the tube bore.

The next stage in our design was to dispense with the dead leg arrangement altogether, and adopt a hot base by sealing the base of the tube at gas outlet level with an HK alloy closure casting. This ensures tube base metal temperatures are the same as the outlet gas temperature. Thus caustic potash can not condense and the possibility of stress-corrosion cracking is removed. The change in design has meant changing to tube top catalyst extraction, but this is a very small price to pay for the assurance that stress-corrosion will not occur again at the tube bases.

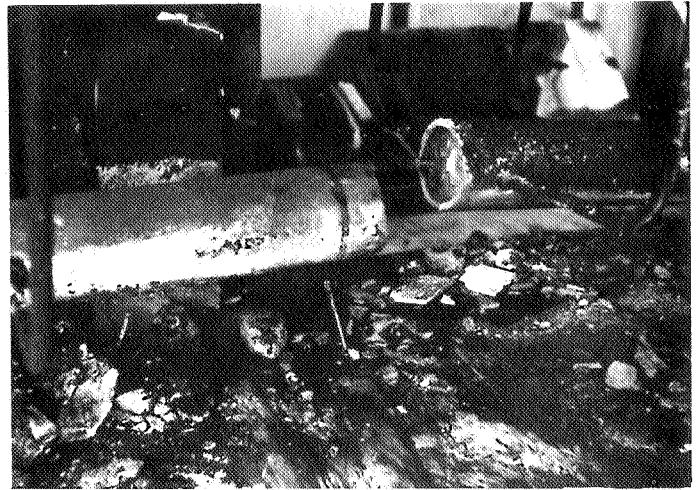
Despite these precautions, brittle failures of manifolds in town s gas reforming plants have occurred. In all of these cases the cause was a sudden plant upset involving a rapid change in make gas temperature, resulting in rapid chilling of the manifold and in brittle failure.

Figure 4 shows the fractured ends of a manifold tube which had been subjected to such a drastic thermal quench. It is clear that the fractured surfaces are brittle and there is no evidence at all of plastic deformation in the fracture region. The material has obviously been completely unable to relax the sudden high stress buildup by yielding.

Figure 4. Brittle failure of A351 HU alloy manifold.

changes, it is now my company's practice to utilize the considerably tougher wrought 20% Cr/35% Ni, alloy 800 for manifold construction. This is done despite the fact it is weaker and considerably more expensive than the cast HU alloy.

Alloy 800 owes its improved ductility to a lower carbon content (0.10% maximum) and also, to a lesser extent, to its finer grain size. It is an alloy which does not significantly age at service temperatures, so that its high ductility is retained over the full working temperature range from ambient to 850 °C. Since it has been used there have been no cases of failure. It is confidently expected that should an alloy 800 manifold be subject to thermal shock treatment that it would deform rather than crack. In this respect the safety of personnel and plant is upheld.
