FABRICATION PROBLEMS WITH HEAVY PRESSURE EQUIPMENT FOR LARGE AMMONIA PLANTS

The trend to large, single-train plants has resulted in several serious problems involving fabrication; both construction schedules and plant reliability are affected.

G.P. Eschenbrenner, C.A. Honigsberg, and A.M. Impagliazzo
M.W. Kellogg Co.
New York, N.Y.

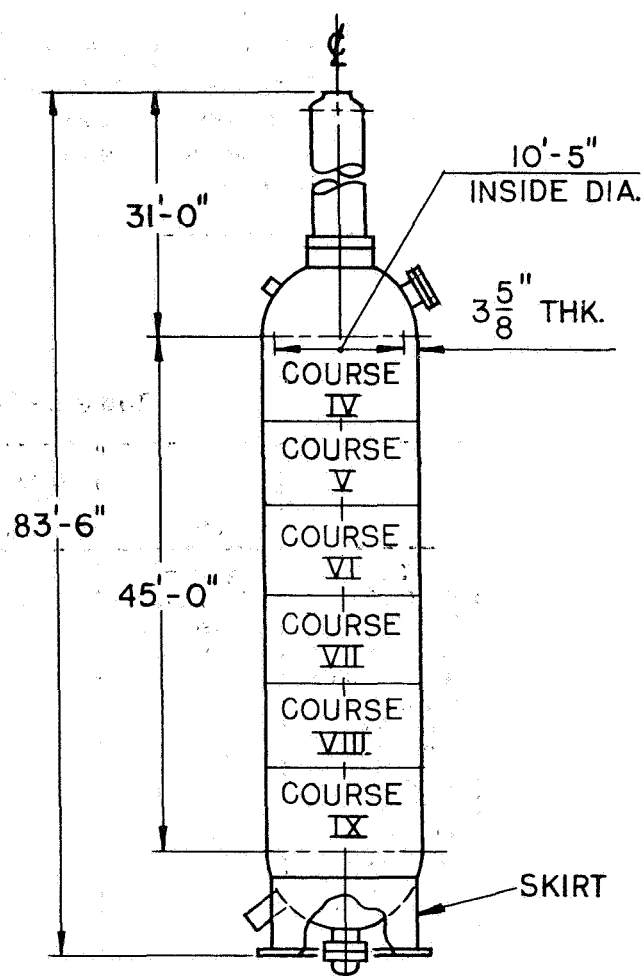
Outline of the vessel is shown in Figure 1. No nozzle corrections or other major stress raisers were permitted in the cylindrical shell. In general, construction requirements approached or exceeded nuclear code level of quality. The basic design was based upon the German code which for pressure vessels below the creep range permits a design stress of:

Figure 1. Elevation view of ammonia converter.

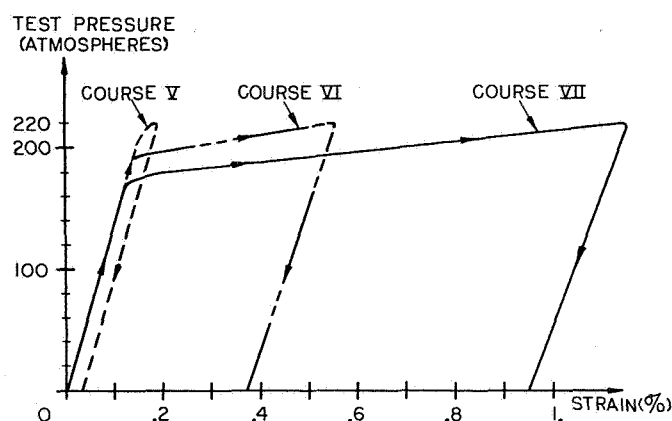
During the hydrostatic test several strain gages were installed to measure axial and circumferential strains of individual shell courses. Figure 2 shows measured strains against test pressure. The following conclusions can be reached:

1. Vessel Course 7 reached the yield point (.2% offset) at approximately 175 atmos. test pressure.
2. Vessel Course 6 reached the yield point at approximately 190 atmos. test pressure.
3. Vessel Course 5 approached yield point at the specified test pressure of 220 atmos.
4. Remaining courses showed no permanent yield after pressurization.

Figure 2. Vessel strain measurements.

Corrective measures to avoid recurrence of these failures were as follows. The extent to which they could be applied were dependent on the stages of fabrication of the individual vessel courses and assembled converters.

5. The final hydrostatic test pressure was increased approximately 10%. Together with strain gage measurements this permitted final verification that the design factor of 1.5 from the yield point was closely approximated.

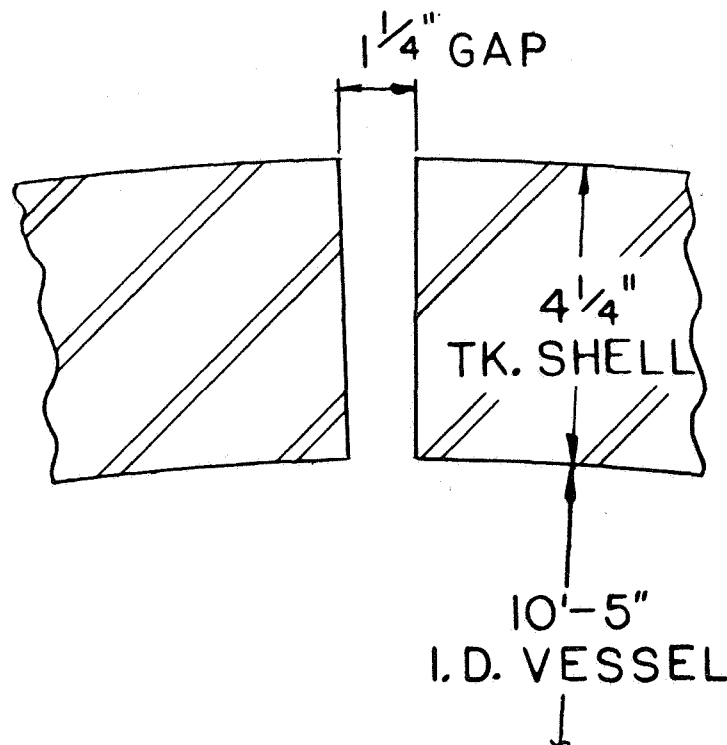
The electroslag welding on the first seven ammonia converters had proceeded in a satisfactory manner. However, on the eighth ammonia converter, ultrasonic examination revealed serious defects in the electroslag welds. The defects were of two types:

1. Fine shrinkage cracks in a herringbone pattern running along the axis of the weld near the mid-depth of the weld.
2. Longitudinal defects running along the fusion zone, approximately 1/16 in. wide and several inches long.

Figure 3. Plate preparation for electroslag weld of longitudinal joint of ammonia converter.

In the case of this ammonia converter, it was concluded that the higher carbon content was the principal cause of the cracking. Plates and welding wire were reordered with reduced carbon content for subsequent electroslag welding on this vessel. Further corrective action included reducing the welding speed, preheating the plate to a higher temperature and, immediately after welding, placing the welded course into a hot stress relieving furnace without intermediate cooling. The objective of the latter requirements was to minimize any tendency toward cracking which might have been caused by thermal and shrinkage effects in the weld metal.

In addition to the steps involving the welding procedure and heat treatment of the material, the procedure for nondestructive examination of the welds was modified to provide greater assurance of detecting cracking in the event that the problem persisted or recurred. Previously, the ultrasonic examination of the welds was done by the normal beam technique only. The revised examination now includes shear wave searching at various angles and directions in addition to the normal beam technique.

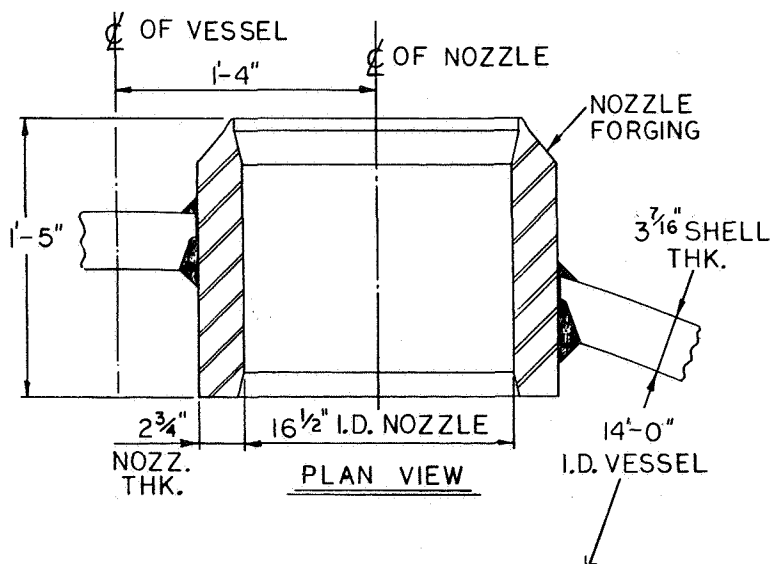
The general location of nozzle "X" is shown in Figure 4. Figure 5 is a plan view showing the nozzle and its attachment weld as originally designed. The nozzle is an 18 in. nominal size connection with a stub end for welding to the external pipe line in the field and an internal extension for attach-in an internal non-pressure pipe (not shown in Figure 5). The nozzle is slightly

Figure 5. Original design of nozzle "X" for shift converter.

hillside in the shell, which is 14ft. inside diameter and 3.5 in. thick. Thickness of the nozzle forging wall where it passes through the vessel shell is 2.75 in.

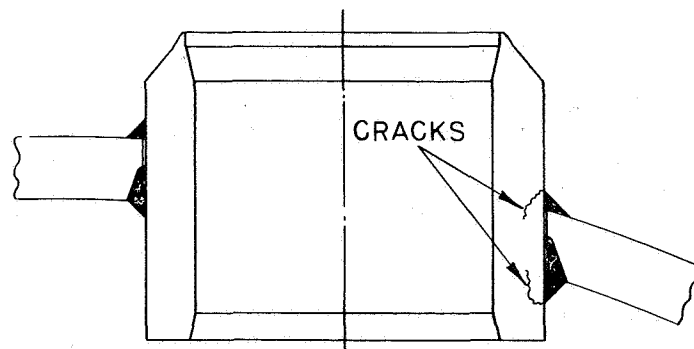
On the second shift converter, much more serious cracking was encountered at nozzle "X". The cracks were located as shown in Figure 6 and extended most of the way around the circumference of the nozzle. Repairs were unsuccessful, so the forging was cut out and scrapped, and a new forging obtained. The same type of cracking occurred when the new forging was welded into the vessel.

Figure 6. Cracking of original nozzle design for shift converter.

The heat treatment of the forging and its physical and chemical properties were checked again and were found to be within specification limits. It was concluded that the principal cause of the cracking was thermal restraint between the thick shell and thick nozzle wall. Contributing factors were the unbalanced design of the attachment weld and the lack of full penetration of the weld through the vessel shell. Also, carbon-molybdenum steel on some previous occasions has shown tendencies toward sensitivity in welding, with cracking being a source of trouble. All of these factors apparently had combined in this case to cause the problem.

Careful repairs again were attempted, involving complete removal of the cracks by chipping and grinding, controlled pre-heat for welding, "buttering" the forging to replace metal chipped away, inspection for incipient cracks after each weld pass, local stress relieving before allowing the metal to cool from welding, etc. All this was to no avail, since the cracks repeatedly recurred.

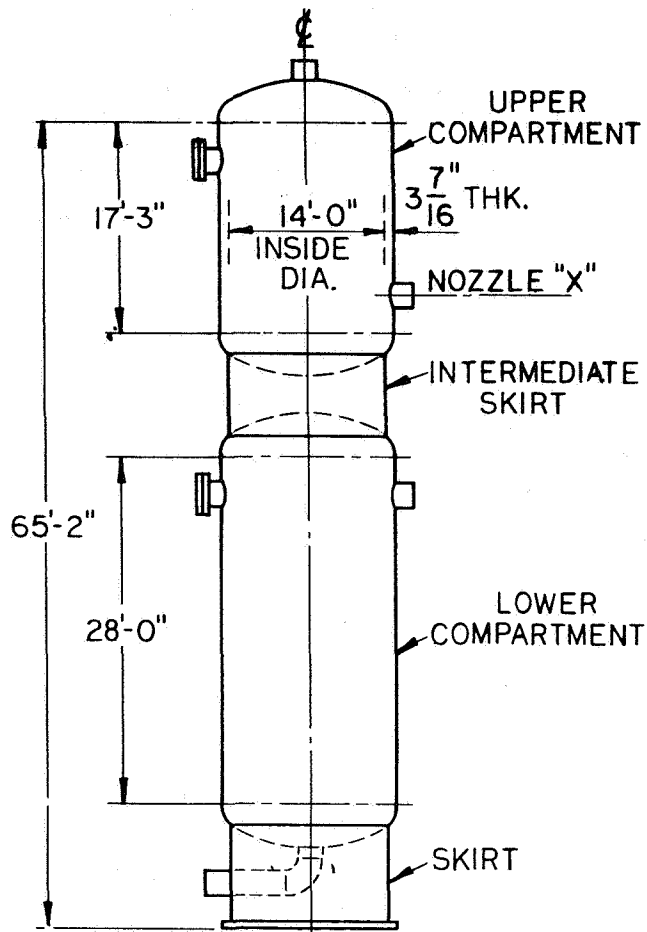
Figure 4. Elevation view of shift converter.

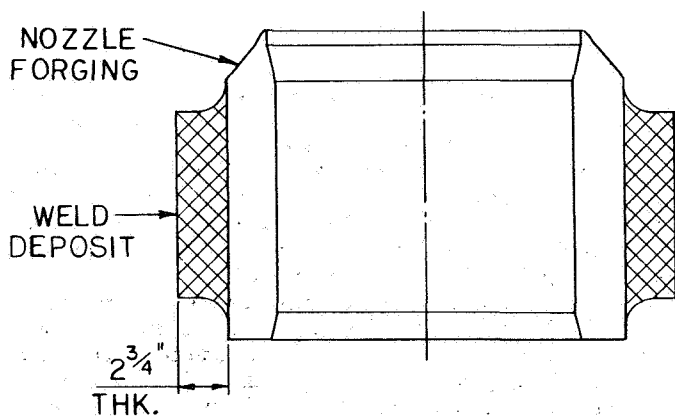
Figure 7. Weld deposit for revised design of shift converter nozzle "X".

A weld deposit was applied to the outside of the forging by submerged arc welding, after which the forging was normalized and the weld deposit machined as shown in Figure 7.

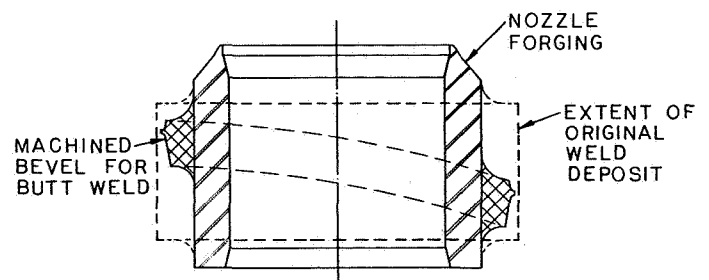
Figure 8. Revised design of nozzle "X", ready for welding to shell of shift converter.

A weld bevel for a full thickness double welded butt joint to the shell was machined into the weld deposit as shown in Figure 8. The final weld of the nozzle to the shell is shown in Figure 9.

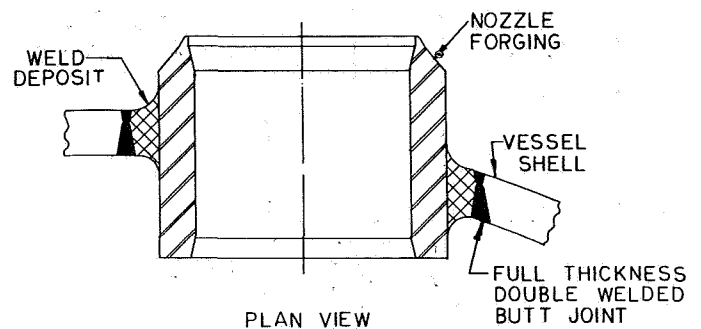
Figure 9. Weld of nozzle "X" to shift converter as successfully completed.

The manual metal arc welding of the nozzle into the shell was performed by two welders working simultaneously at opposite points to obtain balanced thermal effects. The finished weld was then heat treated and examined by radiography and ultrasonics. Nondestructive examination, not described in detail here, was applied to the weldment at various intermediate stages of the work.

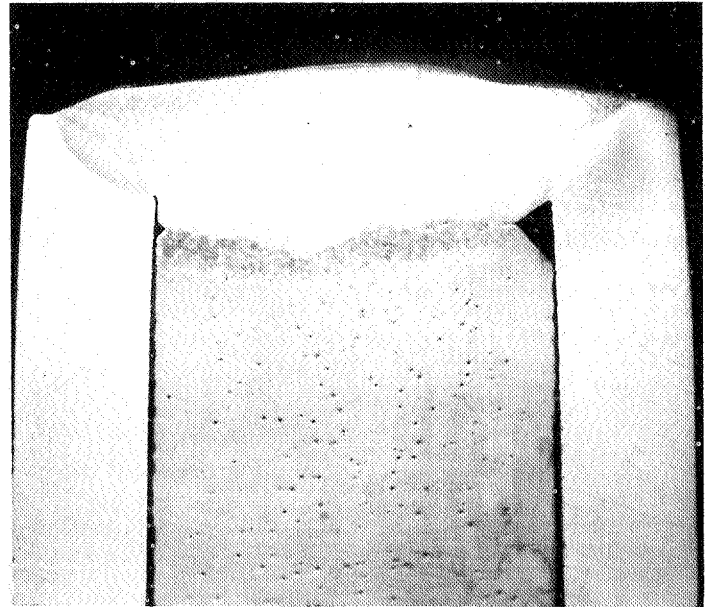
The problem is aggravated by the fact there is no simple nondestructive test which will detect the presence of sub-surface flaws of the most serious nature. Figures 10 and 11 are examples of such defects. The usual practice is to develop a procedure which is capable of producing sound joints as demonstrated by leak tests and random sectioning of representative samples, and then to assume that all joints produced by such a procedure which are free of leaks and/or surface defects are sound.

Figure 10 and 11. Welded tube joint samples with serious defects in subsurface.

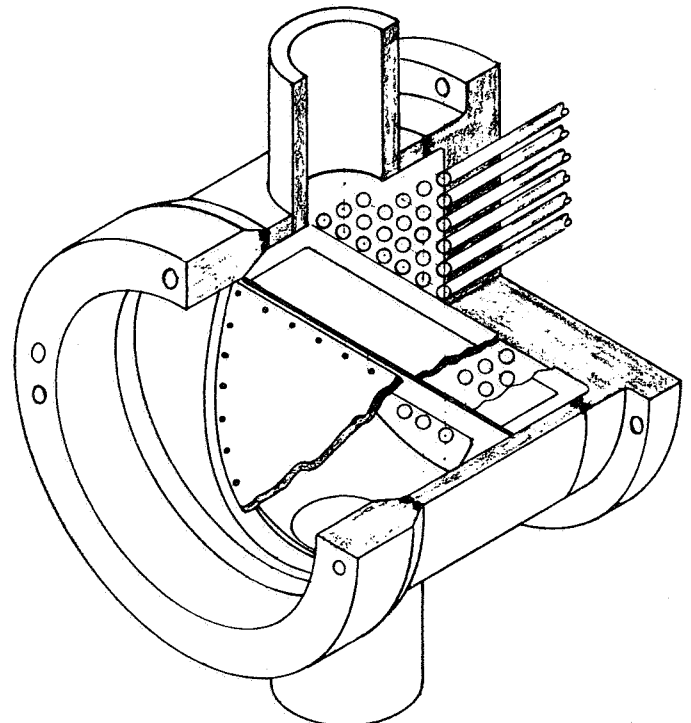
In the current generation of ammonia plants there are a number of exchangers of the general type shown in Figure 12. The high pressure, somewhat above 2,000 lb./sq.in. gauge is on the tube side and the shell side design pressure is 150 lb./sq.in. gauge.

Figure 12. Typical high pressure exchanger.

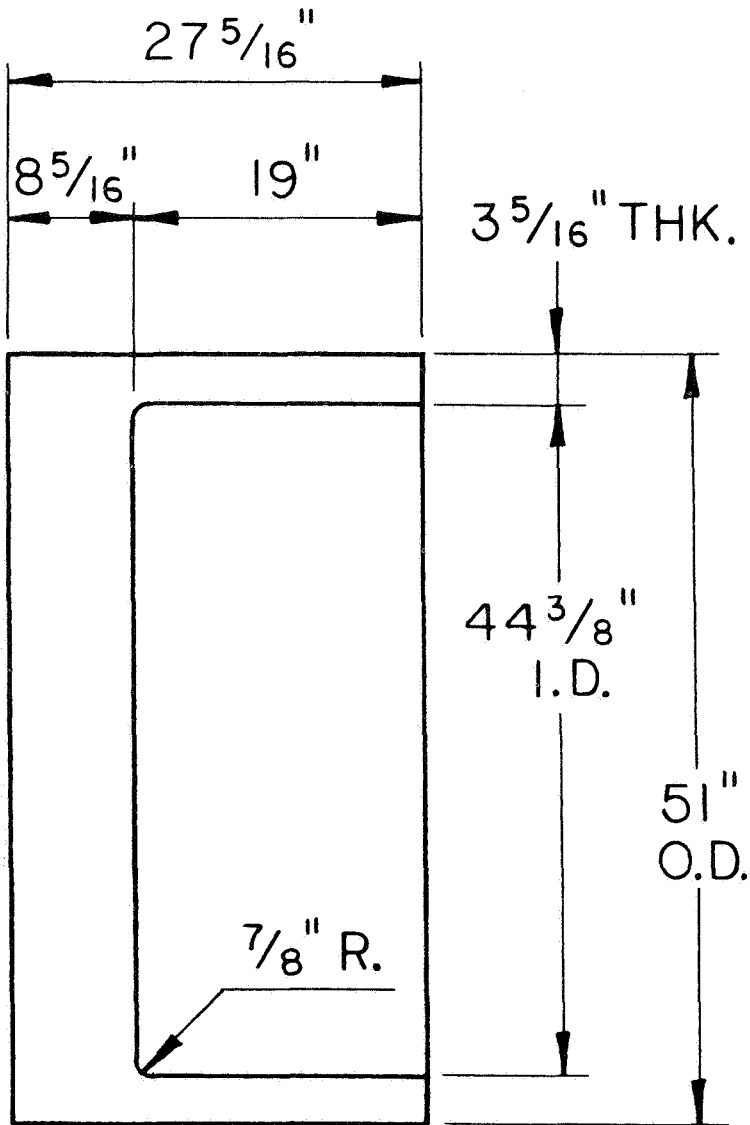
It was established that the forging manufacturer had started with a billet smaller in diameter but longer than required by the final forging, and had worked this billet so as to produce a disk somewhat thicker than 30 in. The disk then was punched at the center of one of the flat sides so as to produce a relatively shallow recess with a correspondingly short peripheral prolongation from which the required test samples were taken after heat treatment. This meant that the test specimens were taken from a section of the forging which cooled rapidly compared to the balance of the piece. The required final shape was obtained by hogging out the forged disk.

It is clear of course that the test specimens in this case were not representative of the properties of the material in the rest of the forging. Nevertheless it is claimed that this practice is permitted by the wording of the specification and that it is commonly employed.

Figure 14. Heat Exchanger channel forging.

Subsequent to this heat treatment, impact and other physical properties obtained from test specimens cut from the samples heat treated with the forging were all found to be within specified requirements. The channel forging was grit blasted to remove the coating applied to minimize scaling. Thickness loss and distortion were found to be negligible. The channel was therefore salvaged for use in the heat exchanger.

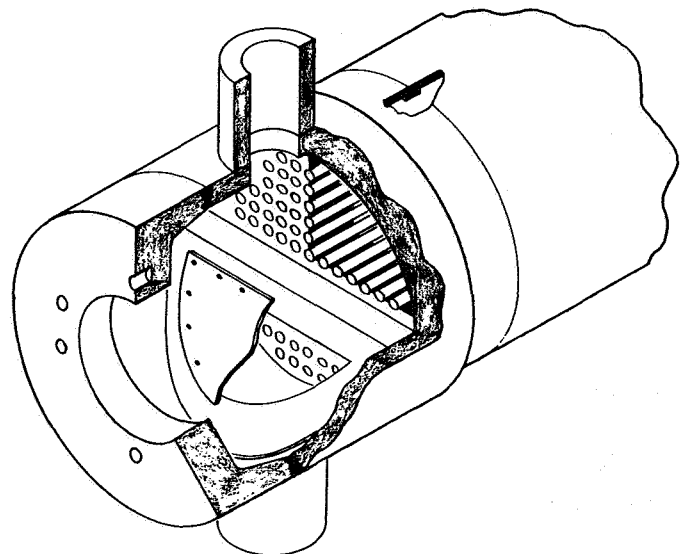
Details of the channel construction are shown in Figure 15. It consists of separate tubesheet, barrel, and flange forgings welded together. The nozzle forgings were welded into the channel assembly prior to stress relieving as were three strips of the horizontal pass partition, one to the tubesheet and one on each side of the channel interior.

The central part of the horizontal partition was welded to the strips, previously welded to the tubesheet and to the channel, after the tubes were welded to the tubesheet, tested and expanded. The elliptical segment to which the pass cover plate is bolted was also welded to both the channel and to the horizontal partition after the tube joints were completed, and after final post-weld heat treatment of the channel.

Figure 15. Synthesis gas compressor after cooler channel.

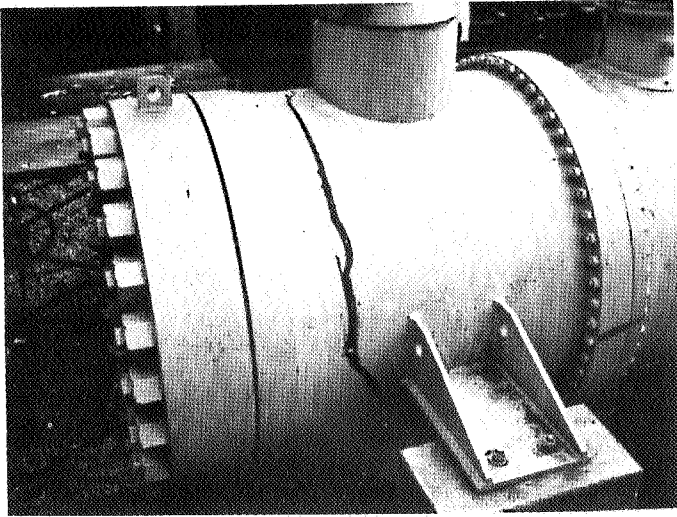
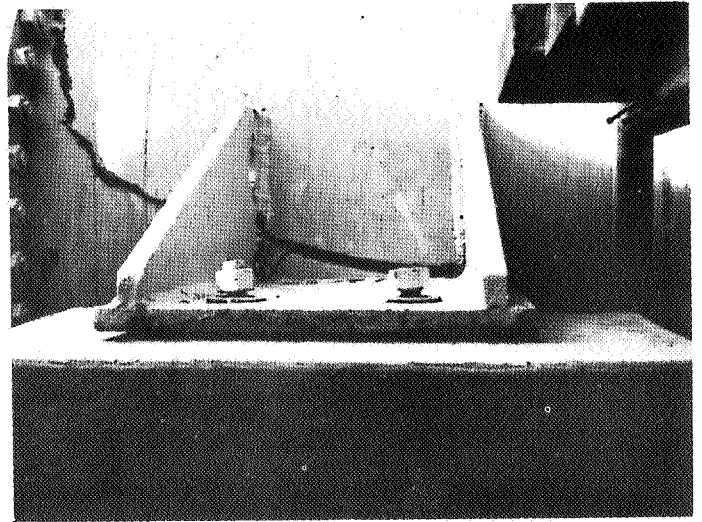
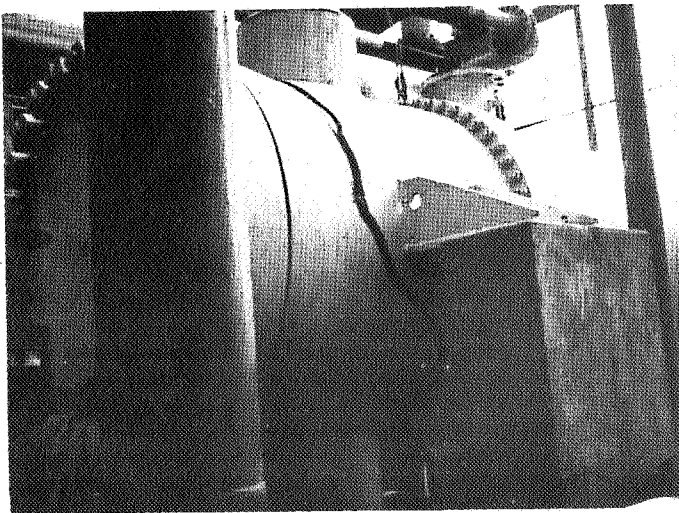
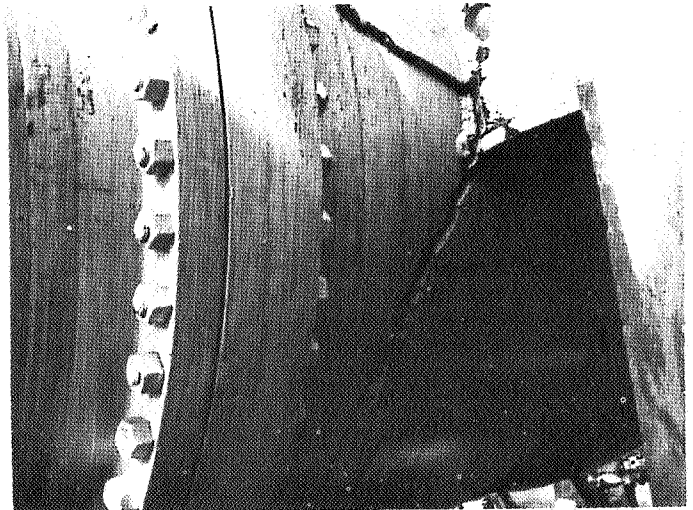
In February, 1967, the installation of a synthesis gas compressor aftercooler in a brand new 1,000 ton ammonia plant was completed. It was in the process of being hydro-tested when massive failure of the channel occurred by brittle fracture. Hydrostatic pressure had reached 3,490 lb./sq.in.gauge in the channel when failure occurred in spite of the fact that the exchanger had previously successfully undergone hydrostatic testing in the manufacturer's plant at the full test pressure of 3,525 lb./sq.in.gauge.

The extent and nature of the failure can be seen in Figures 16 to 19 inclusive. It is quite clearly a brittle failure. This is most unusual in view of the fact that the exchanger had previously been hydrotested without incident. In fact, the fabricating procedure employed required that the channel be tested twice; once to prove the tube joints after they were welded and before welding the internal partitions, and then again after all welding was completed. On this final test, the pressure was cycled from 0 to 3,225 lb./sq.in.gauge three times.

Figures 16, 17, 18, and 19. External views of fractured exchanger channel.

The failure adds to the mounting evidence that there must be an upgrading of carbon and low alloy steel plates and forgings of heavy cross section. It also indicates that initial pressurization, both in the manufacturer's plant and in the field, should be made at a temperature higher than the probable transition temperature of the material. Further, it indicates internal pass partition attachment welds must be more carefully examined both for quality and strength. This is particularly true of welds subject to high residual stresses not relieved by post weld treatment. Better yet, such welds should be avoided.

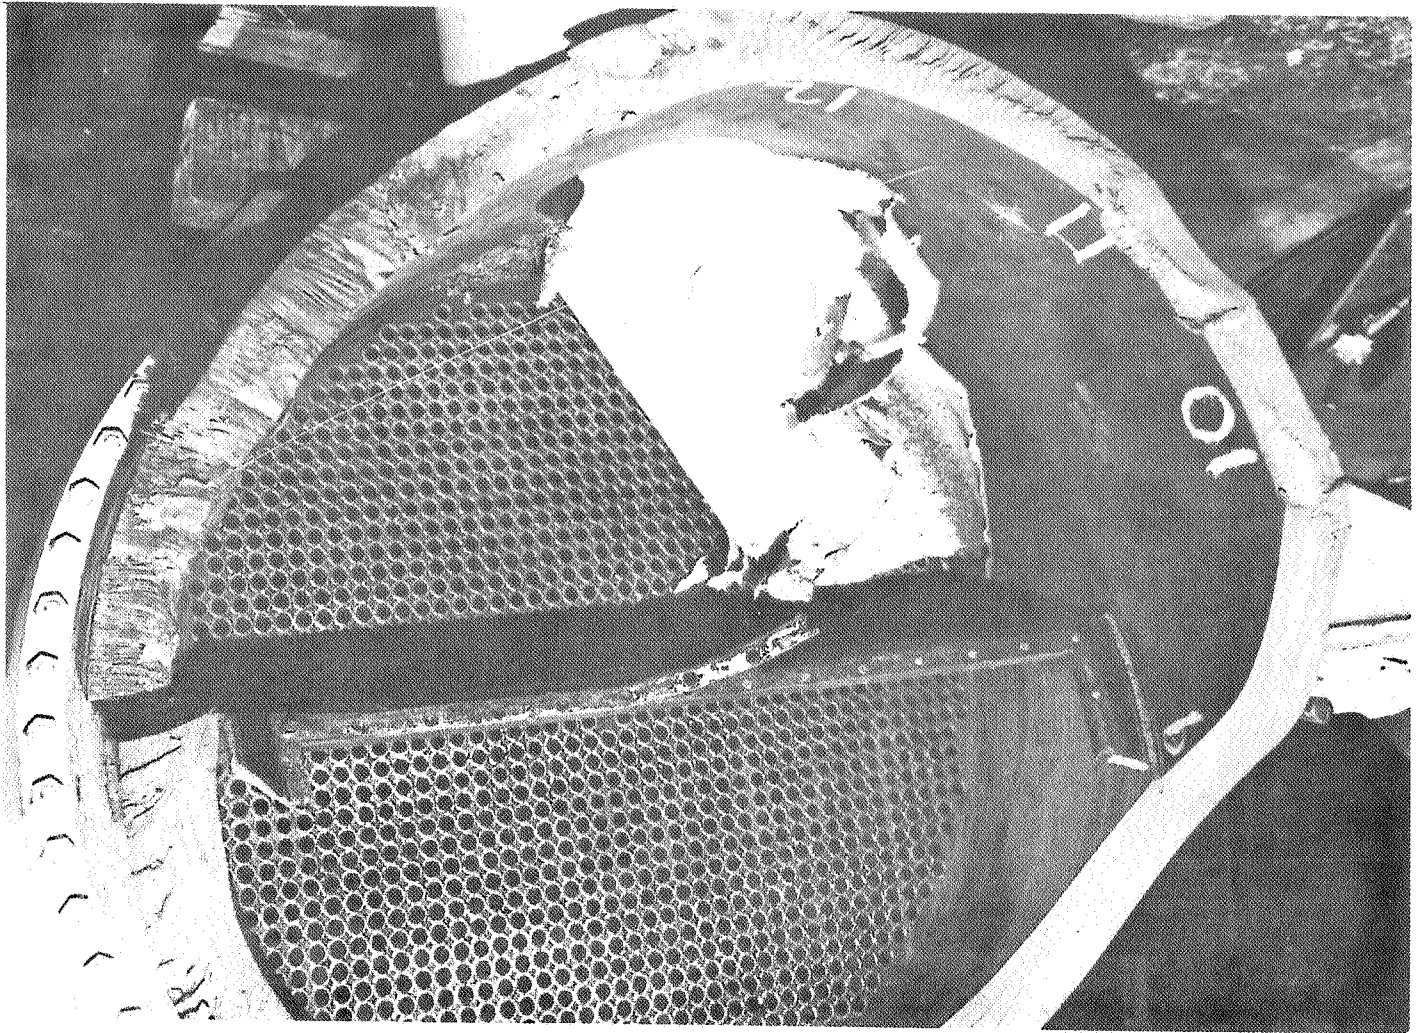
propagation through the channel barrel of a toe crack along the weld between the horizontal pass partition and the channel at the junction of this partition and the inclined pass cover plate holder, Figure 20.

Figure 20. Internal view of fractured exchanger channel.
