# LARGE PLANT OPERATION

The larger plants have had their share of problems, but experience has been gained and is being engineered into the new plants to make them operate better and safer

Hays C. Mayo  
M.W. Kellogg Co.\*  
New York, N.Y.

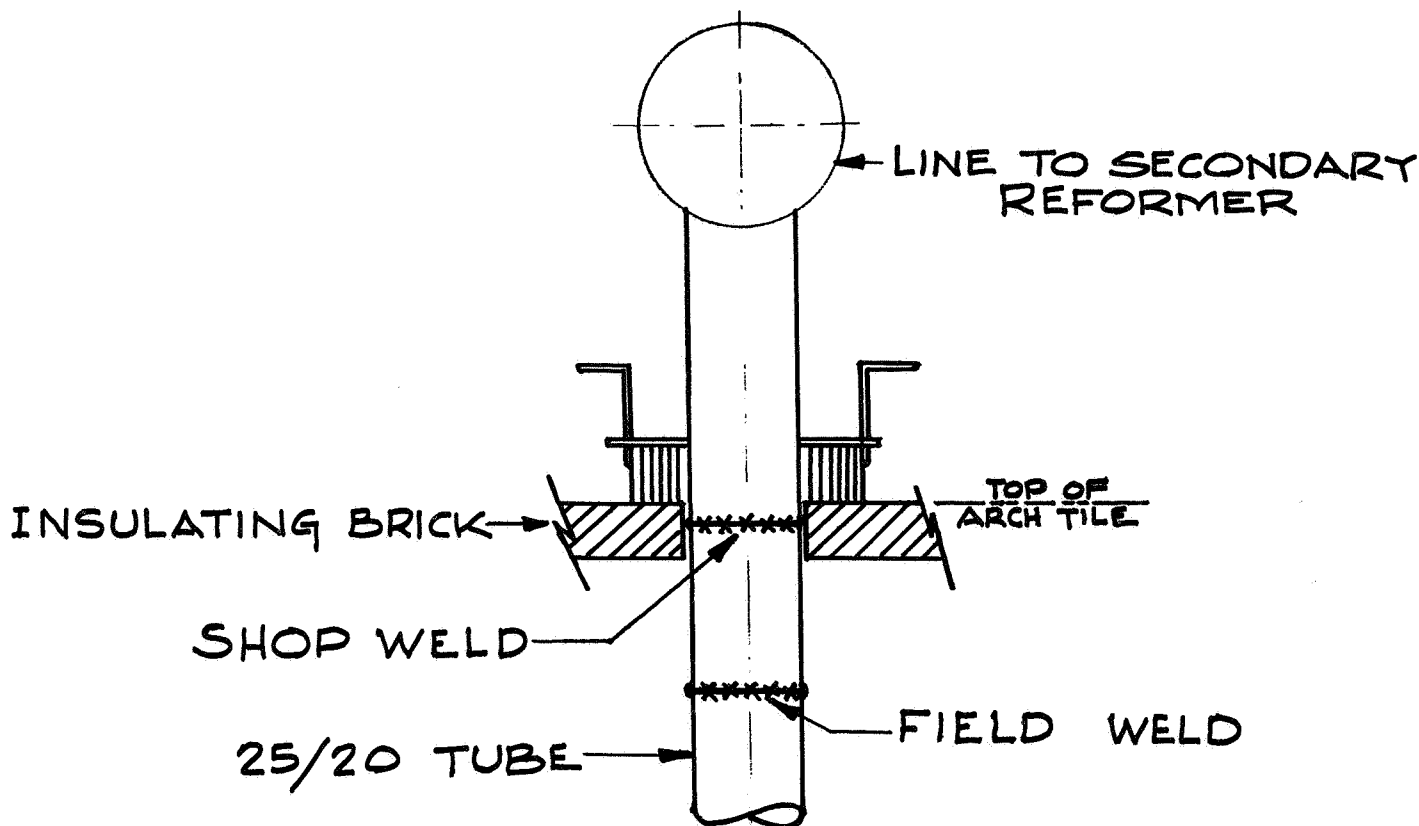
Figure 2. Diagrammatic arrangement and location of weld joint failures.

Cracks have occurred at weld joints in the riser tubes which carry reformed gas from the bottom collecting manifold to the transfer line at the top of the furnace. The cracks are predominantly in the uppermost section of risers, or in attachment welds to the bottom manifold.

Cracks and complete breaks have occurred in riser tubes at welded joints; these have been in weld metal, base metal, and through both weld and base metal. Failures near the top of the riser have resulted in fire and damage to equipment; fortunately, there was no injury to personnel. Figure No. 2 shows the diagrammatic arrangement and location of these weld joint failures.

Complete severance of the riser at the shop weld has occurred, resulting in damage to the top of the reformer. Investigation revealed that the welding electrodes used were not as specified. Instead of the required high-carbon 25 Cr-20 Ni composition, the electrodes were Type E310 with carbon content of 0.15 max. Not only does this produce a weld deposit of lower creep/rupture strength, but the composition is more crack-sensitive because of an unfavorable carbon/silicon ratio.

Cracks have developed at the field welds or in tube metal adjacent to the field welds. These have been variously analyzed as creep/rupture failures possibly associated with weld root contour, or as casting defects and inadequate ductility of both cast and weld metals.

In order to minimize the likelihood of further failures in the critical upper portion of risers, a design has been developed which will double the effective strength of welds by reducing metal temperatures. In addition, this design will direct the escaping gas into the fire box in the event of a complete tube severance. This design modification is adaptable to existing furnaces and is being made available to individual plants.

Two reformer furnaces containing a total of 16 welds were made with the wrong weld rod. One weld failed in service; an additional weld showed cracks. All 16 welds were repaired in the field by grinding out the low-carbon material and rewelding with Inconel 182 electrodes.

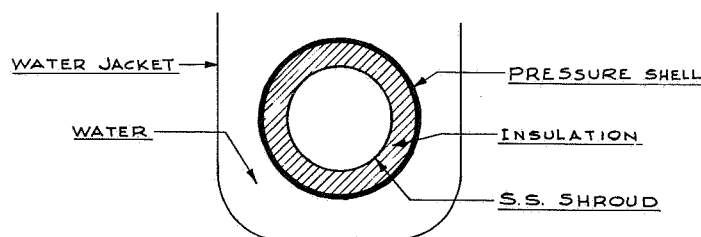
Figure 3. Diagrammatic arrangement of the line connecting the primary and secondary reformer.

the line connecting the primary and secondary reformer. Loss of the insulation was indicated on two units by excessive boiling of water in the jacket. An examination of the line showed that insulation had eroded away.

In one instance there was an over-heating failure of the pressure shell resulting in fire and severe damage. It is not definitely established whether the failure was caused by lack of water in the jacket, loss of insulation, or other causes. However, it is difficult to explain gross overheating where an adequate supply of jacket water is maintained. The design has been changed to use a low-silica insulating material with better mechanical properties. In addition, more rigid inspection procedures for lining installation have been instituted.

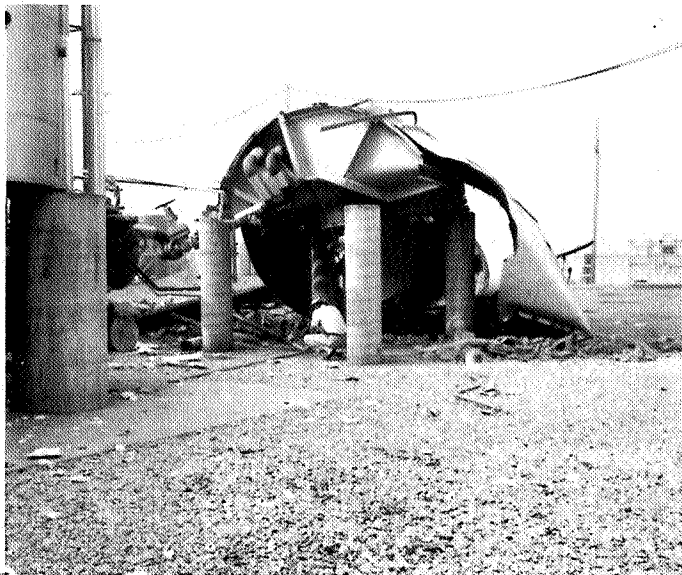
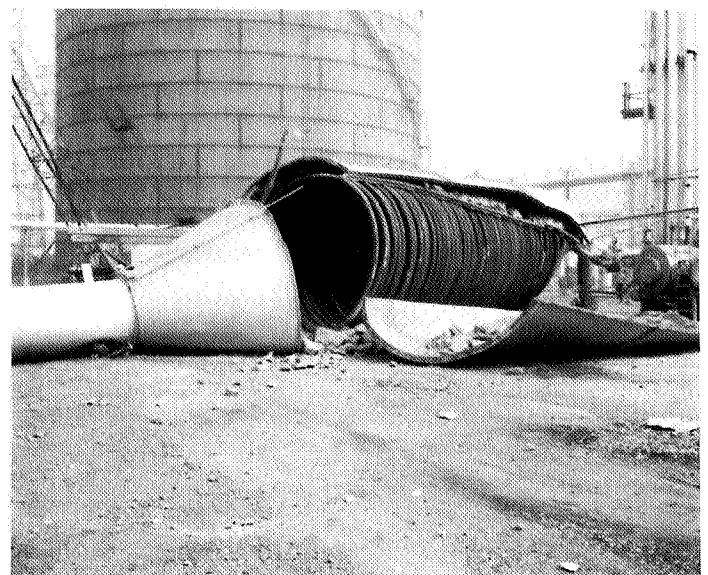
Figure 4. Photo of heater after the explosion.

The second instance of a startup heater explosion resulted in the heater falling over and severing of the line from the heater to the converter. The converter was depressurized but there was no fire. The heater was in normal operation and operating stably as confirmed by an operator who had been at the heater a few

The explosion occurred on the combustion side. Examination disclosed separation of the threaded connection of the gas line to the cast iron burner block; there seemed to be insufficient thread engagement and the line had pulled loose. Whether the gas line came loose as the result of the explosion, or before and caused the explosion, is not known. Figure No. 4 shows a picture of the heater after the explosion.

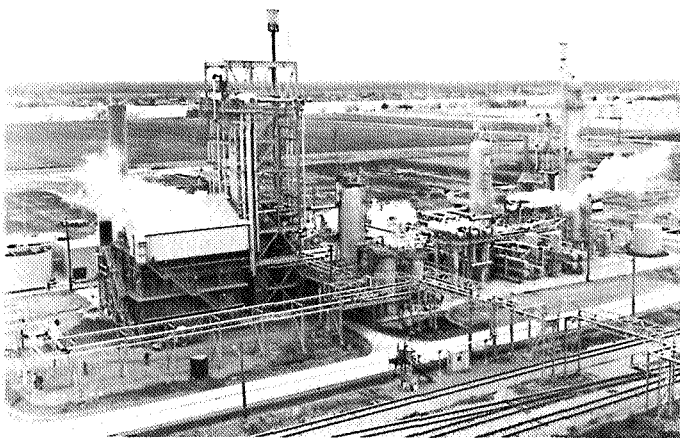
Figure 6. Location of process vents normally used during startup.

Vents frequently catch fire and once burning are difficult to extinguish. Normally, it is necessary to stop gas flow to the line in order to put out the fire. Vents should be designed so that they can burn continuously and safely.

The large pressure drop available in high-pressure reforming units together with the large flows has resulted in structural failure of vent lines. Silencers represented to be structurally suitable for pipe mounting without additional supports have failed mechanically. One lesson learned from plant operation is that vent systems should have the same mechanical integrity as continuously operated process systems.

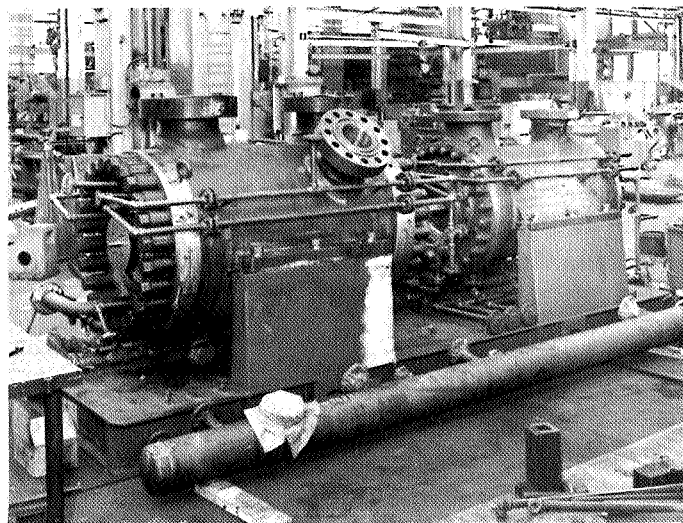
Figure 8. Photo of the synthesis gas compressor.

*Plant No. 1* As a result of the compressor failure, gas was pressured into the lube oil reservoir causing buckling of the cover and throwing of oil over the area. The oil and gas caught fire, resulting in extensive damage, and the compressor shut down due to loss of oil pressure. The synthesis loop was isolated from the compressor but the block valve on the compressor suction was involved in

Dismantling of the compressor showed that the thrust bearing had failed and the rotor had moved in the direction of the impeller suction. All wheels suffered damage on the impeller side with 1/8 to 3/8 in. worn off. Prior to the accident, the thrust load indicator showed 4,000 to 6,000 lb. which is well below the 14,000 lb. maximum allowable. The compressor had operated for more than 2,000 hours.

*Plant No. 2* The failure in the second plant was similar. There was a failure in the high-pressure stage of the synthesis gas compressor. Again gas was pressured into the lube oil reservoir causing buckling of the cover and throwing of oil over the area. The synthesis loop was isolated and the block valve to the compressor suction was closed. The first evidence of failure was reported to be a flame at the coupling between the high and low-pressure cases, followed by a flame at the coupling guard between the low-pressure case and the steam turbine. The lube oil consoles then burst into flame and ruptured. Fire damage was moderate.

Dismantling of the damaged compressor showed thrust bearing failure and extensive internal rubbing. Prior to the accident, the high thrust load alarm had gone off on more than two occasions. However, a check of the thrust load indicator showed a reading of 600 pounds versus a maximum allowable of 14,000 pounds. It was therefore felt that the thrust load was normal and that the switch was not working properly.

Figure No. 9 shows a schematic diagram of the seal oil system. Steps are being taken to add venting capacity to the lube oil reservoir and strainers are being added to the suction lines of all machines.

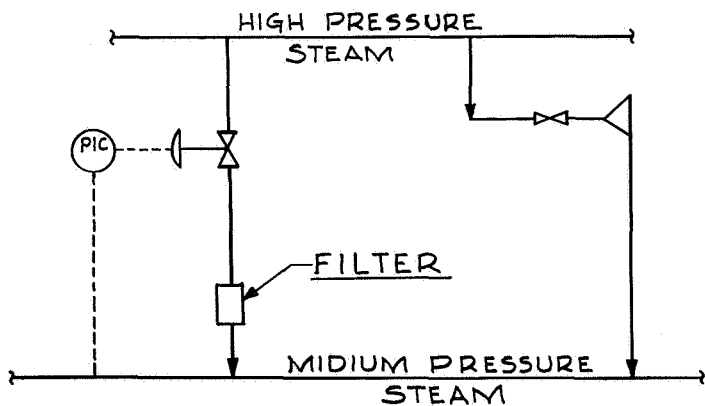
Figure 7. Normal steam flow in the unit.

Normal steam flow in the unit is shown in Figure No. 7. In normal operation high-pressure steam is reduced to the medium-pressure level by the topping turbine. During startup and in the event that the topping turbine trips out, steam pressure is reduced through a pressure control valve. On 1,000 ton units, the line downstream of the control valve developed cracks. This was surprising inasmuch as the problem was not encountered on 600 ton units. Field measurements showed low amplitude, high-frequency vibration to be the probable cause of failure.

Corrective measures such as thicker pipe wall and better support of the installation did not solve this problem. Consequently, a digital computer program developed by Kellogg to analyze vibration in reciprocating compressor piping was used to develop a design for an acoustical filter that would absorb the energy. This filter has been successful in all cases and the problem has disappeared.

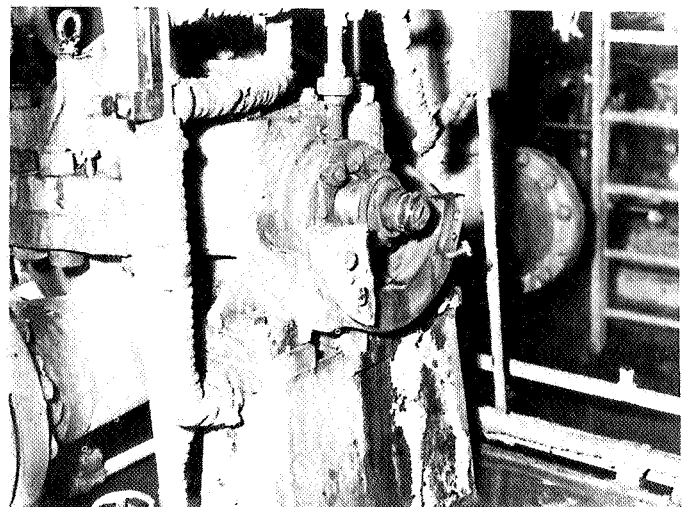
Figure 10. Pump after failure in which coupling was thrown 20 ft.

There have been a number of failures in one plant where operation was delayed for six weeks due to shaft failures of a pump circulating CO<sub>2</sub> removal solution. Figure No. 10 shows this pump after one such failure in which the coupling was thrown 20 feet through the air. Cause of the failure has been attributed to the use of close-clearance ball bearings instead of the normal clearance ball bearings. Pumps using the proper bearing clearances have now been in successful operation for several months.
