Reformer Manifold Cracking

Unusual cracking of manifold tubing welds in ammonia plant reformer may alert operators to possible malfunctions in other units.

G. Kobrin, E. I. DuPont de Nemours & Co., Beaumont, Tex.

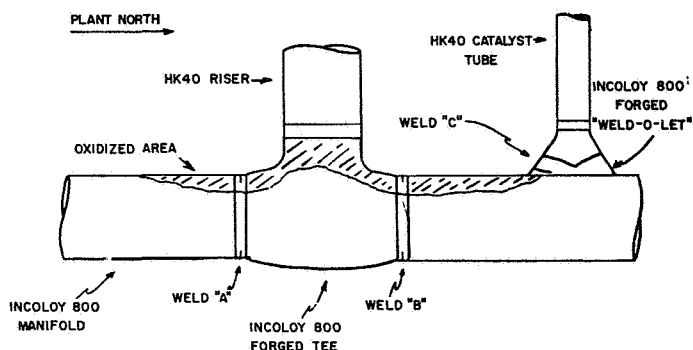
Figure 2. Manifold schematic—tee and Weld-O-Let welds.

catalyst tube Weld-O-Let on both sides of each riser, and these welds were also dye penetrant tested. One more crack was found, on the riser side of the first Weld-O-Let-to-manifold weld north of No. 3 riser. A description of each crack, plus observations regarding surface appearance and degree of magnetism, follows, and shown in Figure 2:

- Row No. 1: Circumferential crack about 2 in. long in top of weld "B". Tubing on both sides of tee showed slight oxidation and little or no magnetism. Upper half of tee was moderately magnetic; lower half showed little or no magnetism.
- Row No. 2: Circumferential crack about 2 in. long at bottom of weld "B". Tubing showed no significant oxidation. Upper half of tee was moderately magnetic; lower half showed little or no magnetism.
- Row No. 3: Circumferential cracks about 1½ in. and 3 in.

long in top of welds "A" and "B", respectively; circumferential crack about 2 in. long at bottom of weld "A"; circumferential crack about 4 in. long in the riser side of weld "C". Upper surfaces of manifold tubing showed severe oxidation and considerable magnetism, particularly north of tee. Upper half of tee was moderately magnetic. Area around crack near weld "C" showed slight oxidation and magnetism.

- Row No. 8: Circumferential crack about 2 in. long in top of weld "A". Tubing around crack showed slight oxidation and magnetism. Upper half of tee was slightly magnetic; lower half and all non-oxidized tubing areas were nonmagnetic.
- Rows Nos. 4, 5, 6 & 7: No evidence of cracks. Little or no oxidation. Magnetism varied from very slight to essentially none.

1. Grind out cracks and adjacent tee and manifold surfaces until dye penetrant shows no indications within 1½-2 in. of weld area.
2. Deposit "Inco-Weld A" stringer

beads, one at a time, with cooling, slag removal and dye penetrant testing after each bead. Grind out weld and base metal defects to sound metal before depositing the next bead.

3. Continue one-bead-at-a-time repair until welding is complete. Grind weld smooth and flush with adjacent base metal and dye penetrant test.
4. Ultrasonically measure wall thickness at all ground areas. Weld overlay, using above procedure, all areas showing less than minimum specified allowable wall thickness.
5. Dye penetrant test and radiograph repaired and overlaid welds, and remaining unaffected tee welds.

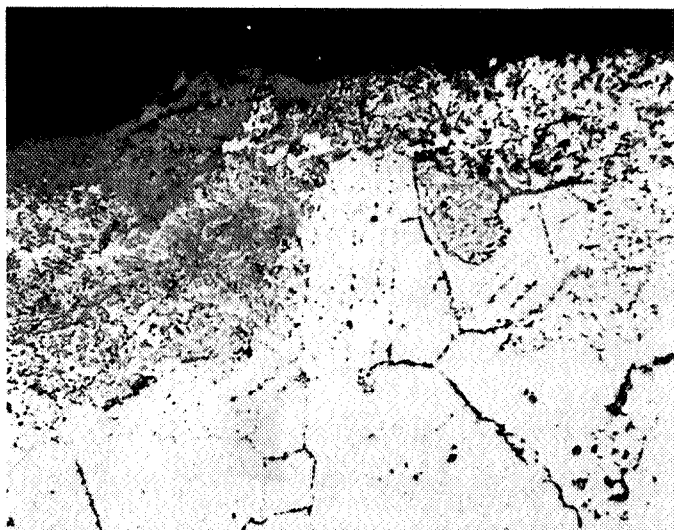
Figure 3. Microstructure at 200x.

The manifold sample was first clamped in a vise and tapped lightly with a small hammer. It failed in a brittle manner through about 90% of its thickness. Examination of the fracture faces showed a thin, greenish layer on the external surface, and a dull gray, sugary appearance throughout its remaining thickness. Then the sample was examined metallographically. A typical microstructure is shown in Figure 3.

The outer surface is shown near the top of the photomicrograph. Note the non-uniform depth of the heterogeneous phase. There appears

to be virtually 100% non-metallic material at the extreme outer surface, followed by a mixed metal-non-metallic layer, and then essentially 100% metallic phase. Note also, the large grain size and considerable amount of material in grain boundaries. Photomicrographs taken at higher magnification of surface and grain boundary phases are shown in Figures 4 and 5. These structures help explain the dye penetrant test indications of extreme porosity previously discussed.

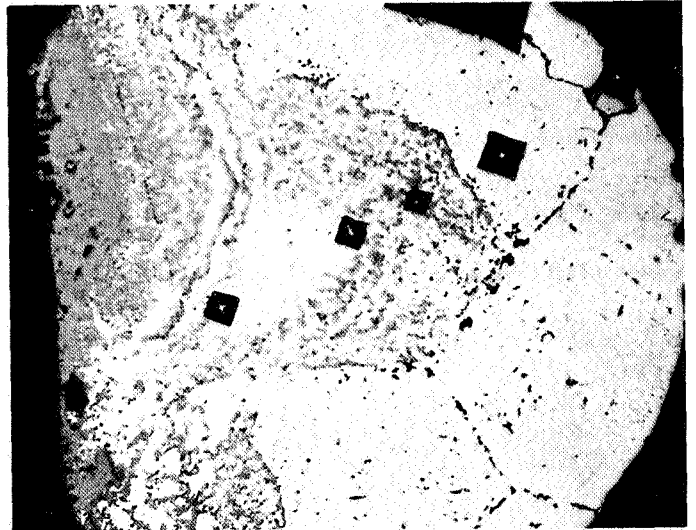
Figure 6. Microhardness impressions at 250x.

A Vickers microhardness determination showed a wide variation in hardness, as seen in Figure 6. The metallic phase was in the range 100-120 VHN. However, heterogeneous areas approached 1,000 VHN, indicating a complex, refractory-like composite material.

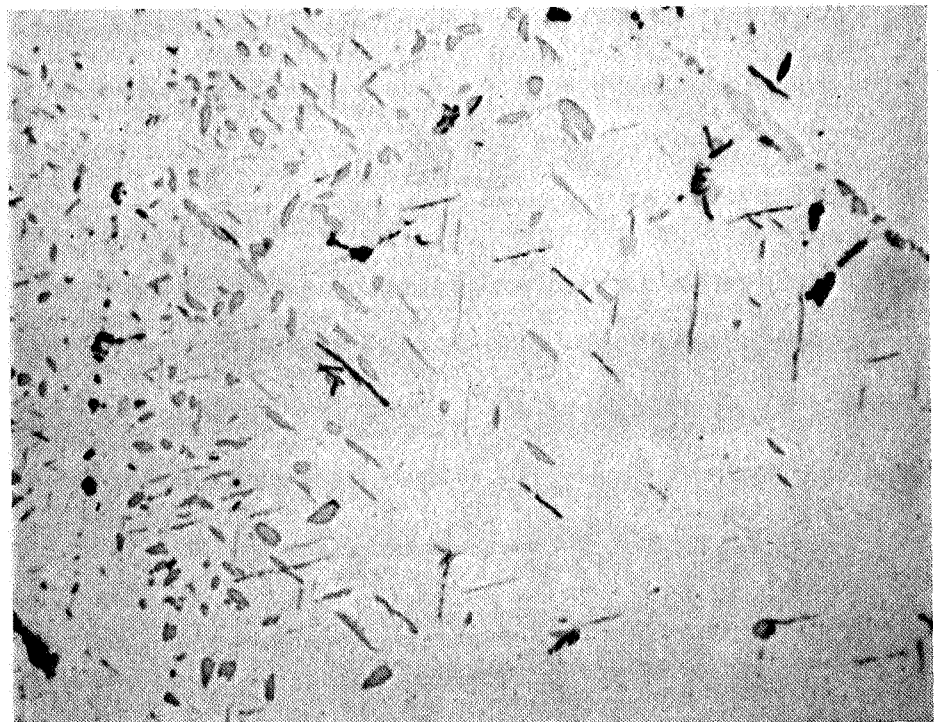
Figure 7. Needle-like inclusions at 750x.

During investigation at high magnification, an unusual, unidentified, needle-like phase was noted within some grains, seen in Figure 7. Some needles actually appeared to be micro-cracks, whereas others appeared to be some type of non-metallic inclusion.

Note that chromium is segregated at the heterogeneous zones. Oxygen, silicon and titanium are also segregated at these zones as well as in the grain boundaries. Sulfur appears as a random dispersion of particles throughout the structure. This suggests that some of the particles shown in Figure 7 may be sulfide inclusions. Neither nickel nor iron appears segregated in heterogeneous zones or grain boundaries.

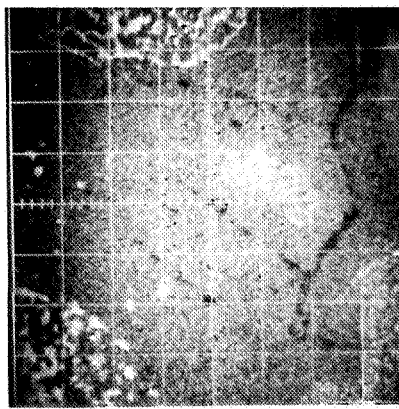
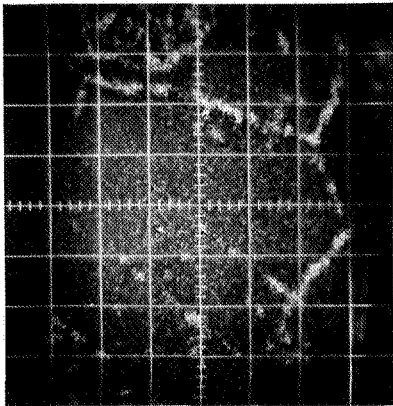
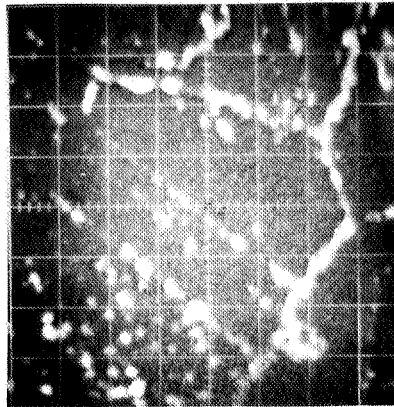
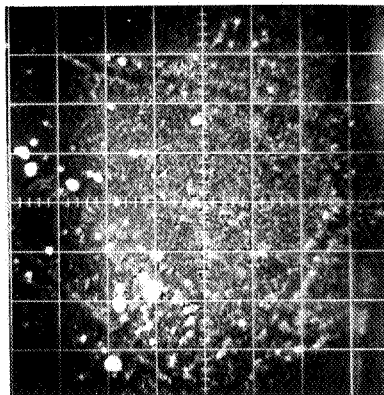
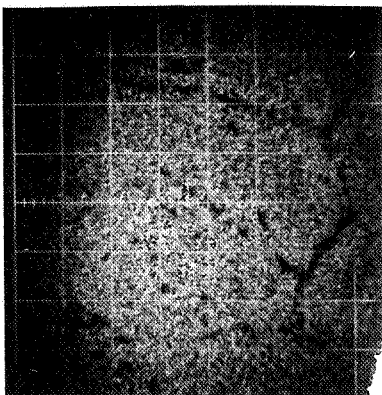
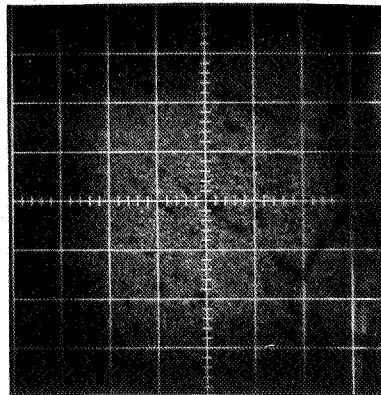
Figure 8. X-ray fluorescence microprobe micrographs of Target Area 1.

A photomicrograph of the target area chosen for one series of microprobe X-ray fluorescence analyses is shown in the upper left-hand corner of Figure 8. This area includes heterogeneous zones along with grain boundary constituents and inclusions within grains. In this kind of analysis, the element being determined appears as a bright area against a dark background in the photograph. Microprobe micro-

graphs showing chromium, oxygen, silicon, titanium, sulfur, nickel and iron scans are also shown.

Results of the inspection, metallographic and microprobe studies indicate a type of internal oxidation of Incoloy 800 alloy base metal (and, presumably, the Inco 182 weld metal) initiated from the external or fired side of the reformer manifolds. Oxidation was non-uniform, and chromium, oxygen, silicon and titanium were segregated in heterogeneous zones at and below the external surface, and in the grain boundaries. This left an extremely

brittle, weak, porous magnetic layer on the surface, varying in depth from a few thousandths to $\frac{1}{4}$ in. All cracking appeared to be confined to this layer; underlying metal appeared sound.

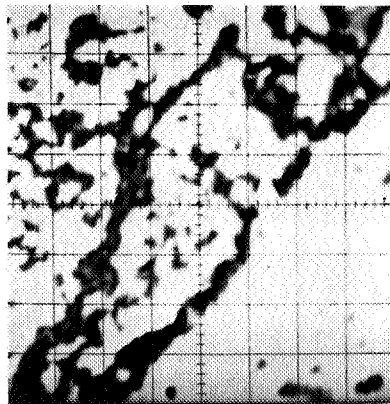
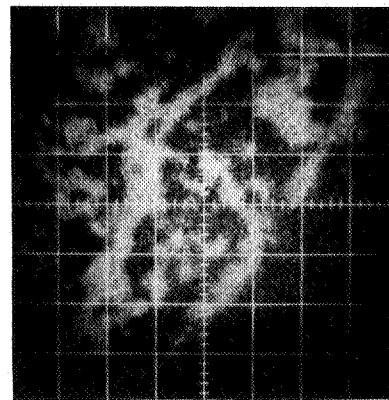
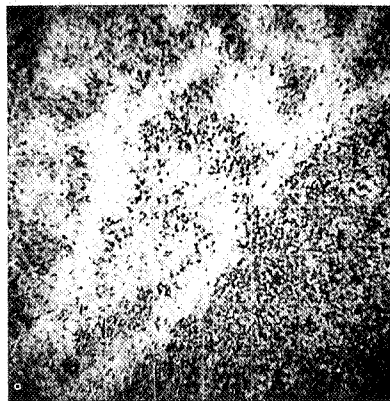
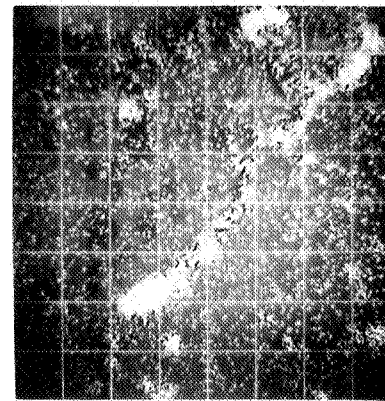
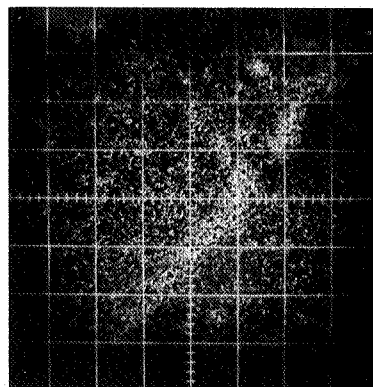
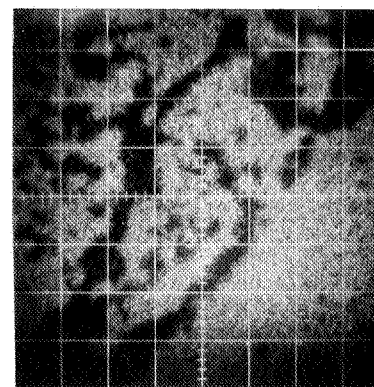
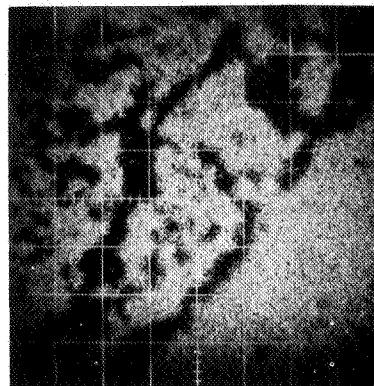
Figure 9. X-ray fluorescence microprobe micrographs of Target Area 2.

A photomicrograph of a smaller target area chosen for a second series of microprobe analyses is

shown in the upper left-hand corner of Figure 9. Microprobe micrographs for all of the above elements except sulfur, which also appear in Figure 9, show similar results.
