# Transfer Line Failure

When problems with transfer line insulation or liners are discovered, new ones should be installed since they are very costly to repair or fabricate when in place.

C. C. Chaffee, Cooperative Farm Chemicals Assoc., Lawrence, Kan.

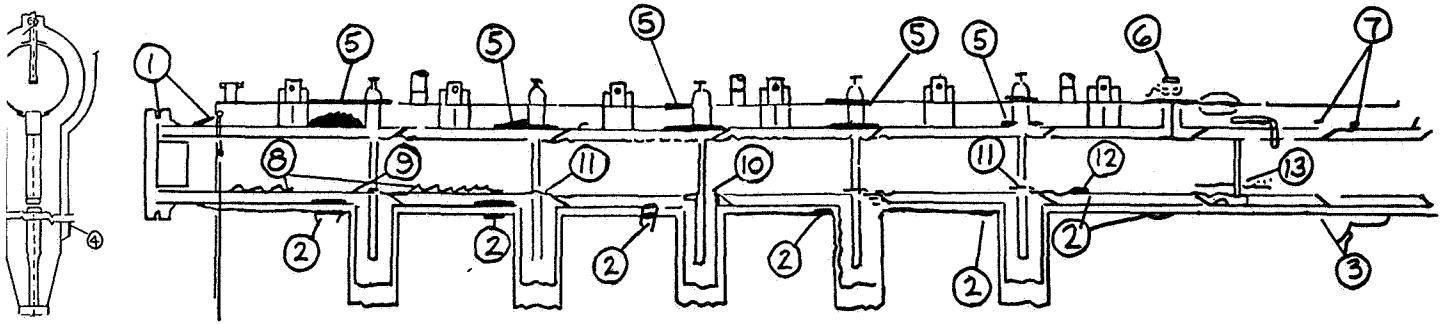
Figure 1. Outline of transfer area.

Numbered areas indicate cutouts for inspection and repairs.

Removal of the top sections of the water jacketing for inspection of the pressure line revealed a 16 in. rupture near the #5 east riser and several bulged areas which are described further with reference to marked areas on Figure 1. A photograph of the rupture is shown in Figure 2.

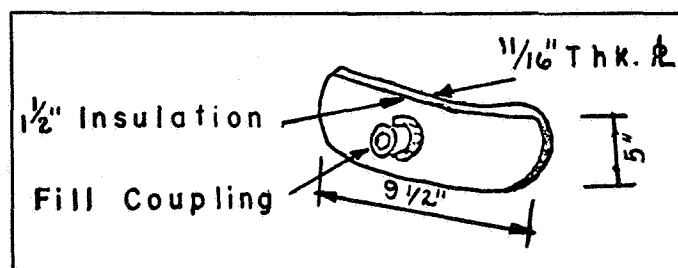
Figure 3. Typical bottom cut-out.

2. On the bottom of the header, inspection and insulation removal plates were cut out from the water jacket and pressure shell. The size of pressure shell plates are approximately 9½ in. x 5 in. and each plate received a 1½ in. 6000# screwed coupling as shown in Figure 3. New plates were welded in the bottom of the header as shown on Figure 1. Each has a ⅛ in. thick back-up plate. All welds were x-rayed and dye checked, but pressure testing was not required.

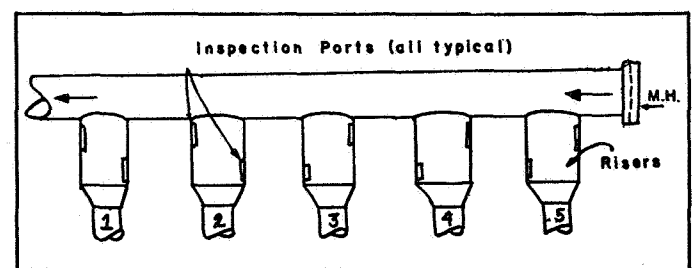
Figure 4. Water jacketed risers.

4. All riser water jacketed areas and pressure shells were inspected, as indicated on Figure 4. Each riser pressure shell had two 8 in. round holes cut out to inspect the insulation. All risers were found in good condition and no insulation was required except on risers #2 and #4 where the insulation had been partially removed for inspection. This insulation was replaced with dry packed, shredded asbestos chips and the ½ in. thick ports were replaced with a full penetration weld. The water jackets were cleaned and the ¾ in. plates were rewelded in place.

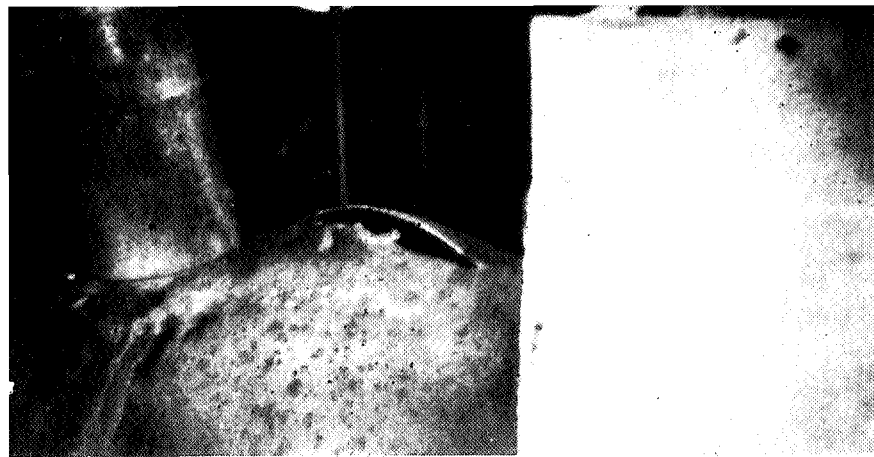
Figure 2. The transfer line rupture.

5. The pressure shell ruptured at this point on the top north side leaving a gash approximately 16 in. long and 2 in. wide at the most open point. A measurement of the steel at the rupture opening showed only 1½ in. thickness. The rupture was east of the thermocouple and, viewed from the side, it resembled the contour shown on Figure 5. The tube opening was clear, but the shroud was flared up at the bottom near the tube and had buckles in the shroud on one side of the tube, Figure 6. The shroud was pushed back into place by heating and jacking. The thermowell was removed and the pressure shell was repaired with a 37 in. x 46 in. oval piece. A 1 in. 6000# screwed inspection coupling was installed in this piece directly above the tube opening.

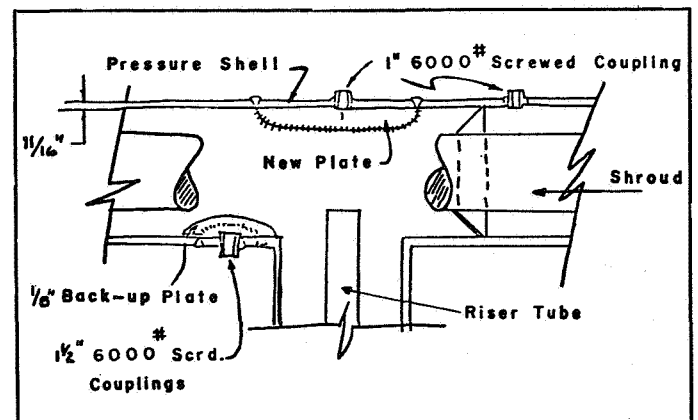
Figure 7. Pressure shell area.

The repairs to the pressure shell above the other risers were basically the same except for size. Each had a 1 in. 6000# screwed coupling welded nearly over the riser tube. There were bulges on the pressure shell on the top side east of the thermowells on all risers except the riser closest to the secondary reformer. Figure 7 illustrates the method used in repairing the pressure shell over the other risers and Figure 8 shows the top pressure shell repair plate sizes.

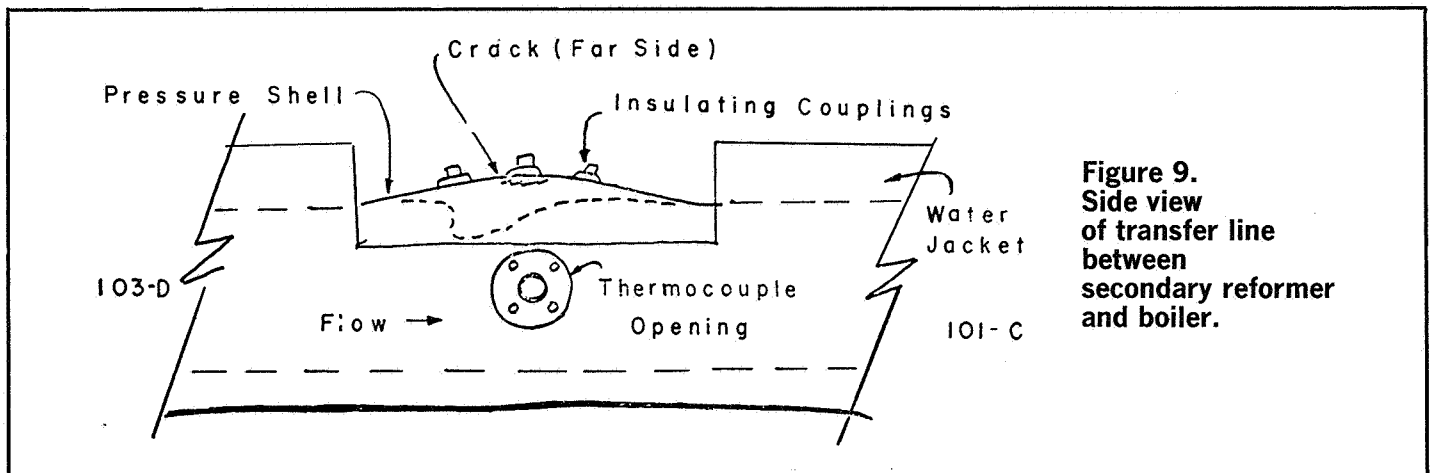
Figure 9.  
Side view  
of transfer line  
between  
secondary reformer  
and boiler.

Following inspection of a similar reformer gas boiler producing 1,500 psig steam and with knowledge of a thermocouple-sample line failure between two vessels at another plant, it was decided to inspect this equipment at Fort Dodge. Necessary cut-outs were completed during the prolonged reformer repairs. The 4 in. crack, critical lining and insulation failures were revealed as indicated in Figures 9 and 10. A very hazardous rupture was imminent at this point and possibly along the lower shell of the boiler.
