Failure of a Primary Waste Heat Boiler

Indications are that silica-based castable refractories lose insulating properties when used in reducing-atmospheres, and under the temperature-pressure conditions in the steam-methane section of an ammonia plant.

J. R. Attebery
Terra Chemicals International, Inc.
Sioux City, Iowa

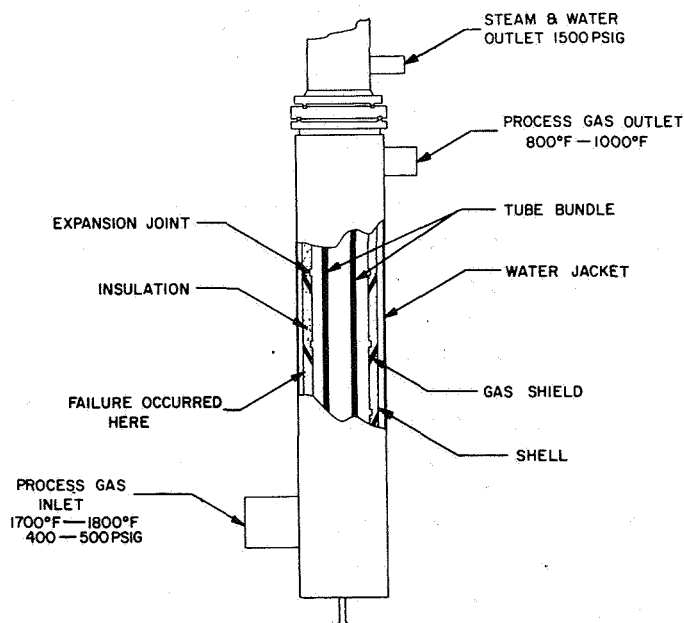
Figure 2. Primary waste heat boiler.

The shell of the waste heat boiler, approximately 28 ft. long by 51 in. inside diameter, Figure 2, is made of ASTM A-212 Grade B Firebox Quality Carbon Steel. The nominal shell thickness at the point of failure is 15/16 in. The shell of the vessel was internally insulated with 4½ in. of Insulag (trade name for a silica based castable refractory) and water jacketed on the outside. The refractory is protected from collapse and the erosive action of the gas by a ¼ in. thick stainless steel shroud. The sections fit together with slip joints.

To prevent hot gas from bypassing the heat exchange section and passing between the refractory and the carbon steel shell, conical gas shields (vapor stops) are welded between the pressure shell and the shroud. The shields are also constructed of stainless steel.

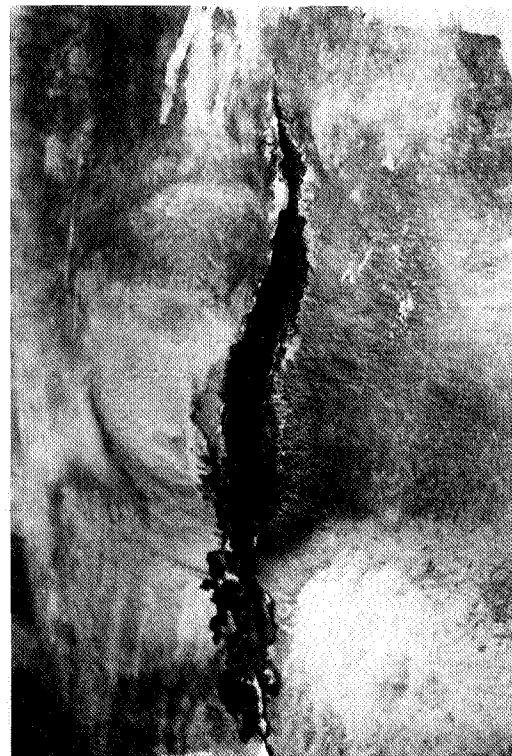
Figure 3. Vertical crack in the water jacket.

A window, cut in the water jacket where a bulge indicated the failure might be, revealed a vertical crack about 20 in. long and opened about 2 in. at its center, Figure 3. The failure was located approximately at the north-northwest side of the shell towards the secondary reformer. The crack started approximately 12 ft. 5 in. below the underside of the shell top closure flange and terminated about $\frac{1}{2}$ in. into a circumferential weld. There were numerous small cracks parallel to the main fracture on both inside and outside surfaces. Most of the fracture was at an angle of 45° to the wall and had the general appearance of shear. There was also "necking" of the wall at the fracture. Surrounding the crack was a bulged area about 3 ft. dia.

The conical gas shield just below the rupture was torn loose from the pressure shell and the shroud slip joint adjacent to the rupture was separated about 3 in.

Observation through the crack did not reveal any insulation present in the sections either above or below the torn gas shield. Inspection of the shroud after the tube bundle was removed revealed two small bulges about 12 in. above the inlet gas distributor and visible damage and distortion at each of the slip joints. The butt weld seam joining the bottom two shroud sections was damaged.

As the stainless steel shroud was removed, it was discovered that the castable refractory (Insulag) had deteriorated to the point where an estimated 50% of the vessel wall was unprotected. A small amount of insulation was found in the bottom of the water jacket. (During the failure, the overflow from the jacket was "black" in color indicating some of the Insulag had blown into the water jacket when the shell ruptured.) A significant amount of failed insulation was found covering the inlet tube sheet, in the channel head of the secondary waste heat boiler, and in the high temperature shift converter. The inlet distributor, vessel wall, hold down grating and raschig rings were also coated. Many of the raschig rings had the center completely filled with insulation, which had also penetrated an undetermined distance into the catalyst bed.

A metallurgical examination of the rupture area determined the failure was due to a short-time, high temperature stress-rupture of approximately 100 hours duration at metal temperatures between 1,000°F and 1,200°F. The examination also determined that high temperature hydrogen attack did not cause the failure, but may have influenced it slightly. A sample taken from the rupture area was also examined and found to be normal with no apparent deterioration of metal properties.

The stainless steel liner was removed in six sections by welding lugs on the inside of the liner and attaching cables. The conical gas shields were cut by air-arc gouge next to the vessel wall and each section was lifted clear of the vessel with an air hoist. After all six sections and remaining insulation were removed, a window 4 ft. x 4 ft. 9 in. was cut in the damaged area. A new patch of the same material (A-212 Gr B FBX) was rolled to 51 in. inside diameter. The new patch was 1 in. thick material as 15/16 in. plate was not available. The plate edges were ground to a double bevel with a matching bevel ground on the vessel wall opening. The plate was lifted into place, positioned and welded out.

The welding procedure used was E 6010 rod for root pass and E 7018 for weldout. A single root pass using a 1/8 in. rod was made. For the weldout, 12 passes were made (6 on each side) using a 5/32 in. rod. A pre-heat of 400°F was maintained during welding using a welding torch with a "rosebud" tip. The pre-heat was periodically checked with tempil sticks rated at 400°F and periodic checks were made during the course of welding with dye

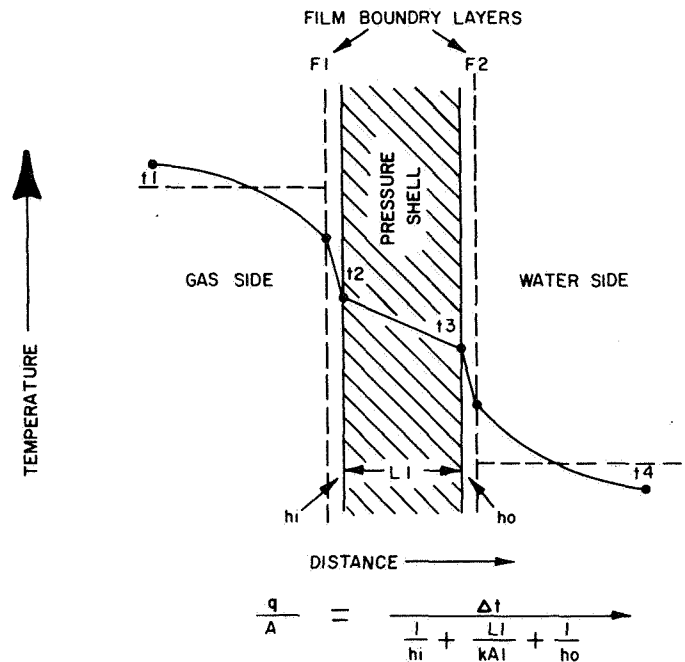
Figure 4. Temperature gradients in forced convection.

We knew two facts which assisted us in investigating the failure. First, we knew water was overflowing from the jacket both before and during the failure, and second, that there were substantial insulation voids in the vessel. Calculations were made to determine the conditions necessary to have a temperature gradient across the pressure shell sufficient to cause it to rupture from overheat, Figure 4.

With insulation intact and water in the jacket, external shell metal temperatures could not exceed 220°F to 250°F. Calculations were then made to determine metal temperatures assuming no insulation and nucleate boiling and no insulation with film boiling. With no insulation and nucleate boiling, the shell temperature would be about 950°F on the water side and 1,024°F on the gas side. With water scale on the outside, no insulation and film boiling, the external shell temperature would be about 1,000°F and the internal, 1,070°F.

The calculations indicate that failure cannot occur from overheat if water is in the jacket and nucleate boiling is occurring. They also indicate that metal temperatures can be high enough to cause failure from overheat if film boiling is occurring. Since we know from observation that the jacket was full and overflowing, we have theorized that "steam blinding" was occurring in the ruptured area due to the abnormally high heat flux and the transition from nucleate to film boiling. The continuous film of vapor virtually insulated the area and the heat transferred through the vapor film by conduction and radiation resulted in a temperature difference between the metal wall and the vapor-bound surface of the water sufficient to cause the rupture from overheat(2).
