FAILURE OF A LOW TEMPERATURE AMMONIA LINE

Pipelines carrying low temperature liquids can fail due to freeze-thaw pressure. Eliminating water from the pipe sleeved area, or inserting a non-freezing solution can prevent damage.

R. W. Miller and L. V. Caserta
American Oil Co.
Texas City, Texas

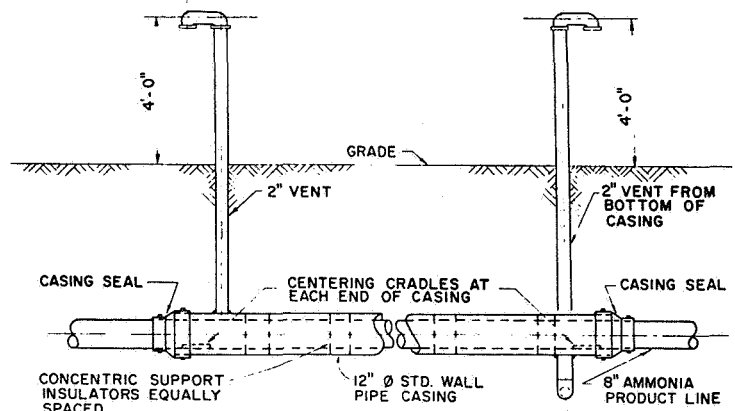
The ammonia barge loading line is insulated with preformed polyurethane and laid on concrete piers just above grade. At road and track crossings, the line goes below grade in 12 in. pipe sleeves as shown in Figure 3.

Parts of the line runs underground for short distances. These portions of the line are vinyl wrapped for corrosion protection. The 12 in. sleeve is swedged to the 8 in. line with rubber casing seals at each end. Concentric support insulators are spaced in the sleeved section. The sleeve is vented at both ends, one venting from the top and the other

from the bottom of the sleeve. Cathodic protection is provided.

Figure 3. Design of an ammonia pipeline for highway crossings.

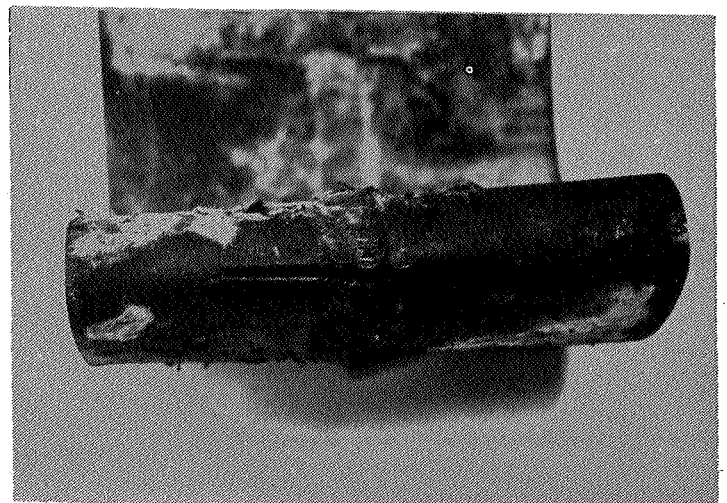
When the leak at the crossing developed, ammonia vapors started pouring from the vents on the pipe sleeves. To make repairs the dock line was depressured and purged with nitrogen. It was cut on either side of the road crossing outside the sleeve area, and this section of line pulled out for inspection and replacement. A portion of the line 8 ft. long was collapsed causing a crack in a circumferential weld. This is the leak from which ammonia vapors escaped to the sleeve vent. Figure 4 shows a damaged section of the pipe. The pipe is much too strong to collapse from a vacuum and, besides, a vacuum would be difficult to produce.

Calculations of forces necessary to collapse the pipe section indicated a high external pressure was required. The only sequence of events that could produce this high external pressure was a freeze-thaw cycle between the pipe sleeve and the pipe. The pipe section and sleeve were well below the water level, and it is probable that the casing bushings leaked. The sequence of events postulated for the failure is shown below:

1. Water seeps between the pipe sleeve and line when the line is at ambient conditions.

2. Water inside the sleeve freezes when -28°F ammonia is pumped through the line. Force of ice indents 8 in. ammonia pipe while being contained by 12 in. external pipe sleeve.

3. Ice thaws when ammonia loading line is idle. Sleeve space refills with water.

Cycle reoccurs when cold ammonia is pumped through line until total collapse.

Figure 4. Damaged section of the pipe.

CASERTA: The failure was a crack running across a weld, and as far as the type, it was a ductile fracture. Perhaps we have someone here who may be familiar with details of the installation. Do you know, Bruce?

1. Efforts were made to make the seal between the sleeve and pipe more watertight.
2. An ethylene glycol antifreeze mixture (50 per cent solution, -37 F) is added to the sleeved portion of the line.
3. Level of antifreeze is maintained in vent pipes. Level glasses are installed above grade on the vent pipes. Antifreeze liquid in the sleeve is always at higher pressure than ground water.
