Vol 13
1990
Safety in ammonia
plants

REMOVAL AND REPLACEMENT OF CATALYST IN AN AMMONIA CONVERTER

D. F. DeLong
CF Industries, Inc.
Chicago, Ill.

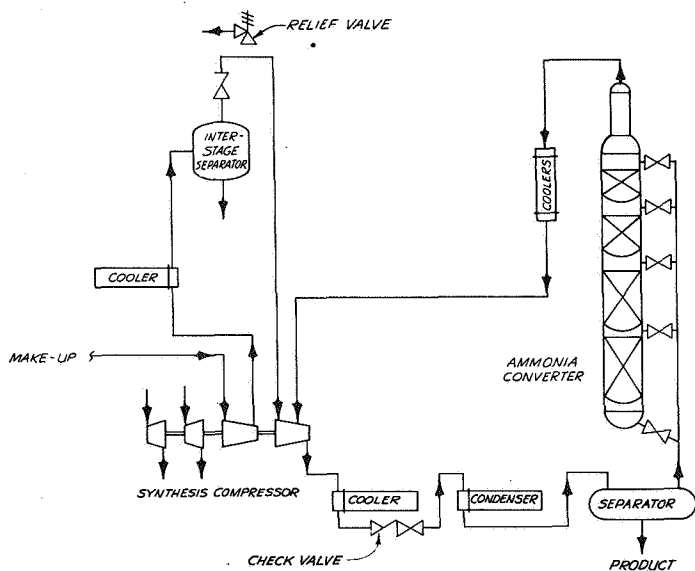
Figure 1. Simplified flow diagram of synthesis loop.

Note that the following comments on the events preceding failure are made with reference to Figure 1.

After the machine tripped, the relief valve at the suction of the high pressure case of the syn-gas compressor lifted and vented for an unusually long time. Subsequent investigation revealed that the check valve in the syn-gas compressor discharge was broken and had failed to close. With the syn-gas compressor down and the discharge check open, the contents of the synthesis loop was vented through the relief valve at the second case suction until the discharge valve was closed.

1. The piping around the syn-gas compressor has been up-graded, in accordance with the latest Kellogg design, so that back-flow cannot occur unless the check valves at both the suction and discharge of the high pressure case should fail simultaneously.
2. As mentioned above, the design of the screen at slip joints around the riser was changed in an attempt to reduce stress of the screen wire due to differential growth of the basket and riser.
3. The start-up procedure has been modified to reduce the rate of temperature change in the ammonia converter during start-up. It is felt that, if the temperature change is gradual, more even heating and less differential growth will result.

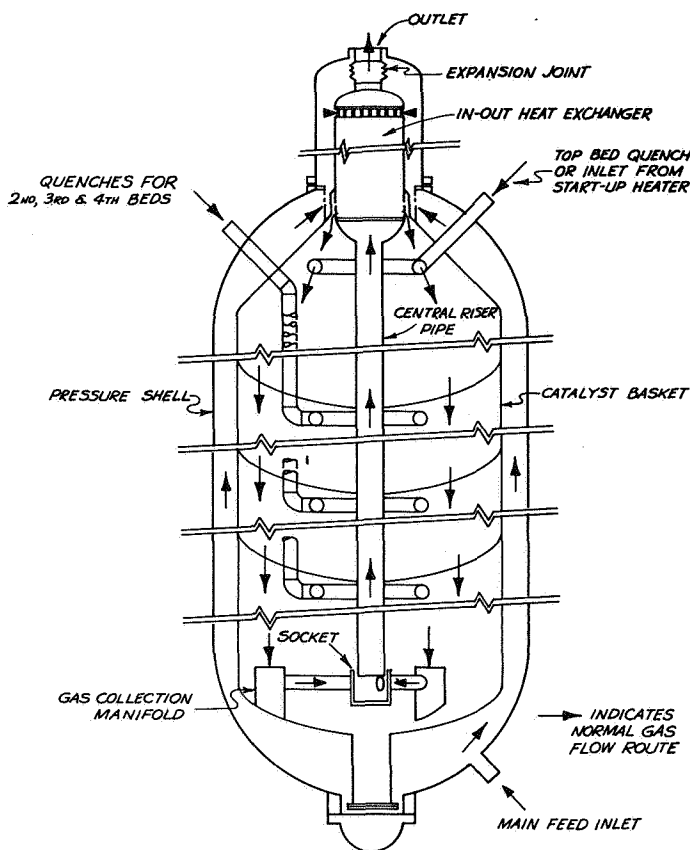
Figure 2. Schematic diagram of ammonia converter.

After the catalyst was removed, internal inspection revealed that the central riser pipe had been pushed upward 5 in. The upward movement of the pipe caused a symmetrical distortion of the bottom channel of the heat exchanger.

When the catalyst basket is empty and at ambient temperature, the central riser pipe is supposed to extend 3 in. into the socket of the gas collection manifold. There was a 2-in. gap between the socket and the end of the pipe, after the pipe moved up. The screen, which prevents small catalyst particles from passing between the riser and the socket, had broken and was pushed into the socket in one area. With the pipe out of the socket and a breach in the screen, the riser pipe and the collection manifold filled with catalyst and alumina balls. Catalyst particles were jammed into the ends of the heat exchanger tubes.

Ratchet effect — The screens around the riser at each catalyst support tray and at the riser to socket joint were found to be damaged. A piece of the screen at the riser to socket joint was found in such a position that it would have been between the pipe and the socket had the pipe been in the socket. If this piece of screen and catalyst particles became wedged between the pipe and the socket or between the pipe and the catalyst trays, a ratchet effect may have resulted. During start-up or shutdown, temperature changes occur which would produce differential growth and movement of the riser pipe and the catalyst basket. On each shutdown or start-up the riser pipe could have been withdrawn slightly from the socket. Due to the presence of foreign material in the slip joints around the riser, it may have been impossible for the riser and catalyst basket to return to their original relative positions.

Since it was impossible to obtain a new bottom exchanger channel in the time available, it was decided to reinforce the existing channel with gussets. By repairing the channel in this fashion, the riser pipe was left 5 in. short. This condition was corrected by adding a 5-in. spool piece just below the exchanger channel.

The screen covering the joint between the center pipe and the socket in the collection manifold was replaced with a larger, two-layer screen. The inner screen is four-mesh, of coarse wire, and is intended to provide structural support for the ten-mesh, outer screen. By virtue of its greater height, the new screen should be exposed to less internal stress, due to movement of the pipe, (relative to the socket) than was the case with the shorter, original screen.
