BRITTLE FRACTURE OF AN AMMONIA SYNTHESIS HEAT EXCHANGER

H.K. KARINEN
Typpi Oy
Oulu, Finland

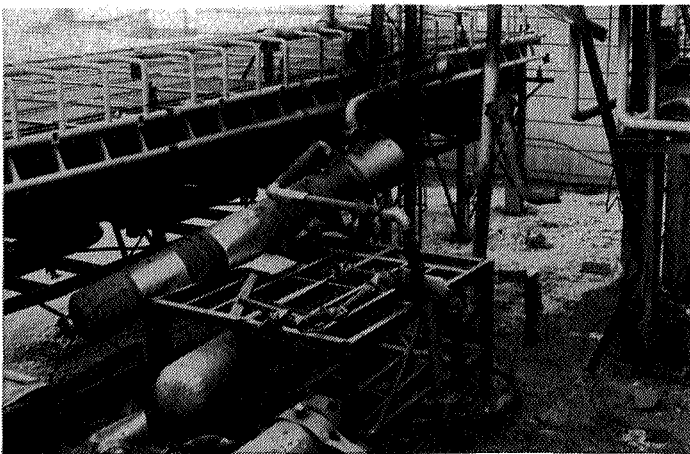
The effluent cooler consisted of four exchangers, two of which were completely destroyed. The other two were only slightly damaged, Figure 2. The heat exchangers were surrounded by the compressor house to the north, the control building to the west, and the Benfield plant pump house to the east, as shown in Figure 2. Severe damage was caused to all these buildings by the ensuing pressure wave. The roof and west wall, and a large part of the south wall of the compressor house had to be rebuilt. The west wall of the compressor house was broken by the suction effect of the pressure wave. This means that the wall reacted as designed since it was intended to withstand explosions coming from inside the compressor house up to a differential pressure of 80 mm. W.G.

Figure 1. Heat exchangers after the explosion.

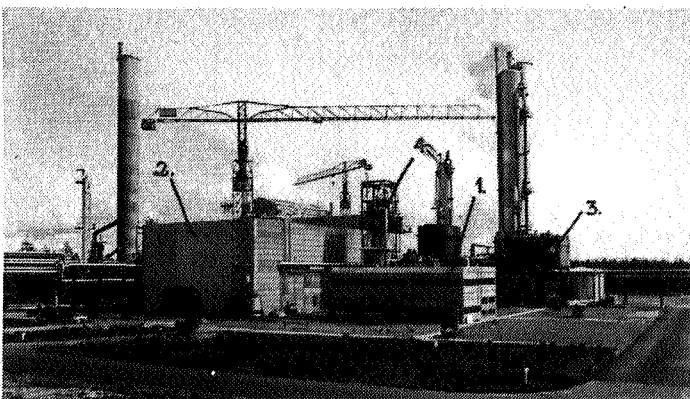
The wall elements of the control building were loosened from the house frame. During the re-erection the structure was made stronger on the process side. The roof windows, through which the pressure wave damaged the inside walls, were removed and blanked off.

Figure 2. Typpi Oy 750 ton/day ammonia plant: (1) control building, (2) compressor house, (3) Benfield pump house, and (4) ammonia reactor.

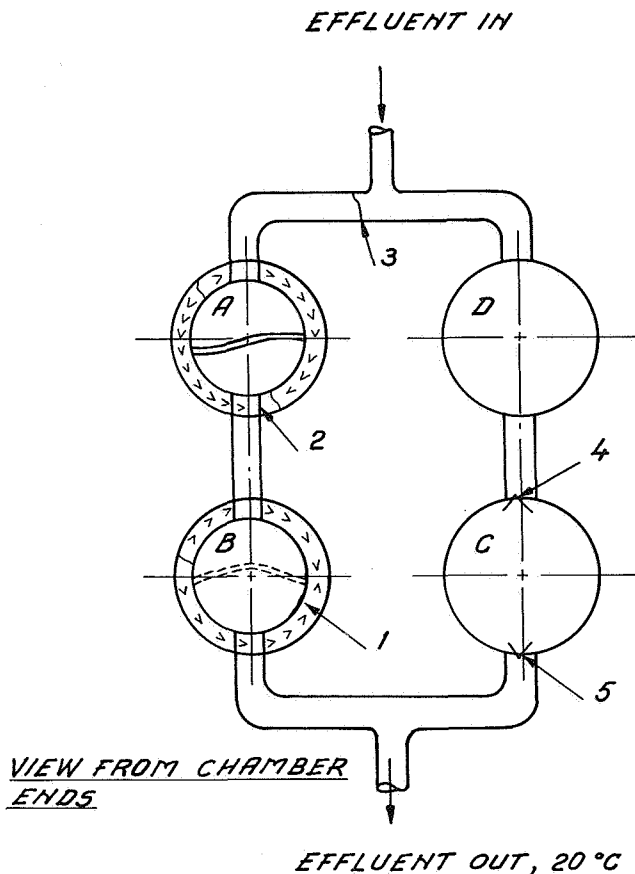
Figure 3. Chamber connections and fracture origins (numbered).

fracture had originated from chamber B, beneath its tube sheet end on the right hand side, Figures 3 and 7. At this point the tube sheet overlay weld extended to the wall of the chamber, Figure 6, and on the fracture surface a crack was detected, which had originated before the postweld heat treatment, Figure 7.

By the force of the reaction power, the rupture proceeded along a pipe nozzle connection to heat exchanger A breaking its exchanger head into pieces. This sequence is also confirmed by the location of the heat exchangers and the fragments thrown from them.

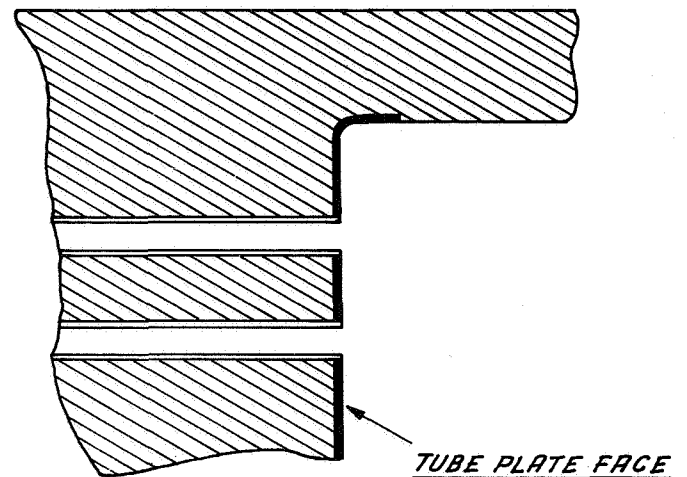
Figure 6. Effluent chamber weld overlay.

to preheating, the tube plate welding had to be carried out under difficult conditions. Because of the structure of the chamber the weld overlay had to be deposited to the very edge where the crack initiated. This is a very critical area in view of the stress caused by operation and residual stresses of the chamber. From this crack the rupture proceeded, apparently with a mechanism of stress corrosion cracking, which was promoted by the moisture left inside during the hydrostatic testing. Crack growth was also assisted by the hydrogen created on the metal surface as well as the high pressure molecular hydrogen of the synthesis circulating gas.

6. The construction of the heat exchangers should be changed so that the overlay welding does not extend to the edge.

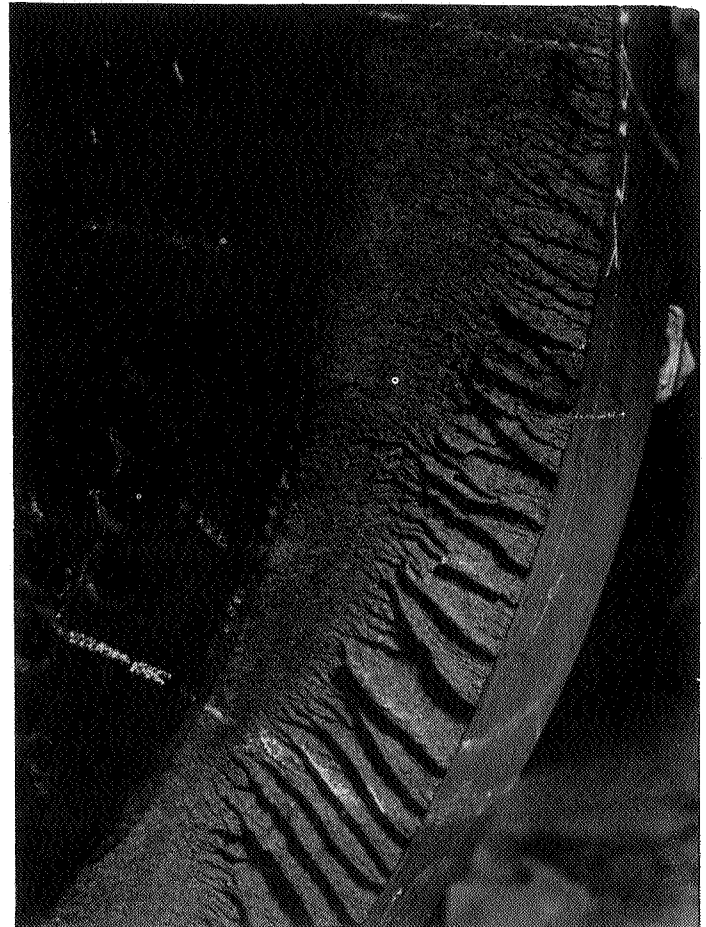
Figure 7. Fracture surface of exchanger B.

The basic reasons for the failure are the selection of the material, light forging, and defective heat treatment. The method of heat treatment used resulted in feather bainitic structure, which is brittle.

Sampling technique was the reason that the brittleness of the material was not revealed after the heat treatment, because the cooling speed of a loose sample ring is much higher than of a massive main piece and, consequently, the structure of the ring was apparently martensitic so the test results showed the material to be tough. Welding of this material gives a HAZ where austenitic grain size is coarse and hardness is high (approximately 400 HV).

The post-weld heat treatment was carried out at too low a temperature (560- to 580°C) and that resulted in precipitation hardening of the steel and added to its hardness. Due

3. The heat treatment should be such as to ensure toughness in the thickest sections. The post-weld heat treatment temperature for CMn steels should be at least 600°C, and for vanadium bearing steels, over 650°C. Stress relieving temperatures should also be above these values.

4. Creation of hydrogen cracking should be avoided during welding. For instance, solid wire CO₂ welding or metal arc welding with electrodes preheated at 400°C should be used. Similarly, the preheating temperature of the chamber should be maintained for a few hours after completion of the weld in order to release any hydrogen.
