# EXPLOSION IN THE FEED-GAS SECTION OF AN AMMONIA PLANT

A. Cracknell  
Imperial Chemical Industries, Ltd.  
Billingham, England

## Hydrodesulfurizer design and fabrication

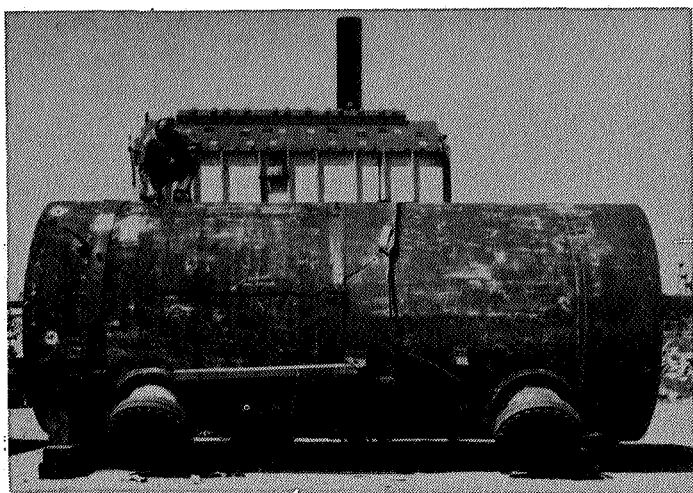
The No. 3 reformer hydrodesulfurizer at Heysham, England cracked in a brittle manner over a 15 ft. length during a recent hydraulic test, Figure 1. The vessel was 7 ft. 6 in. dia. x 17/32 in wall thickness, and about 50 ft. tall.

Figure 1. The ends of the cracked vessel have been cut off and straps fastened around it to allow removal from the plant.

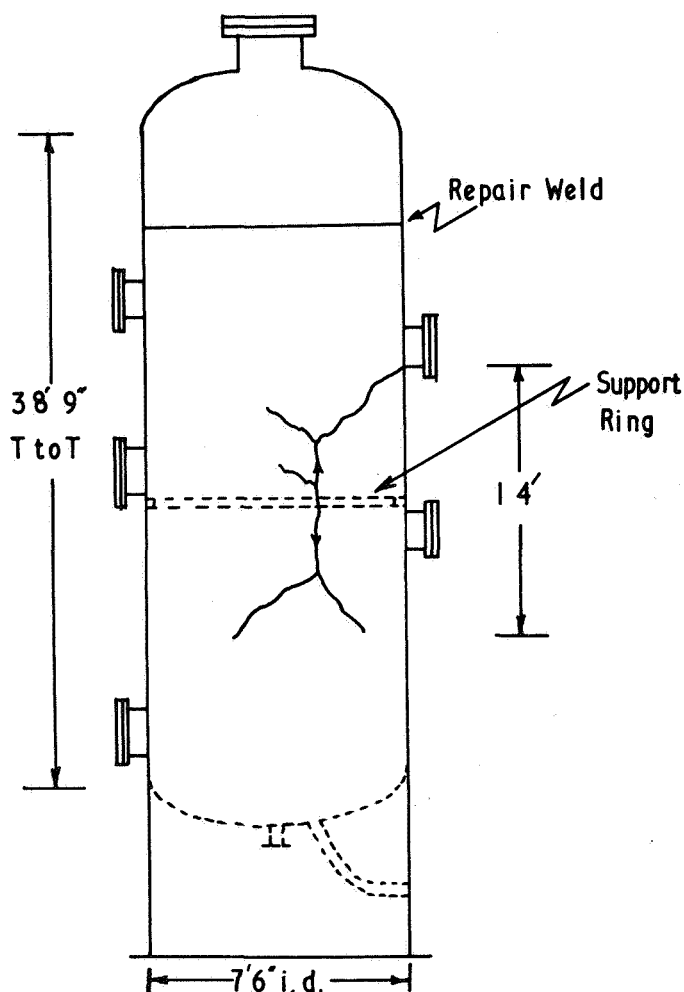
was fixed at 540 lb./sq. in. in view of the partial loss of the corrosion allowance, and the vessel had only been at this pressure for a few seconds when it failed by typical brittle fracture, Figure 2.

Figure 2. The extent of the cracking.

The vessel had a second support ring, higher up, again with two gaps in it. Examination showed that there was a serious crack in the shell at each of these and also at the gap in the lower ring at 180° to the gap which caused failure. Examination of the hydrodesulphuriser on No. 4 reformer at Heysham, which is identical in design, manufacture and service, showed that at each of the four gaps there was similar cracking. Fig. 2 shows the extent of the cracking at one of the other gaps in the failed vessel.

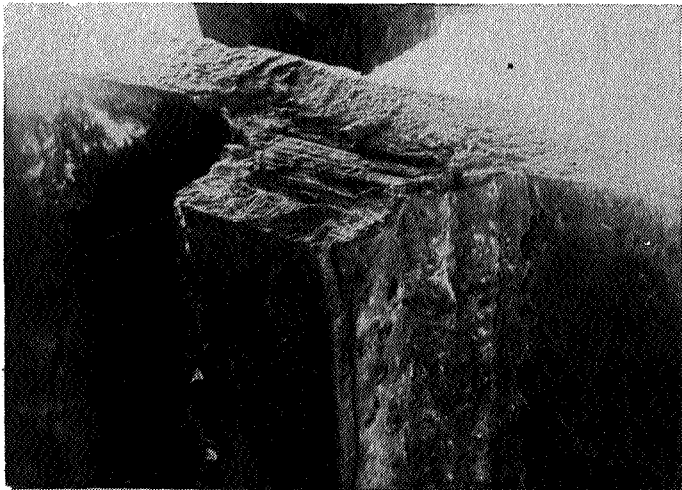
The fracture origin was a butt joint in the lower catalyst bed supporting ring, Figure 3. This ring was made of 1½ sq. in. Cr Mo bar and, for ease of fabrication, was put in the vessel as two half circles. The two halves were fillet welded to the shell with continuous fillets, but the contiguous ends of the bars were not welded together to give a continuous ring. The narrow gaps between the bar ends were joined by a weld bead, but no attempt had been made to produce a full penetration weld. This left a large built-in

**Figure 3. Photo of the crack origin. The unwelded (flame cut) end of the catalyst support ring can be seen beneath the weld bead used to cover the gap in the ring.**

crack or notch with its axis parallel to the axis of the vessel, and in the plane of maximum stress. Moreover, this built-in notch was connected via the fillet weld to the shell of the vessel. This was the direction in which the crack propagated and led to the failure.

It was quite clear that this vessel failed from a crack which was present before the final pressure test. Cracks may of course form during welding, during heat treatment or in service. Microexamination, however, showed that the cracks had formed by cleavage, and were filled with oxide scale which could not have formed during service, thereby eliminating creep as the primary cause. It is probably that they were produced during fabrication/heat treatment, but were small enough to be stable during the initial pressure test at 600 lb./sq. in.gauge. Since the vessel failed at 540 lb./sq. in. gauge, it follows that in service either the crack grew by creep or the toughness of the material (which determines the size of the crack it can tolerate) must be reduced.

1. Joints in support rings or other attachments should be made with full penetration welds.
2. Preheat when welding attachments should be as carefully controlled, as when making main seams.

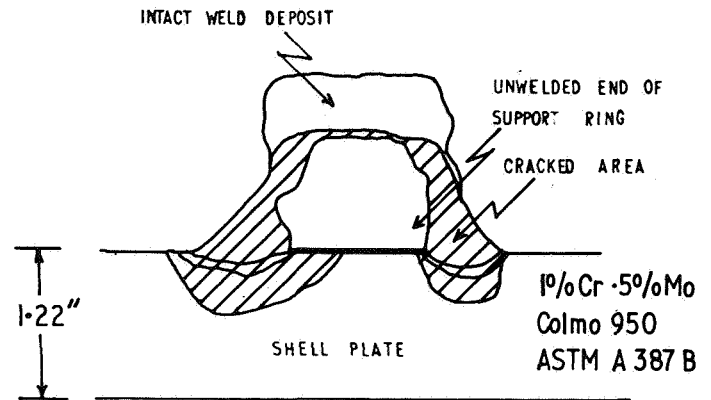
The (unfailed) crack shown in Figure 4 extended 15 mm. into the 31 mm. thick shell, and was 40 mm. long. The extent of the crack which caused failure could not be accurately estimated. It is clear, however, that the failed vessel was severely cracked and the result of the hydraulic test could have been predicted if there had been any reason to suspect cracking and to examine the areas in detail. The cracks in the No. 4 vessel were 6 mm. deep. The support ring has been cut back, the cracks ground out, smoothed off, and the vessel returned to service.

**Figure 4. Profile of crack at support ring joint 180w**
