# AMMONIA REFORMERS AND THE TUBE DEVIATION ANALYZER

L.W. Holloway  
Industrial Technical Corp.  
Baton Rouge, La.

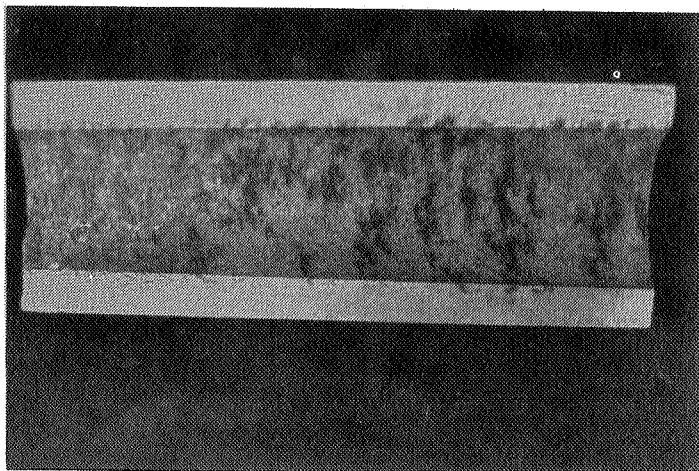
"Based on the data presented, the mechanism of failure appears to be carburization followed by oxidation (See Figure 1). The inner surface of the catalyst tube undergoes extensive carburization in a localized area. The resultant chromium carbides are selectively oxidized. The oxidized surface is not self-protective and oxidation proceeds uninterrupted until the tube wall is penetrated over a broad area. The effective wall area is greatly reduced and stress-rupture cracking occurs because of the reduced strength. . . . It appears that the attack is initiated by contaminants within the process stream, or by physical defects in the tubes, or both. . . . When HK-40 tubes contain excessive bore porosity or inclusions, they are more susceptible to oxidation. . . . Even though the exact promoter or initiator cannot be identified at this time, there are several prime suspects. They are:

1. Sulfur in the form of hydrogen sulfide may have passed through the desulfurizer and acted as a poison.
2. Water treatment chemicals may have entered the reformer with the import steam.
3. Temporary process upset may have allowed deposition of carbon and promoted carburization.
4. The inhomogeneity of the I.D. surface of the as-cast tube may act as sites for local carburization and oxidation.
5. Microsegregation within the inner surface of the catalyst tubes may cause local sensitivity.

Figure 1. Cross section of an HK-40 ammonia reformer catalyst tube that failed due to carburization/oxidation.

1. A more effective catalyst has been charged to the desulfurizer and regeneration occurs monthly.
2. The use of import steam to the reformer has been minimized.
3. The process streams are being analyzed and monitored.
4. The tubes will be inspected with a tube scanner at every shutdown and suspected tubes will be removed.
5. More stringent controls will be exercised during welding of tube assemblies." (2)

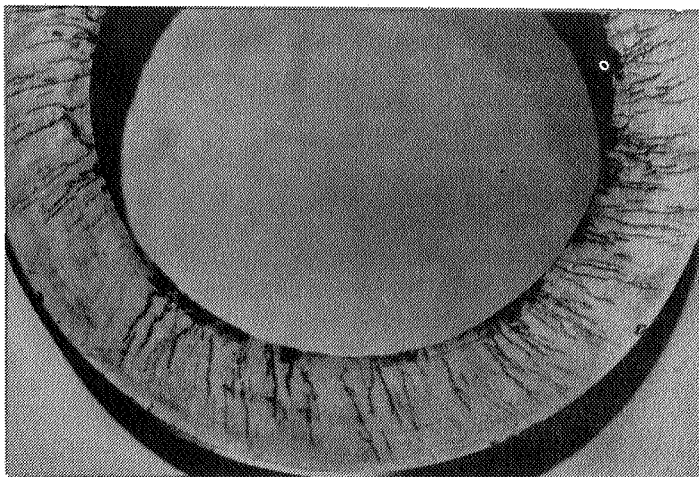
Figure 2. Ammonia reformer catalyst tube (HK-40), failed due to cracking containing oxidation.

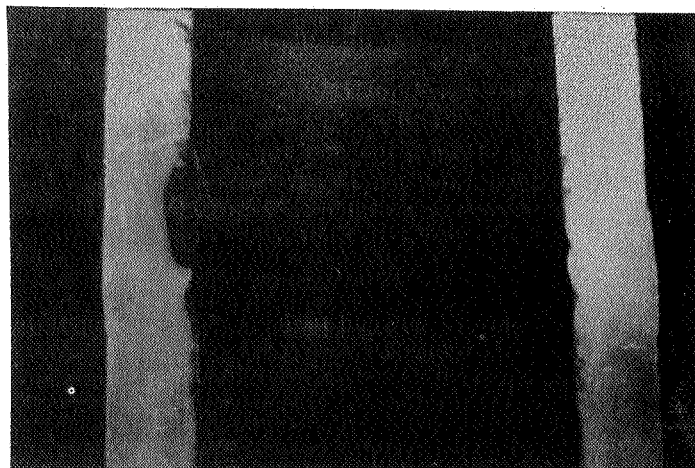
Figure 3. Ammonia reformer catalyst tube (HK-40), failed due to localized massive oxidation.

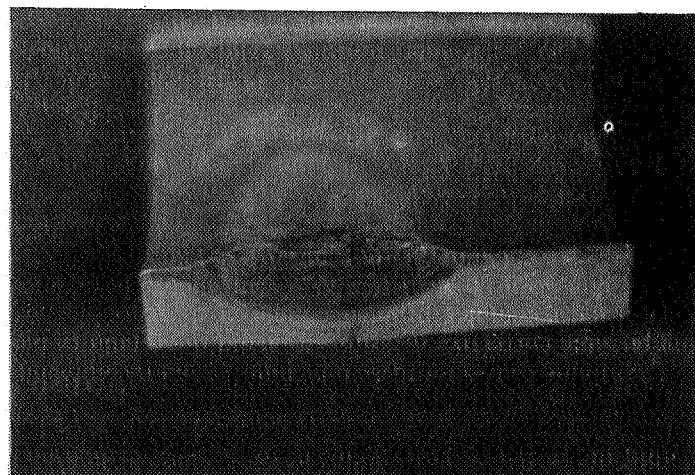
Figure 4. Ammonia reformer catalyst tube (HK-40), failed due to localized massive oxidation.
