Ammonia Storage Tank Repair

J.G. MacArthur
Willchemco, Inc.
Tulsa, Okla.

On November 16, 1970, Gulf's refrigerated ammonia storage at Blair, Neb. overflowed, causing considerable concern to residents of the community but, fortunately, no serious injuries. One hundred sixty tons of ammonia were lost to the atmosphere and three city firemen were treated for fume inhalation.

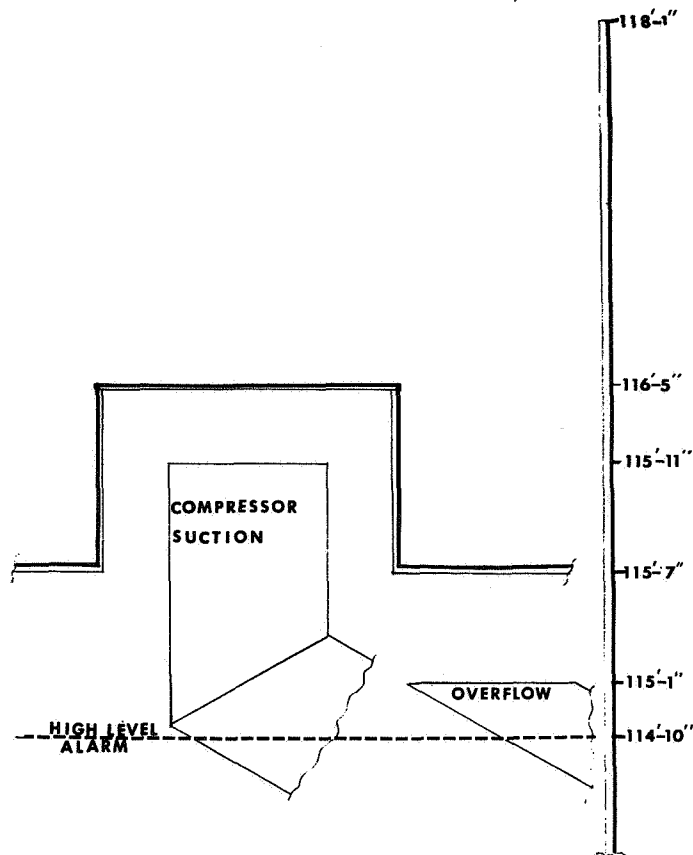
Figure 2. Cross section of ammonia storage tank.

In retrospect, we now know the high level alarm and shutdown system failed to operate. We feel fairly certain the overflow discharge valve failed to respond to the design 2.2 lb./sq. in. opening pressure, and the tank level rose well above the overflow pipe before the relief valve opened. A check of the high level alarm system, after the accident, showed that after maximum deflection of the microswitch lever by the activating cam, an additional 10/1,000 in. displacement to the lever was required to activate the system.

In reconstructing events leading to the overflow, we need to list a few significant tank levels, Figure 2. (This figure is correct with respect to elevation but not to plan.)

Top of tank shell	118 ft. 1 in.
8 in. compressor suction line	115 ft. 11 in.
Bottom of hanging roof deck	115 ft. 7 in.
4 in. overflow line	115 ft. 1 in.
High level alarm	114 ft. 10 in.

Because of the rate of pump in at the time of the overflow and the amount of material lost and pumped into tank cars, it is apparent the tank level was above the overflow pipe for an extended period of time. We believe the overflow relief valve failed to respond to a pressure equivalent to a head of 110 ft. of ammonia (32 lb./sq. in.), and the level continued to rise until it reached the hanging roof at which point the instantaneous pressure increase (hydraulic slap) activated the relief valve. The ammonia level rose rapidly in the compressor suction shroud, spilling into the suction line and the compressor entrainment separator. Fortunately, shutdown procedures were timely enough to prevent any damage to equipment.

2. Tanks equipped with overflow systems should have the relief valve and block valve separated by sufficient distance to allow closing the block valve when the relief valve is open. At Blair, the block valve is directly below the relief and showered with liquid ammonia during an overflow. Had we been able to reach the block valve, much of the overflow material could have been retained in the tank.

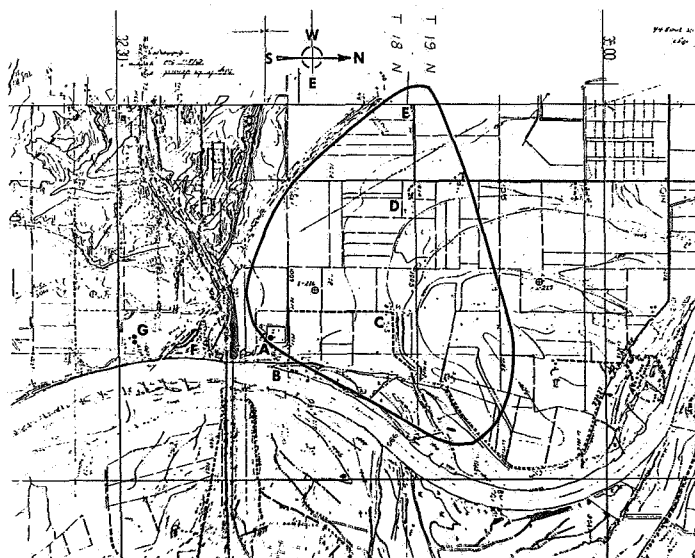
Figure 3. Map showing the approximate area covered by the ammonia cloud.

Once the overflow valve activated, ammonia discharged to the atmosphere for a period of about 2-1/2 hr. From the standpoint of vapor dissipation, atmospheric conditions could not have been worse; there was practically no wind and an atmospheric inversion existed. As a result, vapor migrated from the tank as a low-hanging cloud approximately 8- to 30 ft. in thickness and, at times during the period of discharge, extending over 9,000 ft. from the tank. Figure 3 shows the approximate area (about 900 acres) that at one time or another was covered by the cloud. In this figure, the Gulf terminal is designated "A". "B" is the dock about 1,000 ft. from the tank where the barge towboat stayed most of the time during the spill, and "C" is the nearest residence (3,800 ft. Fortunately, the sole occupant left for work at 4:00 a.m., thus missing exposure. "D" is a stock farm (5,800 ft.) where two hogs are reported to have died due to exposure, and cattle were reported "off their feed" for several days after the spill. At point "E", (9,300 ft.), where a county road was covered, a panel truck was observed driving through the cloud. The driver later commented that the ground fog was heavy and smelled bad. Point "F" (1,700 ft.) is the nearest habitation south of the terminal. This is a manufacturing plant which was closed and evacuated during the spill. The Agrico Chemical Co.'s ammonia terminal is located at point "G" (4,200 ft.).

Apparently, there was a very gentle breeze from the southeast which kept the cloud from covering or passing over the river and, about 2 hr. after the spill started, cleared the operation area sufficiently to allow tank car loading to be initiated. The cloud at no time crossed the railroad fill running in a northwesterly direction between the terminal and Blair. Although no residences in the town were evacuated, school children were sent home and several farm residences were evacuated after being alerted by the County Sheriff through a loudspeaker from a low-flying plane.

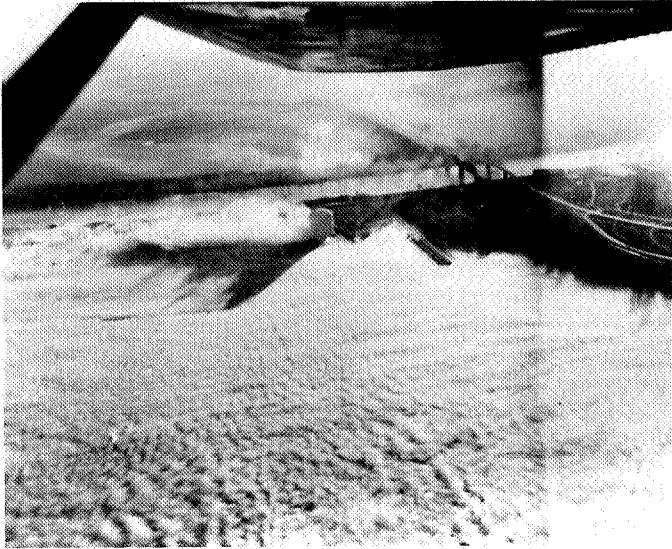
Figure 4. Aerial view of the ammonia cloud shortly after the spill.

As mentioned earlier, the cloud covered a substantial area of the flatlands surrounding the terminal, Figure 4. Fortunately, however, aside from the deaths of the two hogs, and the upset of some cattle, the only other damage that resulted was a grass-burned area of about 4,000 sq. ft. under the relief valve. Undoubtedly because of the time of year, there was no vegetation damage noted in the area covered by the cloud.
