Stainless Steels in a Waste-Heat Boiler

Components manufactured of stainless steel Type 321 failed due to carburization at high temperatures, but those made from Type 310, exposed to the same conditions, showed no signs of degradation.

H.D. Spangler
Farmland Industries
Fort Dodge, Iowa

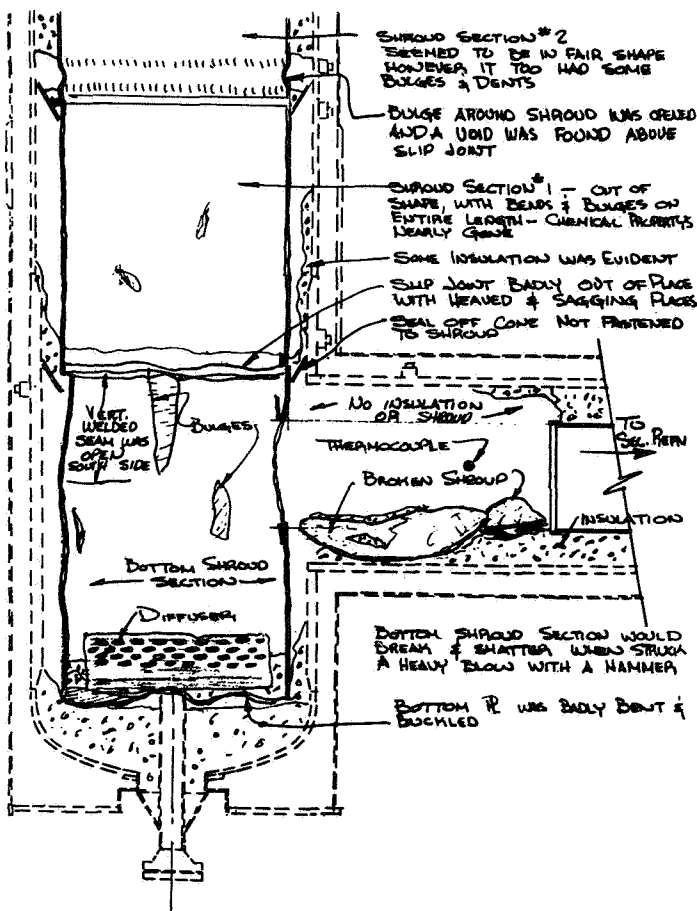
In January 1971, the vessel and the shroud were inspected and the lower section found to be in poor condition. Figure 1 shows the condition of the shroud at that time. The bottom section of the shroud near the hot gas inlet nozzle was found to be severely warped and distorted. The metal had lost all of its metallic properties in that it was brittle and had properties similar to pottery. Sections could be broken out of the shroud in some areas with a ball-peen hammer. The section above this had also deteriorated to a considerable degree, but was not as bad as the lower section. Higher up in the vessel the shroud was found to be in good condition indicating that deteriorating was a function of operating temperature. At temperatures below about 100°F, the shroud appeared to be satisfactory. The section of the transfer line shroud from the secondary reformer to the waste heat exchanger was disintegrated, and lay in the bottom of the transfer line duct.

Metallographic examination of a section of the shroud in the lower section of the vessel showed that failure was due to carburization at high temperature. Substantial amounts of carbon were introduced into the metal, which caused it to become very brittle. Micro-photographs showed islands of carbides in the deteriorated metal matrix. A high concentration of carbides existed at the surface of the remaining metal which decreased towards the center of the specimen. Operating temperature variations then caused fractures and cracks in the carburized metal which resulted in scaling and thinning of the metal surface.

Figure 1. Damaged shroud section.

good physical condition. This is also shown on the figure, but is not immediately apparent at first glance. Notice that the transfer line upstream of the failed section is in good condition, and that the diffuser is in relatively good condition. These two items had been made out of ASTM Type 310 material which is a 25-20 material. It had been in service for over 4 yr. under the same operating conditions. No apparent metal degradation had taken place during this time. Based on this experience, the shroud in the low section of the vessel was repaired with Type 310 material.
