Failure of an Ammonia Loading Hose

> L. V. Caserta American Oil Co. Texas City, Tex.

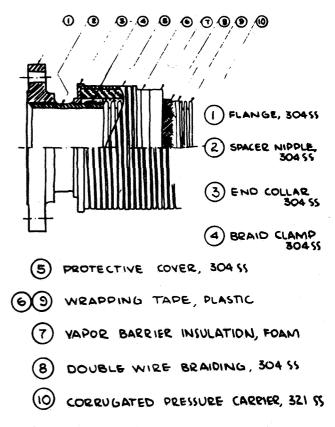
Figure 2. Cross section of the ammonia loading hose.

When the facility was initially constructed in 1964, we employed rubber hoses for loading with a 400 lb./sq. in. maximum working pressure. These were discarded every six months. During 1967, a blister developed in one of the hoses, and we began to encounter some hose deterioration short of the six month life. In 1969 we switched to a stainless hose 6 in. x 25 ft. long, corrugated, having a double wire braiding, plastic tape wrapped, and covered with a vapor barrier insulation contained by a metal hose protective cover, Figure 2. All metallic materials of the hose are stainless type 304, except the carrier hose which is type 321. The hose is tested at 500 lb./sq. in. gauge once a year. The hoses, which have a bursting pressure of 1,000 lb./sq. in. gauge, are considered capable of withstanding pump shutoff pressure, as well as the pressure rise (hammer) associated with a downstream valve manipulation.

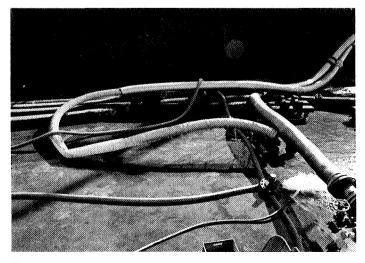
On January 26, 1971, after about 22 hr. into the loading of a large vessel on its maiden voyage, a loading hose ruptured, Figure 3. Our dockmen reported hearing a distinct noise emanating from the loading hose area. On investigation, two men were engulfed in a cloud of ammonia vapor. The lead man was splashed about the face and hands with liquid and vapor ammonia, knocked off his feet, and thrown 6-to 8 ft. by the moving inner liner of the ammonia hose. He ran to the end of the pier and jumped into the bay. Once in the water he reported hearing a loud pop and observing a large, white cloud over the entire dock area. The second dockman pushed the emergency stop switch, activated the fire water sprinkler system, and then closed remote ball valves in the loading line. The dock side air motor operated valve functioned; however, the loading pumps did not automatically shut down. They were secured by unit personnel. Prior to loading, the remote shutdowns had been checked and were operable. However, they later failed due to a malfunction in the telephone system. The first dockman received first and second degree burns on the head and arms, and was absent from work for 31 days.

The loading hose failure was apparently initiated when the main liquid loading valve on the ship closed. A blown fuse was found in the ship's fail safe circuitry, and this was reported to have caused the ship's valve to shut quickly. The hose was subjected to a momentary pressure rise exceeding 500 lb./sq. in. gauge (top limit of our recorder), which we speculate resulted in failure of the double stainless steel on the wire braid cover where it is welded to a flanged stub. When the braiding failed, the corrugated metal hose pressure carrier began extruding from the braid, stretching approximately twice its length before complete

Figure 3. The ruptured ammonia loading hose.

separation occurred. The fractional additional time permitted the dockman to clear the immediate area. Only a small amount of liquid ammonia leaked onto the dock.

The hose, in service for 24 months, had seen extensive use and handling. Following the accident, the hose was inspected by the manufacturer and by our Research and Development Lab. We concluded that the failure was caused by the pressure rise, and the resultant over expansion of the corrugated hose pressure carrier. The expanded hose exerted a stress above the yield strength of the metal braiding at a point of restraint, i.e., at the weld between the spacer and the hose. Studies on the microstructure at the ruptured area revealed no welding defects. The 321 SS base metal showed no evidence of any significant corrosion. We feel that metal fatigue was a factor in the failure. It should be noted that shut-offs have occurred against our loading hoses in the past without a hose failure.

- 1. We will continue to use the stainless hoses. They will be carefully inspected prior to use and tested annually at 1-1/2 times maximum working pressure (375 lb./sq. in. vs. factory test pressure of 500 lb./sq. in. and discarded after 2 yrs.
- 2. We have imposed the following handling conditions on cargo hose:

3. Automatic pressure switches will be installed to shut

down the loading pumps and close the motor operated valves on the pierheads, isolating the hoses from the system in case of excessive pressure rise in the line. 4. Surge chambers will be installed to provide additional protection for the hoses from sudden excessive pressure should the vessel automatic valves be closed.
#
