Catalyst Fusion

In an effort to prevent future catalyst deterioration, care is taken that the top and bottom manyways of the secondary reformer are not open at the same time.

K. Wright
and
G. Haney
Hill Chemicals, Inc.
Borger, Tex.

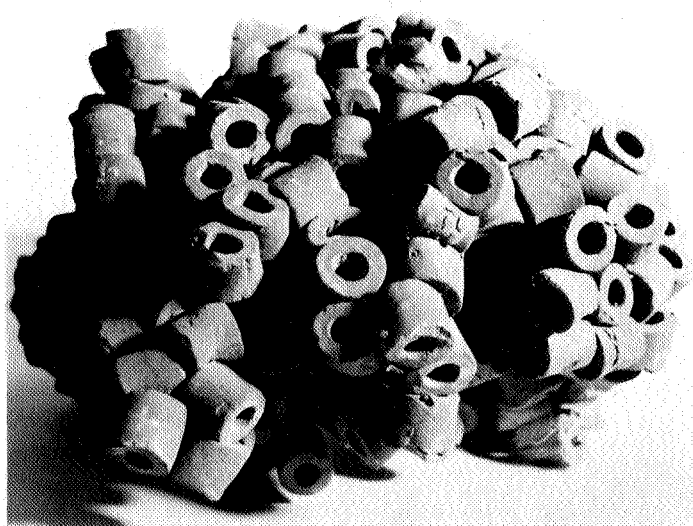
In October 1970, the plant was shut down, the secondary reformer oxidized with steam and air, and then cooled. Upon entering the vessel we found the catalyst level had dropped about 20 in. in 1 yr. of operation. The high temperature chromia catalyst was removed without difficulty and found in good condition. The upper third of the nickel catalyst was found to be slightly fused with the rings cemented together wherever they touched as seen in Figure 1. This bond could easily be broken, but the noticeable condition was the size reduction. As best we can measure, the 3/4 in. x 3/4 in. x 3/8 in. rings had shrunk to 5/8 in. x 5/16 in. rings, a linear reduction of 17% and a volume reduction of 40%. For the most part, these rings were regular in shape and dark gray in color. About 10% of them were deformed. The size contrast can be noticed by

Figure 1. Slightly fused, shrunken catalyst taken from the upper one-third of the bed.

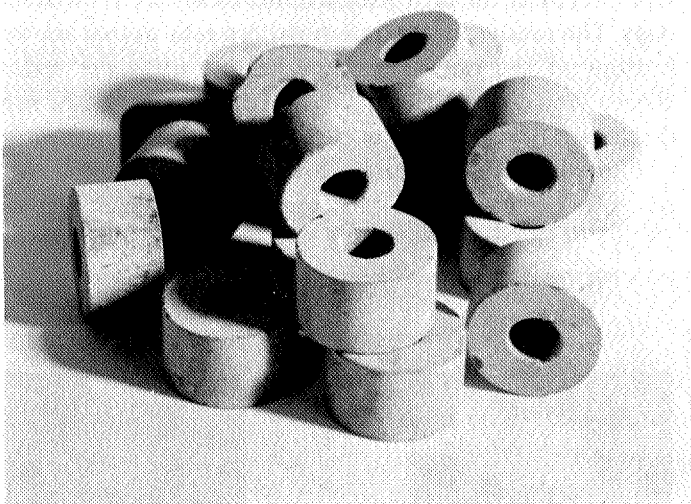
Figure 2. New, unused catalyst.

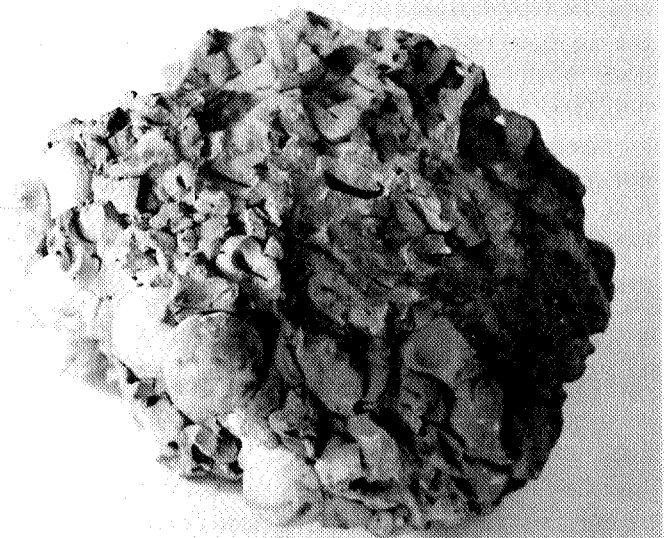
Figure 5 shows that the bottom 2 ft. of catalyst was in deplorable condition. Although the rings were full sized, they were completely collapsed, with no visible free areas or voids through which the gas could have passed. As can be seen, this solid mass adhered to the 1 in. dia. alumina balls that made up the catalyst support. The rings appeared to

Figure 5. Fused, collapsed catalyst taken from the bottom 2 ft. of the bed.

have been deformed while in a plastic state. The reason for the pressure drop was easily understood. As was the case with the previous material, this bottom catalyst was very soft and was removed by cutting up rather than breaking up. Although the catalyst was snug against the refractory lined wall of the reactor, it was easily removed, and no damage of the wall was observed. The alumina ball bed support was also in good condition.

Two theories have been proposed as to the cause. The first one is that while down and the top and bottom heads were off, a slight updraft of air set up a localized oxidation of the unreduced portions of catalyst at the bottom. Due to the low flow, the heat was not removed from the catalyst,

and the temperature reached levels in excess of 2,000°F. If the air flow had been higher, the temperature level would have been reduced and the increase in temperature indicated on the thermocouples in the wall. Due to this localized reaction, it would not have been detected or noticed. The other theory is that some time the natural gas flow to the reformer would have been shut off or greatly reduced while the air flow continued at a high rate consuming the combustibles and starting a high temperature oxidation of the catalyst.

while reduced. In each instance, the heads were off several days. The catalyst deformation pattern tells us that the very bottom of the reactor was the hottest while the updraft theory would predict that the hottest zone would be some distance above the bottom.

Our preventive measures have been to thoroughly check our trip mechanism at each opportunity, which we have always done, and to establish a procedure that the top and bottom manways will not be open at the same time. #

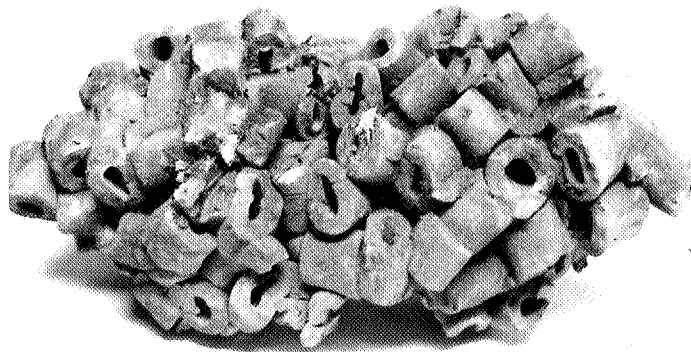
After about one-third of the catalyst had been removed, we noticed that the catalyst rings were about 10% larger than the rings at the top, and about 50% deformed. These rings were stuck or fused more solidly than the top ones. This material, Figure 3, had a light coating of a fine, reddish material which was identified as an aluminum compound.

Figure 3. Fused catalyst with a fine, reddish coating.

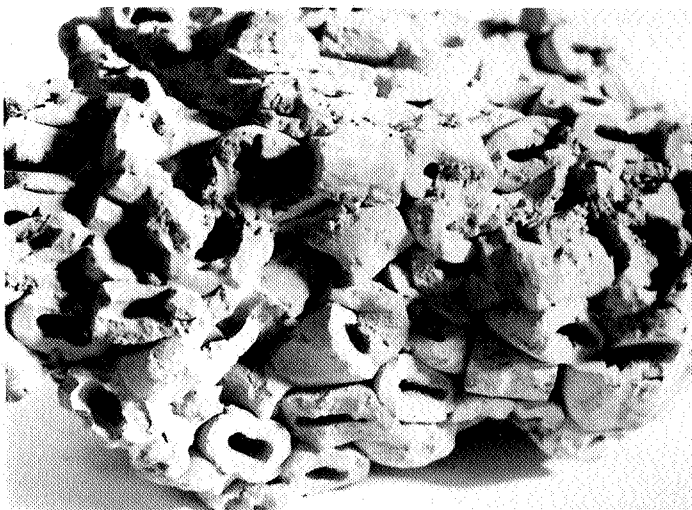
By the time we reached the bottom fourth of the nickel catalyst bed, the rings had become severely deformed, and were fused into a continuous mass as, shown in Figure 4. Although deformed as if in a plastic state, the rings were about the original size with little or no shrinkage. This material was much softer than the top rings. Although the rings were pretty well collapsed, there are some voids visible through which the gas passed.

Figure 4. Deformed catalyst taken from the lower one-fourth of the bed.
