Failure of a Reformer Outlet Header

The catalyst tube failure and fire was attributed solely to the fine grain size of the header. Earlier failure was avoided due to design safety factors and, possibly, because of low operating temperatures.

P. Strashok, and W. Unruh
Esso Chemical Canada
Redwater, Alberta, Canada

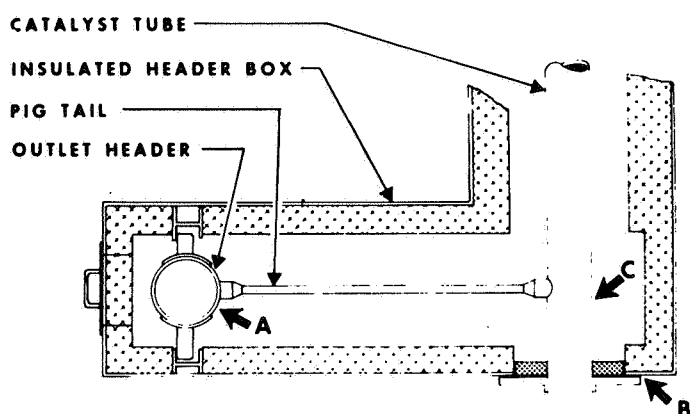
Figure 1. Header and catalyst tube assembly.

The ruptured tubes were identified as numbers 14, 15 and 16 in the east cell. Tube no. 14 had vertical split 4 in. long at point C Figure 1. Tube no. 15 had a 7 in. split centered 6 in. below the pigtail, and Tube no. 16 had a 4 in. split 5.5 in. below the pigtail. These ruptures had occurred on the east sector of the tubes. The tube guide bars had been displaced towards the east, and the header box covers had been buckled and distorted.

3. The hydrogen emission from the header rupture came in contact with air being leaked into the header box, resulting in ignition taking place at point B, Figure 1.

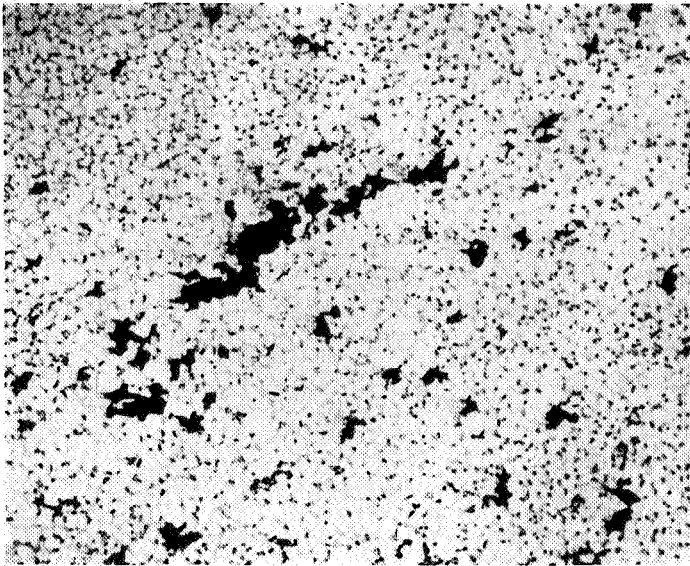
Figure 2. Photomicrograph of header showing intergranular cracking.

800 header failed prematurely in creep rupture because of the fine grain size (ASTM max. 7, min. 10). The catalyst tube failure and fire occurred after the header failure. Metallographic examination of the failed header section showed both extensive intergranular cracking, Figure 2, which is indicative of a creep failure, and a fine grain size which was responsible for the low creep strength.

The fine grain size of the header was solely responsible for the component failure and fire. Incoloy 800 used for components where resistance to creep is vital should be coarse grained and have the properties of Grade II material as specified in Code Case 1325. Data taken from a supplier's product bulletin showed that if a stress was chosen to cause failure in 100,000 hr. at 1,425°F, and if fine grained Grade I material was used in error, creep failure would occur in less than 2,000 hr. These data demonstrate the detrimental effect of the fine grained structure and help to explain the early failure of the header. Earlier failure was avoided due to inherent design safety factors, and possibly due to lower operating temperatures. Photomicrographs of the HK-40 catalyst tubes showed that they ruptured because of overloading. Figure 3 shows the tube O.D. where the failure originated. The metal had seen temperatures in excess of 2,100°F in the areas where the fire occurred.

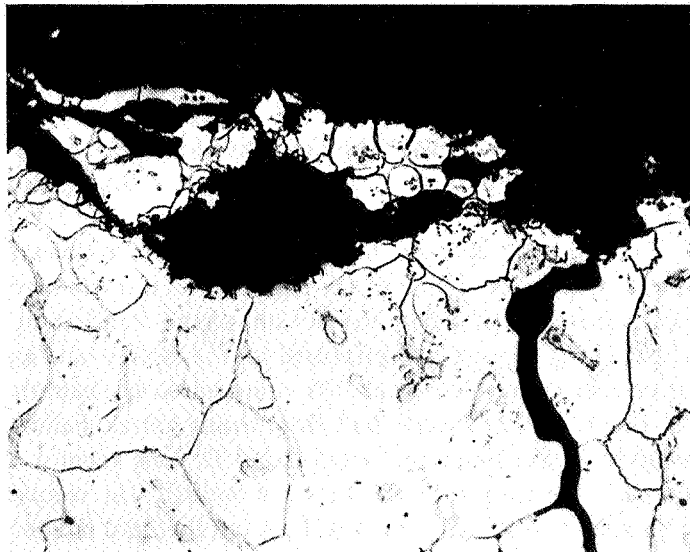
Figure 3. Photomicrograph showing ruptured area of HK-40 catalyst tube.

4. The fire which followed enveloped the east sector of tubes 14, 15 and 16, causing extremely high tube metal temperatures and, consequently, tube failure.

5. The high tube metal temperatures occurred because flame impingement was directed at the dead zone of the HK-40 tubes.

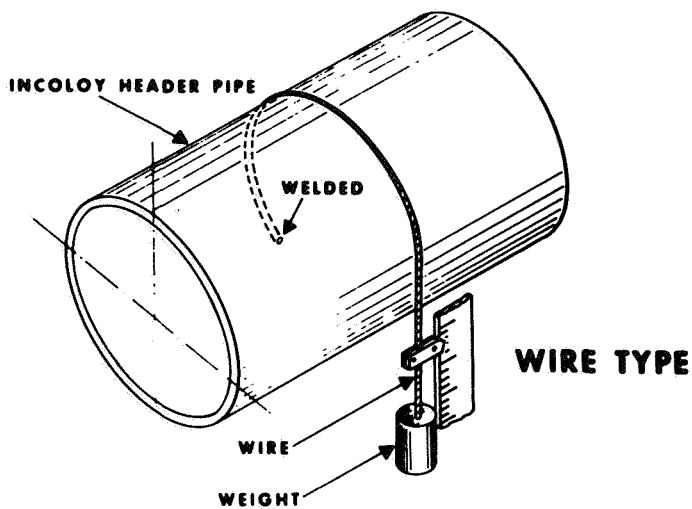
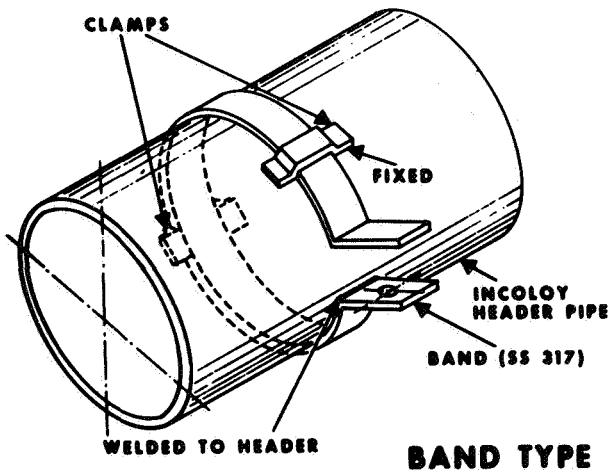
Figure 4. Creep monitoring devices.

BULGE MONITORING DEVICE

Bulge monitoring devices were installed as shown in Figure 4 at the two remaining bulges. Two types of devices were adopted, the wire type and the band type. The band type was found to be of real value. Header creep was measured and recorded on a weekly basis with results, as shown in Figure 5. Surface thermocouples were installed at eight locations. Additional inspection ports and necessary access platforms were installed to improve visual inspection of the header and pigtaills. Approximately one month after the failure, the header box covers were removed, the headers were measured, and a comparison made with the creep gauges.

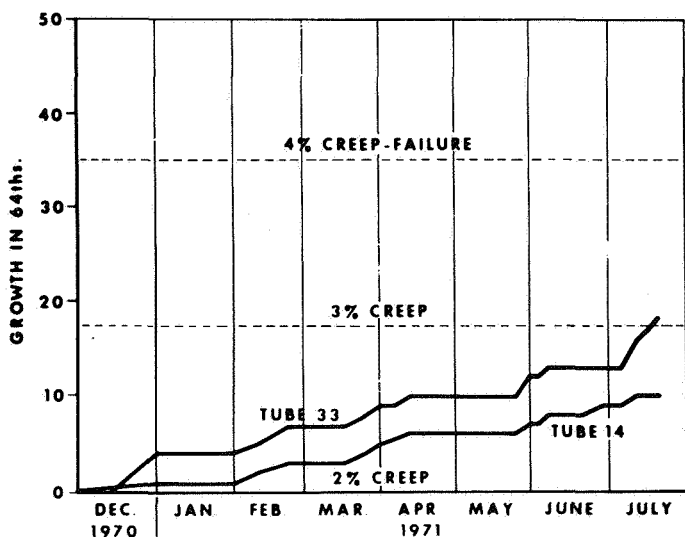
Figure 5. Plot of header creep as measured by monitoring devices.

2. Maximum header temperatures were specified at 1,420°F where the original design had called for 1,480°F. The header pressure was lowered to the lowest pressure as limited by the suction of the synthesis compressor. Subsequent creep measurements indicated that, even at 1,400°F header creep accelerated. As a result, furnace outlet temperatures were reduced to the 1,370°F - to 1,380°F range. Higher steam to gas ratios were used to maintain lower temperatures. Ratios before the failure were 3.7- to 4.0, and 4.0- to 4.3 after. Methane slippage increased from 9- to 10%, to 10- to 12%. #
