Reformer Tube and Weld Inspection, Replacement, and Repair

Dye penetrant testing and gamma-radiography proved the two most useful non-destructive testing techniques for assessing the condition of the welds of a primary reformer.

A.J.P. Tucker
African Explosives and Chemical Industries Ltd.
Johannesburg, South Africa

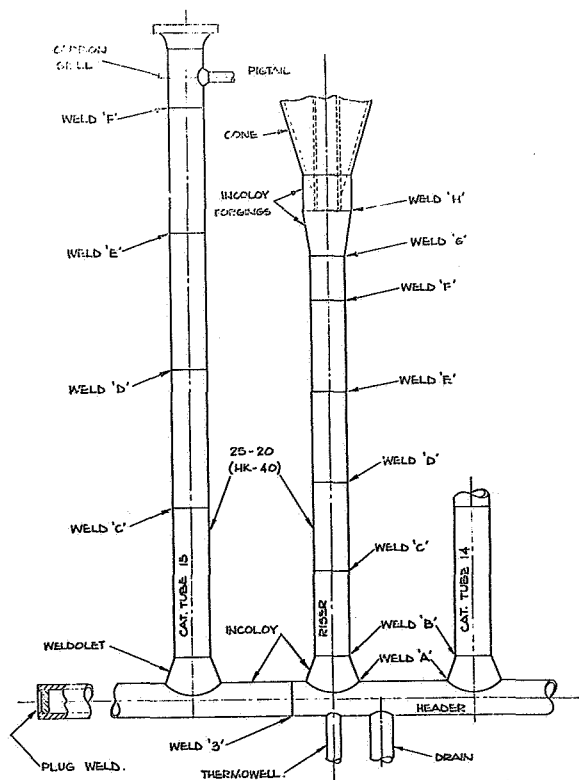
FIGURE 1 PRIMARY REFORMER, RISER & CATALYST TUBE WELD IDENTIFICATION.

Figure 1. Primary Reformer, riser, and catalyst tube weld identification.

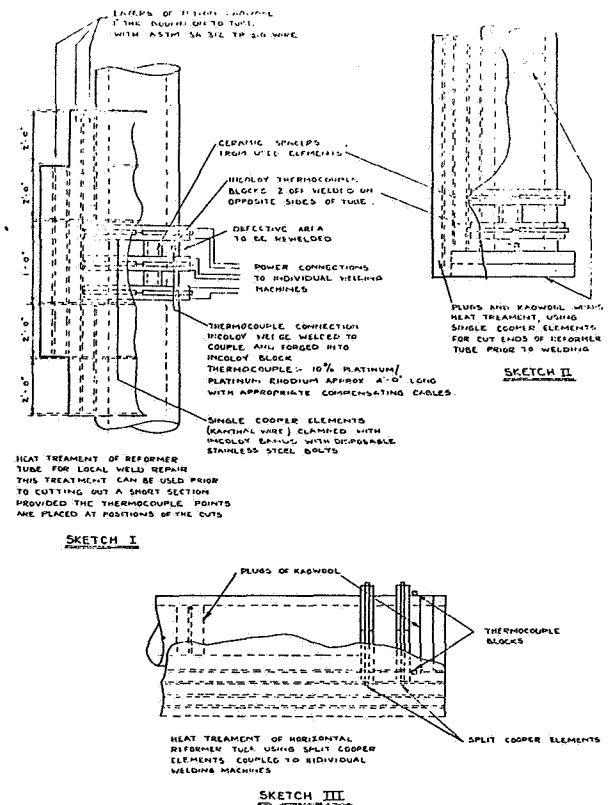
Figure 2. Arrangement for local heat treatment using finger elements.

On advice from, and with assistance of, colleagues from Imperial Chemical Industries Ltd., we decided to heat treat all used HK-40 tubing before attempting any welding. The heat treatment temperature range was considered to be extremely critical; it had to be sufficiently high to dissolve carbides precipitated in service, but not high enough to cause liquation. The difference between these temperatures is small, the optimum temperature for carbide solution being about 1,250°C, with liquation starting at 1,300°C. The range decided upon was 1,225- to 1,275°C held for 1 hr., followed by rapid cooling to prevent re-precipitation of carbides. Local hardness tests were done after heat treatment, and a hardness of less than 200 V.P.N. was considered satisfactory. The treatment proved successful in that we were, at that time, able to make crack-free welds on used material.

The method of heat treatment was to warp Cooper resistance heating Kanthal finger elements around the tube and insulate with two 1 in. layers of Kaowool ceramic blanket insulation held on with Type 310 wire. Power was supplied from welding machines (a.c. or d.c. controlled by a walkie-talkie radio link.

The procedure is illustrated in Figure 2. However, experience on tubes which have been in service longer than those treated in 1967 has shown that successful results are not then certain. Another warning to be sounded is that the temperature required is at the limit for the Kanthal elements, which become embrittled. It is not advisable to attempt two high temperature heat treatments with the same set of elements as a failure of the elements part way through the treatment is possible, and then the treatment has to be started all over again. Since the warming-up period can be several hours, this can be a very time consuming process. It is, however, possible to re-use the elements for lower temperature work (e.g., stress relief at 650°C) if they are handled carefully.

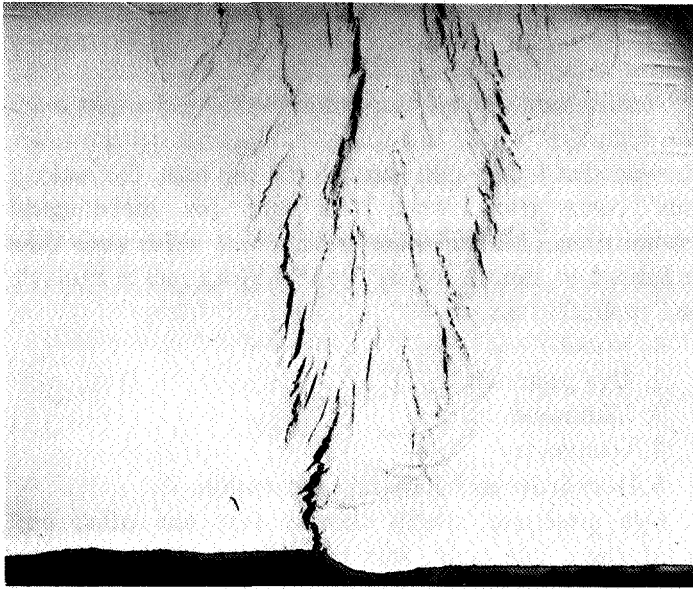
1. The two welds which were obviously cracked had failed by multiple creep fissuring which appeared to start in the body of the weld and proceed towards the bore and the o.d., Figure 3. The leaker had fissured right through, the final failure being through to the bore. The second weld which had cracked but not leaked, was fissured all through except the T.I.G. root run (in Inconel 82).

Figure 3. Section through cracked Inconel 182 weld, bottom header. This appeared as an isolated crack before sectioning (mag. 3x).

To maintain the correct longitudinal dimensions of the headers after repair, it was necessary to insert a spool piece at each place where a butt weld had been cut out. In removing a butt weld about 1-1/2 in. were lost. To avoid having two butt welds very close together, it was decided to cut additional material from the headers at the site of each cut, to allow the insertion of a 4 in. spool piece. Weld repairs were done in exactly the same way as the original weld viz: T.I.G. Inconel 82 root, Inconel 182 metal arc weld out. No heat treatment was necessary and no difficulties were met when effecting the repairs.

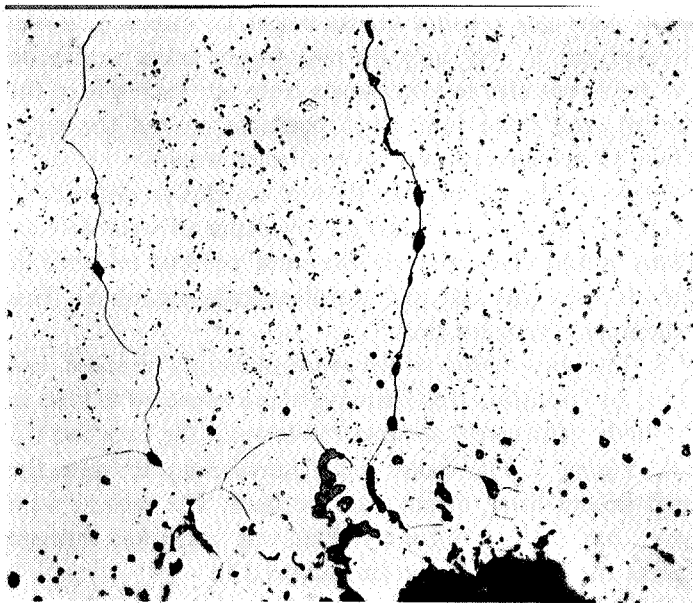
2. None of the welds cut out after gamma radiography was found to contain serious fissures. There was, however, clear evidence of grain boundary creep deterioration as shown in Figure 4.

Figure 4. Creep damage in otherwise uncracked Inconel 182 weld (mag. 200x).

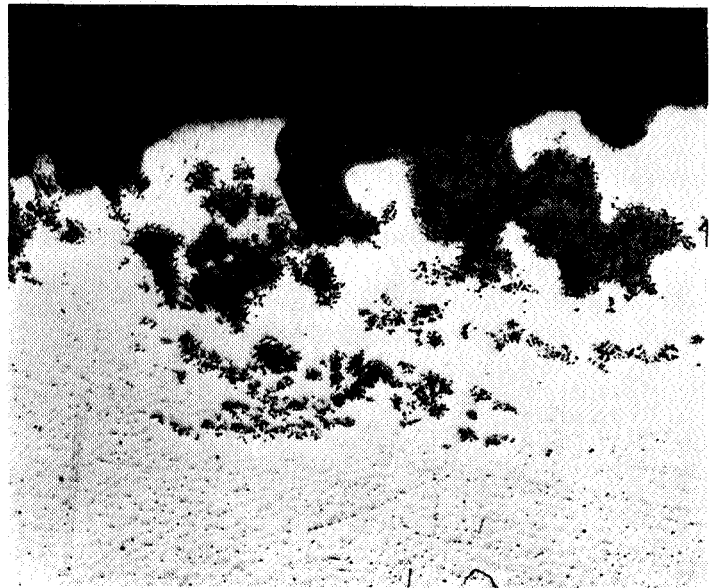
The curved pattern of the crack found above weld D in catalyst tube A9 suggested thermal shock rather than progressive failure by creep or other gradual deterioration under normal operating stresses. However, in the region of the crack there was severe bore porosity and oxidation which reduced the effective sound wall thickness to 0.62 in. (specified minimum 0.88 in.). Typical bore deterioration is shown in Figure 5.

Figure 5. Deterioration of bore of HK-40 tubing (mag. 6x).

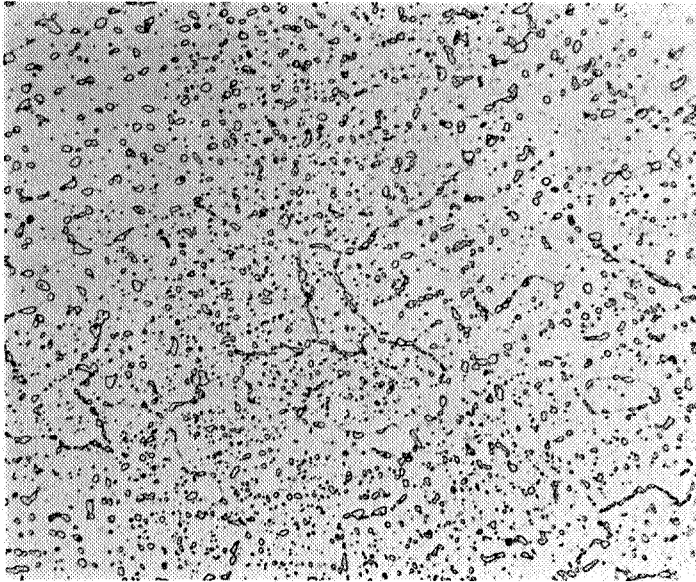
Figure 6. General microstructure of cracked Type 310 weld in HK-40 catalyst tube. (mag. 400x).

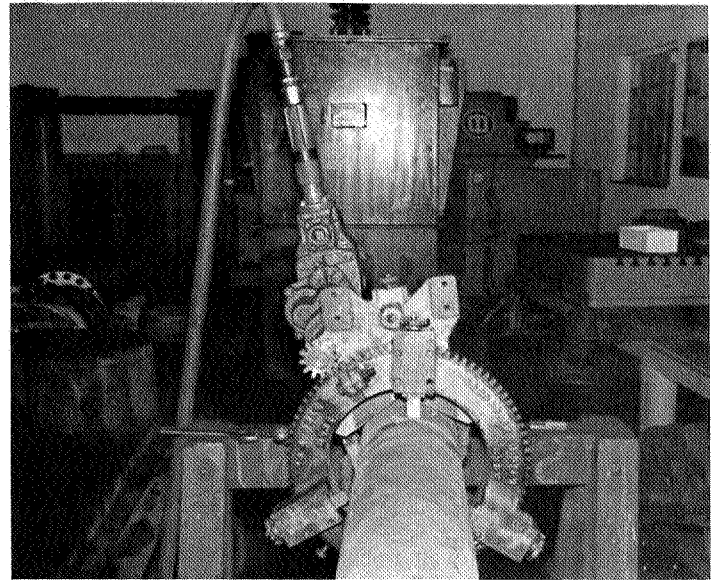
Figure 7. Pass cutter in position on tube.

In 1967, when HK-40 weld failures were discovered, repairs were made in situ, after applying the heat treatment described earlier. On later occasions this procedure was abandoned for two reasons. First, the heat treatment took a long time and, second, we had doubts about the effectiveness of the heat treatment on material which had been in service for more than a few hundred hours. On the other hand, we had more than enough evidence that it was possible to produce sound repair welds on Incoloy 800 and on welds made with Inconel 182, even when they had been in service for several thousand hours. A decision was made, prior to the 1970 shutdown, that no attempts would be made to effect in situ repairs on HK-40 tubing, or on HK-40 welds in catalyst tubes. Instead, if significant defects were found in HK-40 tubing, we decided to remove the complete tube by cutting through at weld B, and install a complete new tube. This decision was encouraged by our acquisition of a cutting machine which enabled us to make this cut neatly and rapidly. The cutting machine, known as the pass cutter, is a portable device which is clamped on to the pipe. It has three adjustable cutting heads mounted on a split ring which encircles the tube. As the ring is rotated by compressed air power, the cutters are advanced

automatically on each rotation. The machine is illustrated in Figure 7.

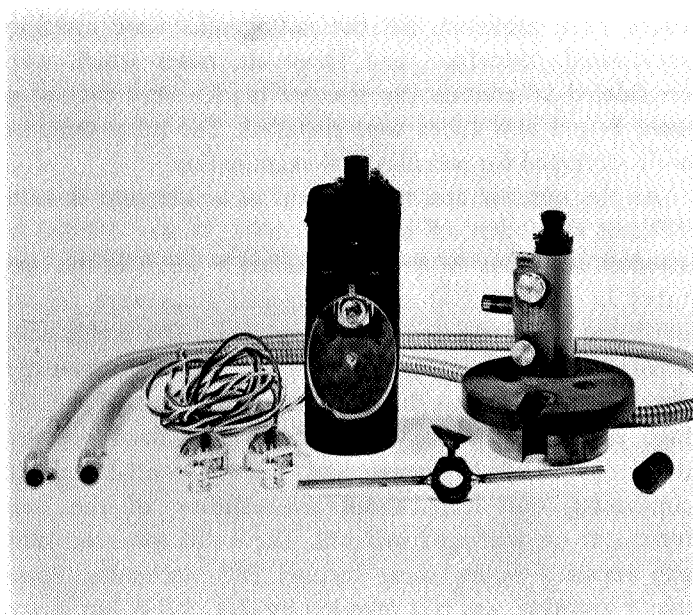
Visual inspection of E welds in catalyst tubes – Visual inspection was done by telescopic viewer which consisted of three basic parts, as shown in Figure 8.

Figure 8. Apparatus for internal visual examination of E welds.

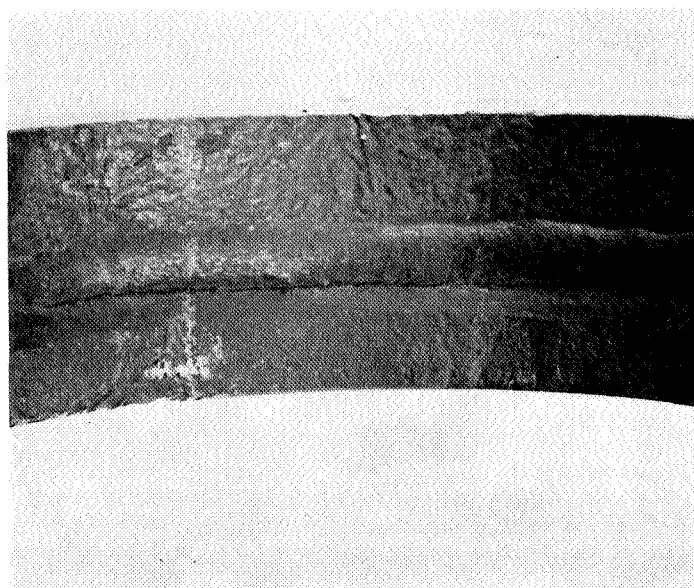
Figure 9. View of bore on typical E weld.

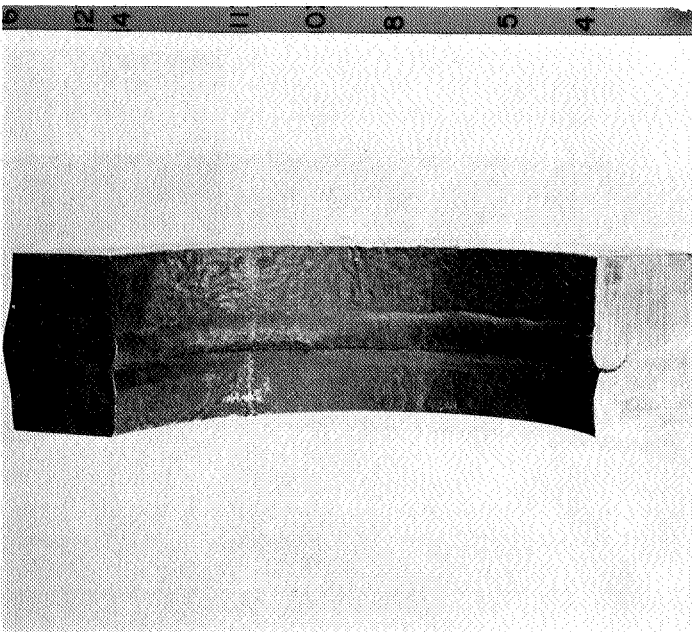
Examination of catalyst tube E welds – Visual examination of the E welds, after they had been removed from the furnace, showed why visual examination with the telescopic viewer had not been informative. Figure 9 is a view onto a ring cut from a tube, and shows the root of a weld. Very little information can be obtained from this. Figure 10 is a view of the same ring, but showing the end sections. There can be no argument about the extent of the cracking.

Figure 10. View of sectioned E weld.

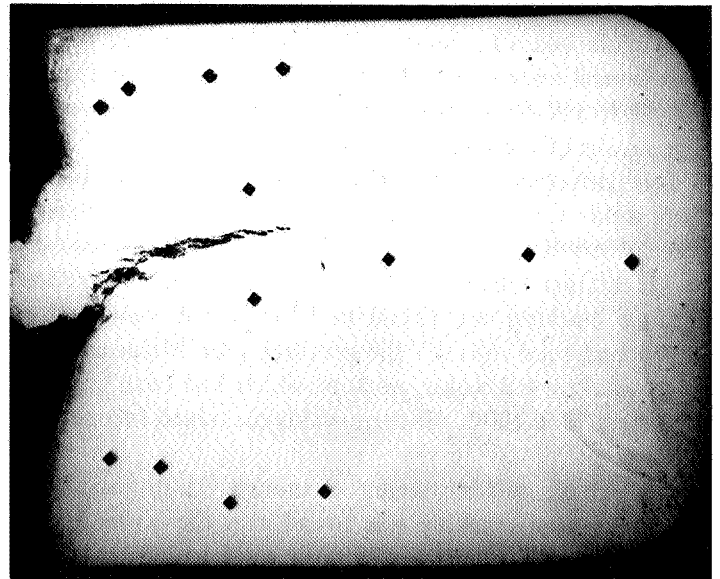
A sample of one of the most severely cracked welds showed, Figure 11, that the cracking originated at the junction between the weld root and tube material. It moved, after some interruption, into the body of the root run and thence into the weld out, without significant

Figure 11. Root cracking in E weld (mag. 3x).

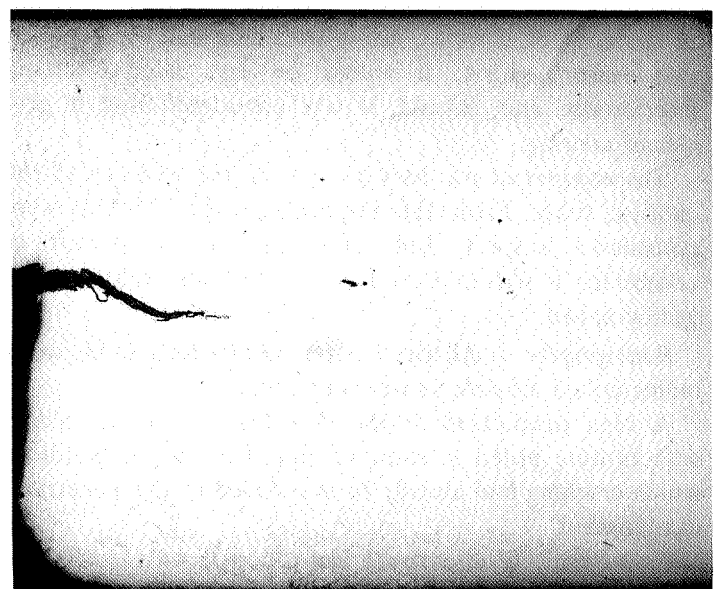
deviation from the horizontal (radial) plane. Figure 12, from another position in the same weld, at the position of worst alignment, shows how the crack starts at an off-set in the root run and proceeds inwards without suppression or elaboration.

Figure 12. Effect of tube off-set on location of root crack (mag. 3x).

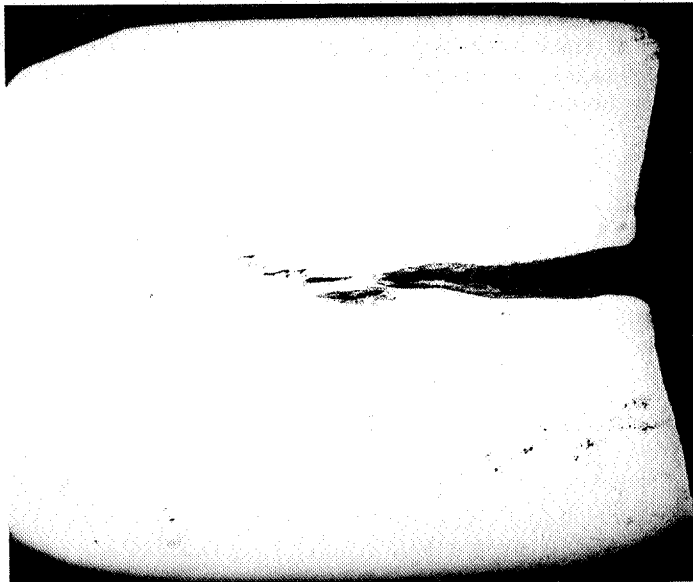
Figure 13, shows a macrophotograph of the weld, which from radiography, appeared to be the worst cracked. It will be seen that the full extent of the cracking extends with much side-stepping through 60- to 70% of the weld thickness. The microstructure of this weld showed grain boundary creep deterioration, as shown in Figure 14.

Figure 13. Deep crack in E weld (mag. 3x).

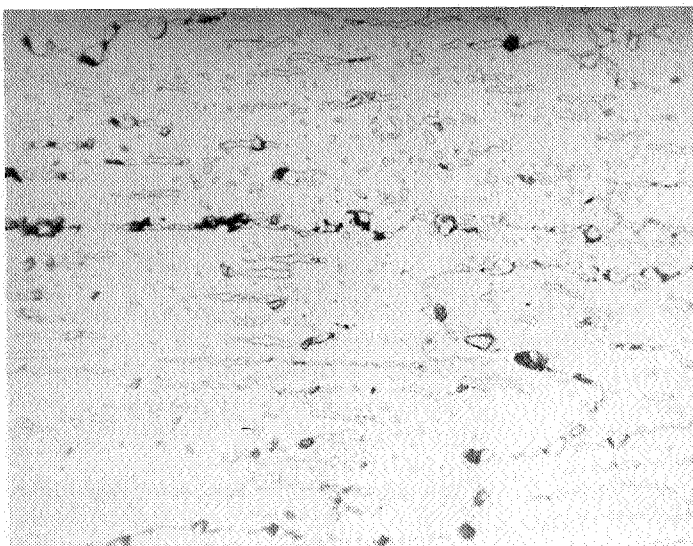
The fact that the cracks observed took a preferential path through the weld metal rather than the cast tube can be attributed to the fact that the weld metal has inherently inferior high temperature strength properties than the tube. It is considered that the cause of the fissuring must be high temperature creep, induced by thermal gradients and

stresses which exist very largely during unsteady conditions, e.g., during startup and shutdown. The location of the fissuring is induced by stress concentrations produced by the weld bead profile.

Figure 14. Creep deterioration beyond tip of crack shown in Figure 13 (mag. 300x).
