Investigation of Hydrogen Damage to an Ammonia Converter

R.V. Gorman
Valley Nitrogen Producers, Inc.
Helm, Calif.

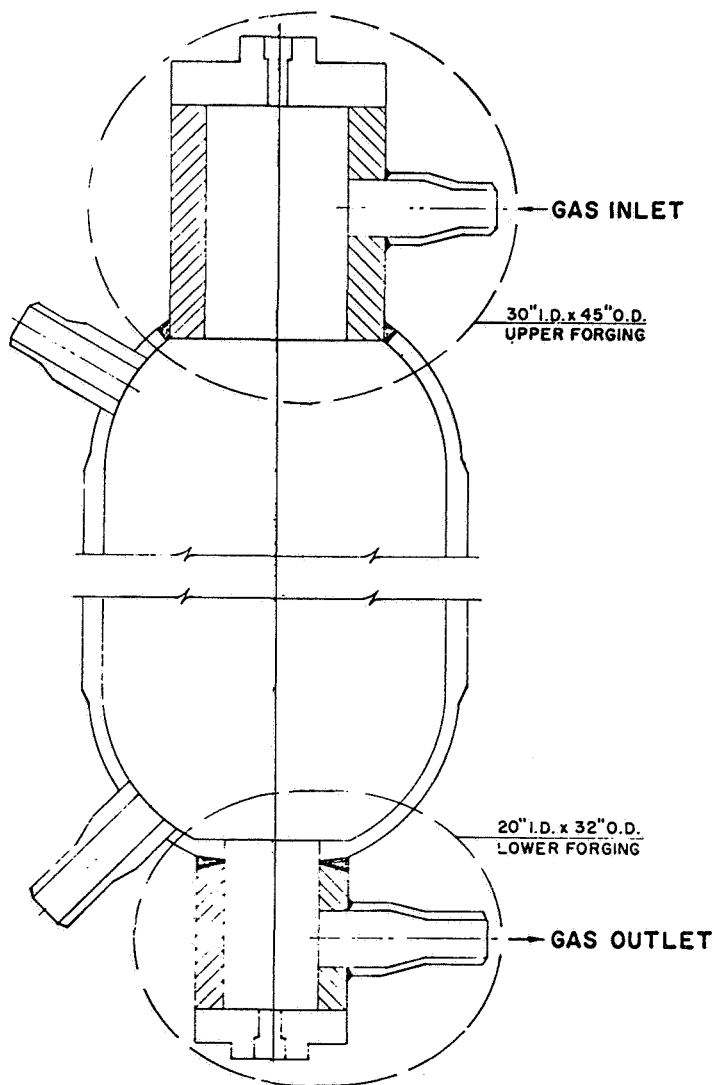
Figure 1. Schematic of the original ammonia converter.

In January 1971, Valley Nitrogen Producers was informed by the original contractor of its El Centro, Calif. ammonia plant that a possible problem of over-heating of the 600 ton/day ammonia converter could exist. The areas of concern were the top and bottom forgings as shown in Figure 1.

ranging up to 600°F were found in the general vicinity of the inlet and exit gas nozzles. External steam cooling was immediately installed on these forgings to reduce the temperature to less than 450°F. The converter forgings were designed to operate in a process gas atmosphere of about 800- to 900°F, and a hydrogen partial pressure of about 1,300- to 1,600 lb./sq. in. absolute. The use of carbon steel for these forgings necessitated the design of internal insulation canisters to reduce the metal temperature to less than 450°F to protect against hydrogen attack. With actual temperatures of up to 600°F, it was assumed that hydrogen attack was occurring on these forgings in accordance with the Nelson chart of operating limits for steels in hydrogen service.

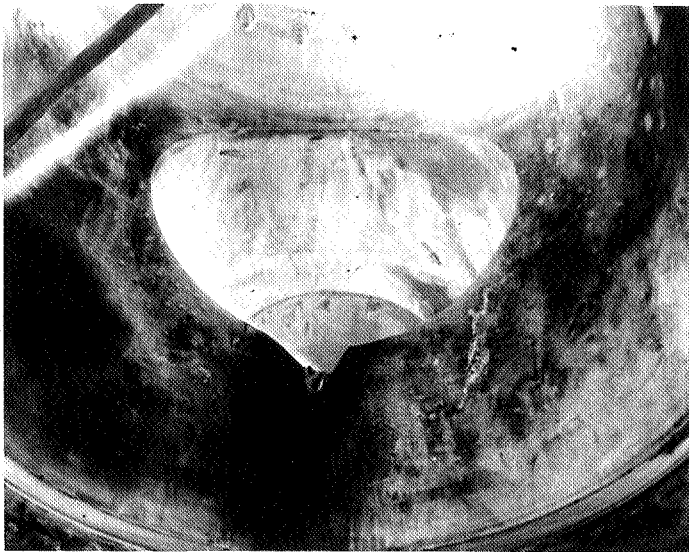
Figure 2 shows the blistering on the inside surface of the bottom forging looking up from the bottom at the outlet gas nozzle. Note where the "pie-shaped" specimen was removed for microstructure analysis. At this location, a

Figure 2. Inside view of the bottom forging.

longitudinal crack ran down the inside wall about 3 in., and back inside the gas outlet nozzle about 2 in.

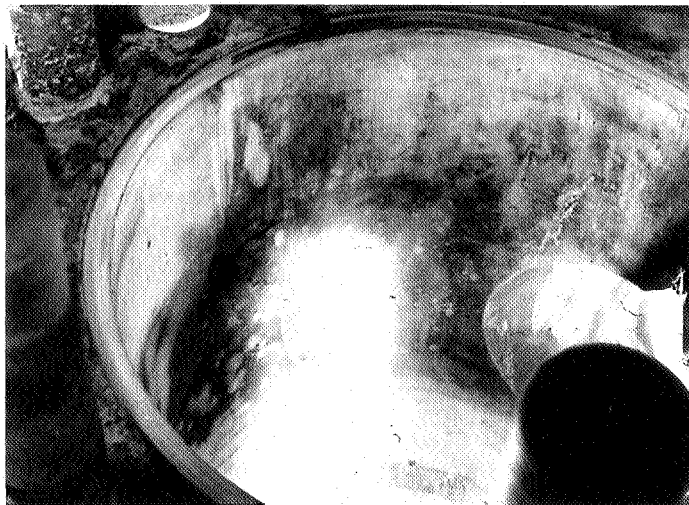
Figure 3. Inside view of the bottom forging.

Figure 3 also shows the blistering on the inside surface of the bottom forging. Blistering was noted in about a 1- to 2 ft. circumference band running 360° around the inside wall. Within approximately 3 in. of the bottom edge and approximately 8 in. above the gas outlet nozzle, no blistering was apparent. The blistered areas corresponded with those areas of higher temperatures.

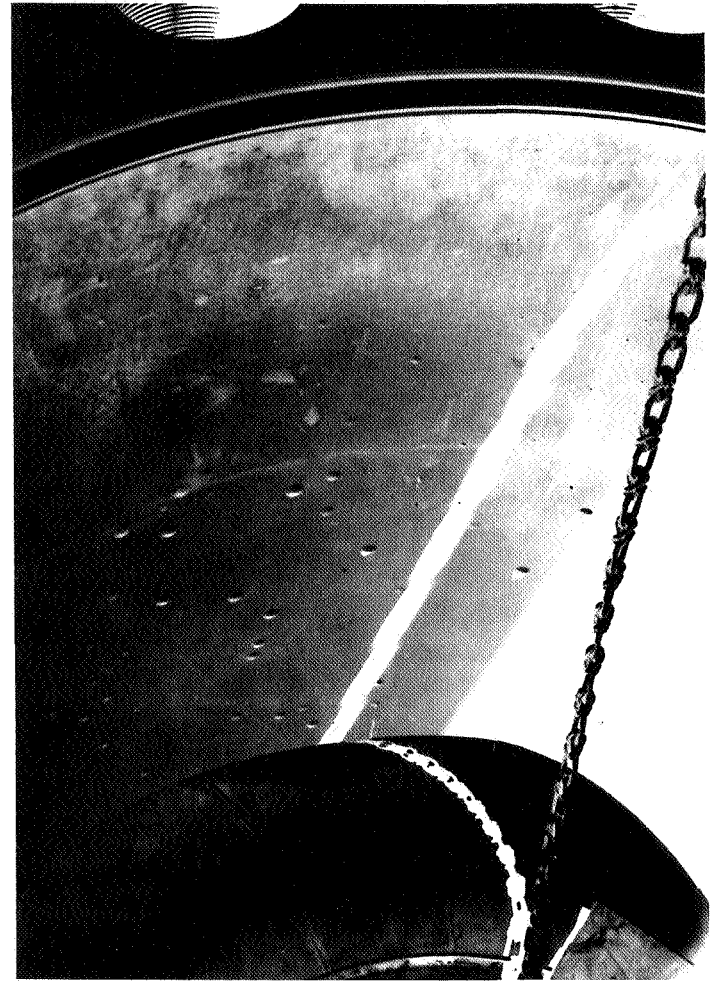
Figure 4 shows the condition of the inside wall of the top forging. The blisterings were fewer in number than those found in the bottom forging, but were larger. Around the inlet gas nozzle the blistering was more extensive, but the size of the blisters was smaller. No major cracks were found in the top forging.

When the blisters in the top and bottom forgings were surfaced ground and checked with dye penetrant, secondary cracks and pin hole defects were noted in the

Figure 4. Inside view of the top forging.

immediate metal under the blister.

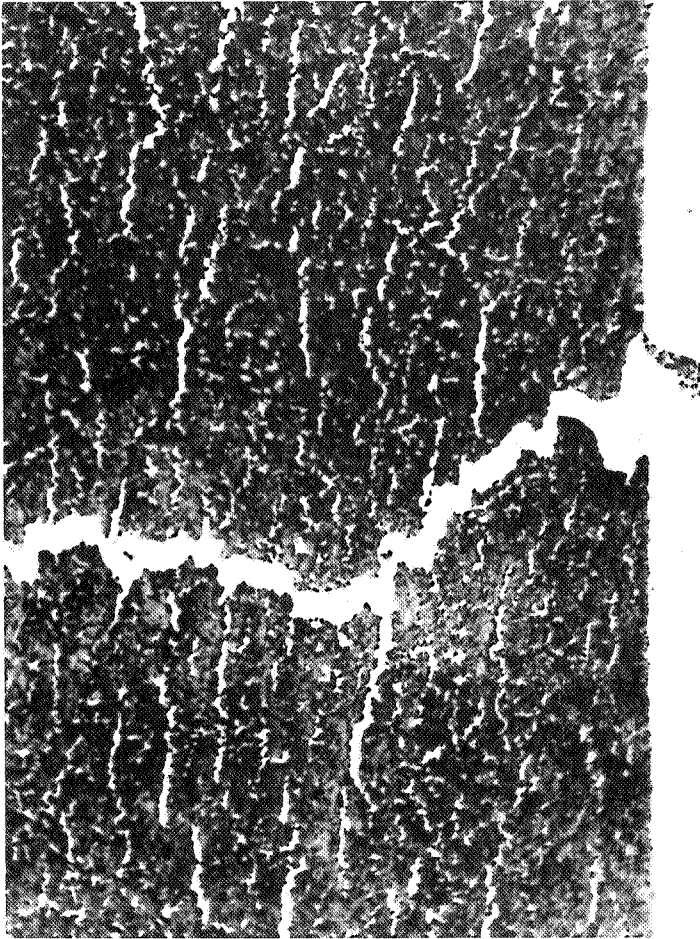
The “pie-shaped” specimen removed from the wall of the bottom forging was found to be consistent with SA 266 Class 2, carbon steel. This specimen was sectioned and the microstructure of each was examined showing significant intergranular cracking and fissuring. Figure 5 shows the extent of this damage at 5 x magnification in the vicinity of the large crack. The nature and severity of fissuring shown here is typical of each section from this “pie-shaped” specimen.

Figure 5. Hydrogen damage at 5 x magnification.

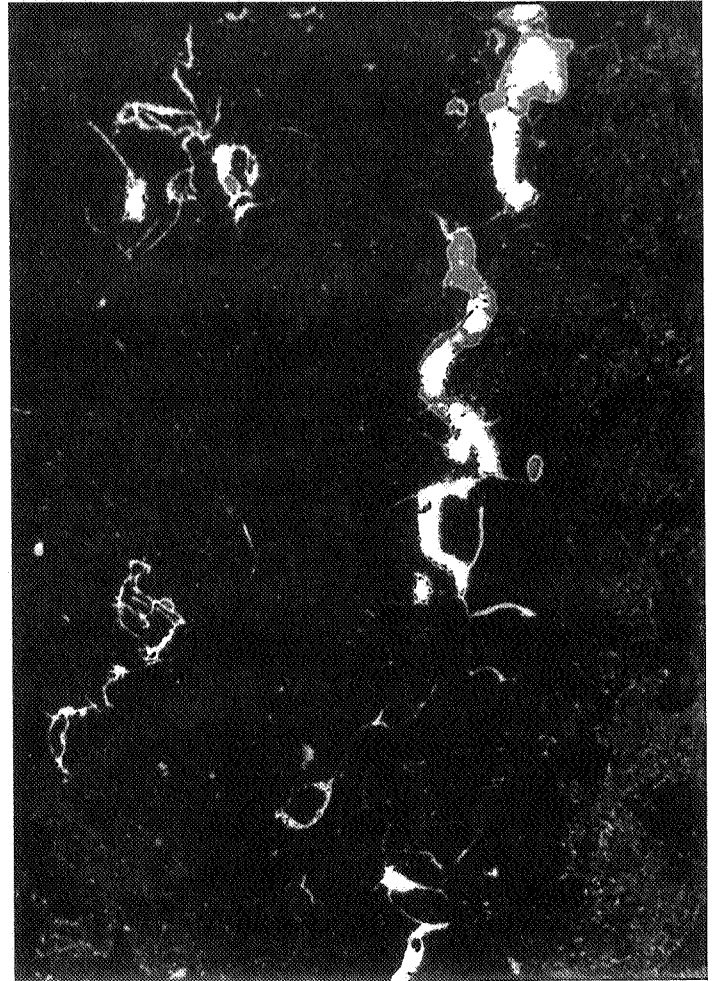
Figure 6 shows the hydrogen damage at the grain boundaries and inclusions at 200 x magnification, and Figure 7 shows the hydrogen damage at the grain boundaries at 1,000 x magnification.

Figure 7. Hydrogen damage at 1,000 x magnification.

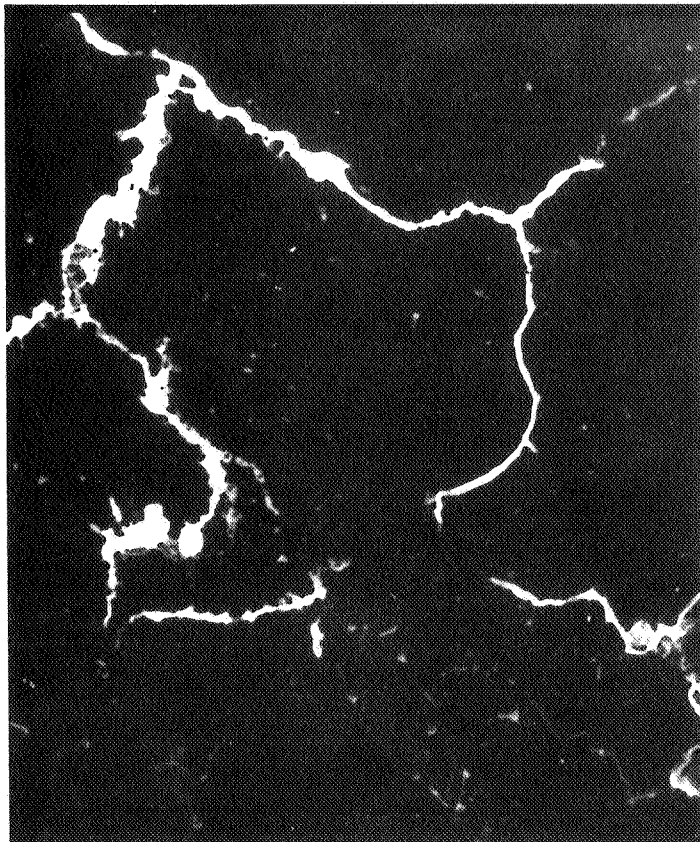
Figure 6. Hydrogen damage at 200 x magnification.
