Cracking and Blistering in a Shift Converter

Although an investigation could not definitely determine the cause of cracking in the exit nozzle weld, the material of construction is suspected to be the source of trouble.

W.D. Clark and E.A. George
Imperial Chemical Industries Ltd.
Billingham, Teeside, England

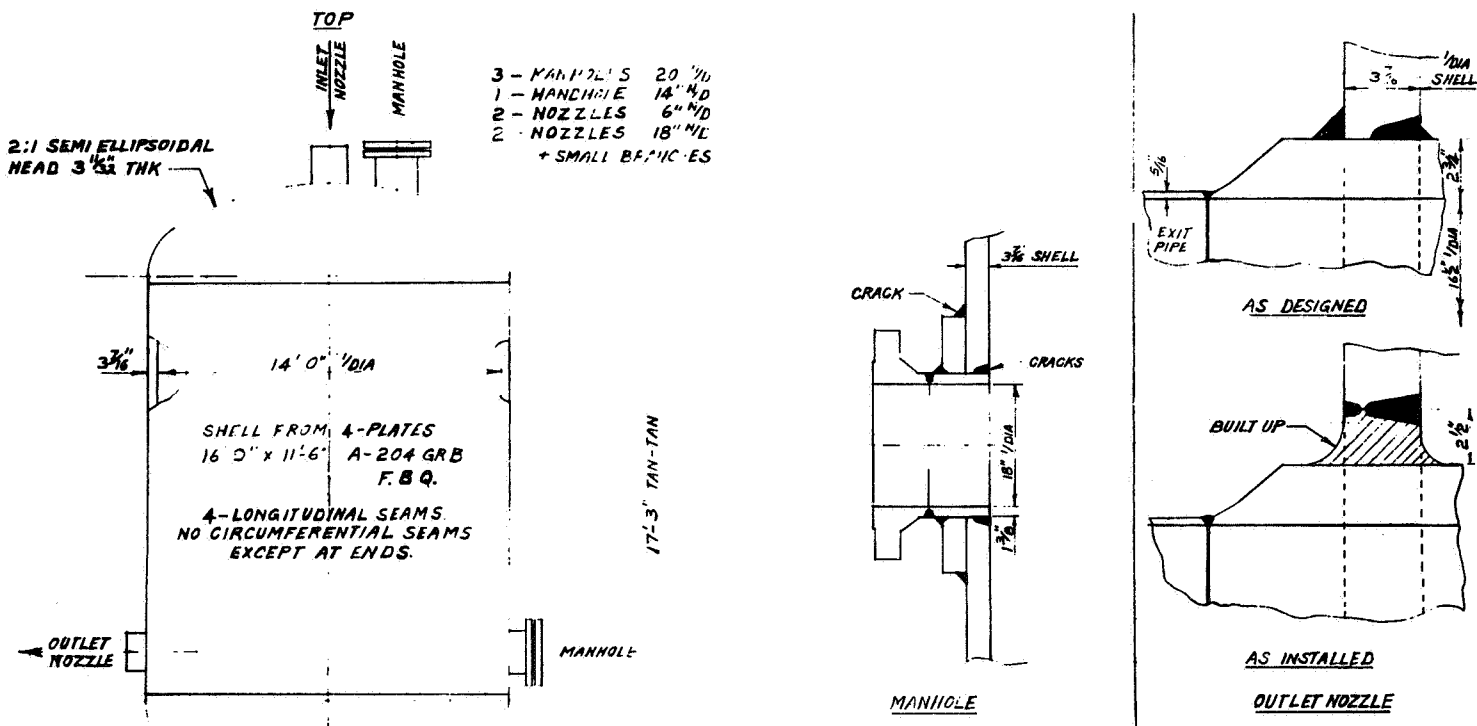
Figure 1. General arrangement of the high temperature shift converter.

The ICI facility at Billingham has three nominally identical 1,000 ton/day ammonia units, originally on naphtha, and now on natural gas. In December 1971, a small leak at the exist nozzle pipe weld on No. 2 unit high temperature shift converter fired and caused a shutdown. Salient details of this vessel are shown in Figure 1. The plant had been on and off line 88 times since 1967. Investigation showed that the 18 in. nozzle was a forging and had an axial crack running back from the weld. Orthodox attempts to cut out the crack and repair the forging soon ran aground when it was found that there were dozens of axial cracks and that the forging was abnormally hard, about 300 Vickers.

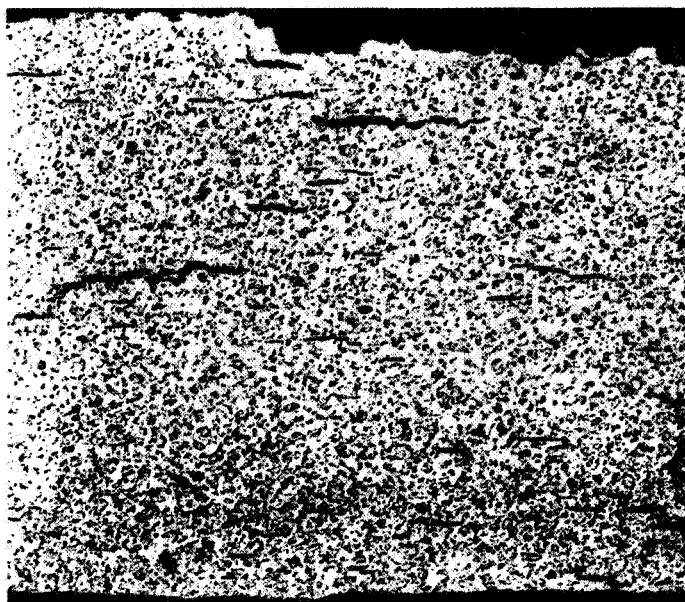
Three of the blisters had cracked across the crown. From a fourth a sample of gas was collected by drilling a small hole, and analyzed as 71% CH₄, 28% H₂. It was estimated that the pressure in the blister was perhaps 60 lb./sq. in. at the time it was tapped, whereas it would have taken at least 3,500 lb./in.² to cause the bulging. A small piece was cut out of the crown of the blister. The cavity was clean and empty, the 'lamination' had been a colony of small platelike inclusions rather than a single sheet, and the steel adjacent to the lamination was heavily decarburized, whereas adjacent to the i.d. of the vessel it was quite normal, Figure 3. Its hardness was normal.

A methane found in the cavity ties up with the

Figure 3. Section of the cap of a blister taken from the inner wall of the vessel.

decarburisation found, but according to the Nelson curves, hydrogen attack would not be expected below about 1,000°F with 160 lb./in.² partial pressure of hydrogen, and the service temperature had not exceeded 800°F.

A well-known mechanism of blistering is the injection of hydrogen by a corrosion mechanism, which can induce very high internal pressures. Some attention has been paid to the fact that potash from the reformer catalyst (on naphtha) tends to collect on top of the high temperature shift catalyst, i.e., in the blistered region. Could this be causing a corrosion reaction which injected hydrogen into the steel? The blistered area showed no sign of corrosion, and injected hydrogen would be expected to cause decarburization as a surface layer, working inwards, and not wait until it has reached a colony of inclusions. Some laboratory work has been done to assess whether a combination of potash, carbon oxides, hydrogen, and steam can cause more hydrogen to diffuse into the steel than the partial pressure of hydrogen alone. The results show an increase in diffusion rates by a factor of up to 10 but this does not fully explain the production of the laminations.

The blisters, open to the contents of the vessel, reduce the effective wall thickness. It was not considered practicable to repair the blisters and the lamination. As the vessel had been designed to ASME VIII Division I it was decided that on a short term basis it was perfectly safe to run it. A new vessel has, however, been ordered.
