Change-out of a Primary Reformer Harp

J. Emrich
Canadian Industries Ltd.
Courtright, Ontario, Canada

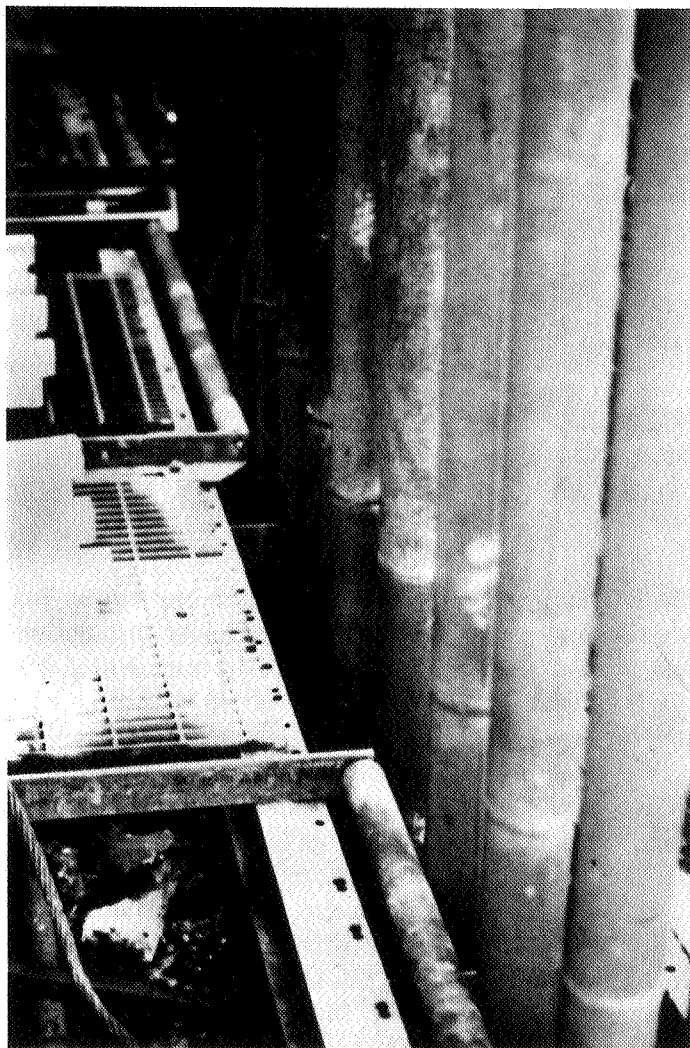
Location and spacing of the rollers.

even a small jar of the bricks when removing or installing the harp could have serious consequences. We also installed 3 ft. long rollers spaced as required along the length of the harp, just above the arch, bolted with slotted holes to the arch support beams. This was to assist during the removal and installation phase, and also to offer some protection for the arch from accidental bumps.

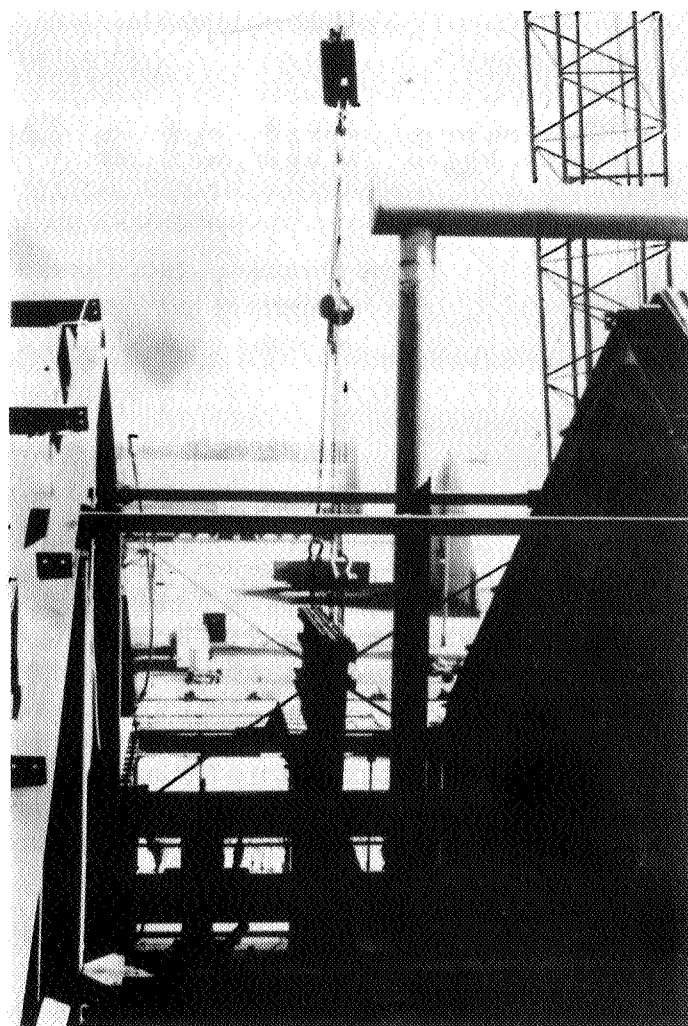
Removal of the east section of the old harp. Note the clearance between the beam and tubes.

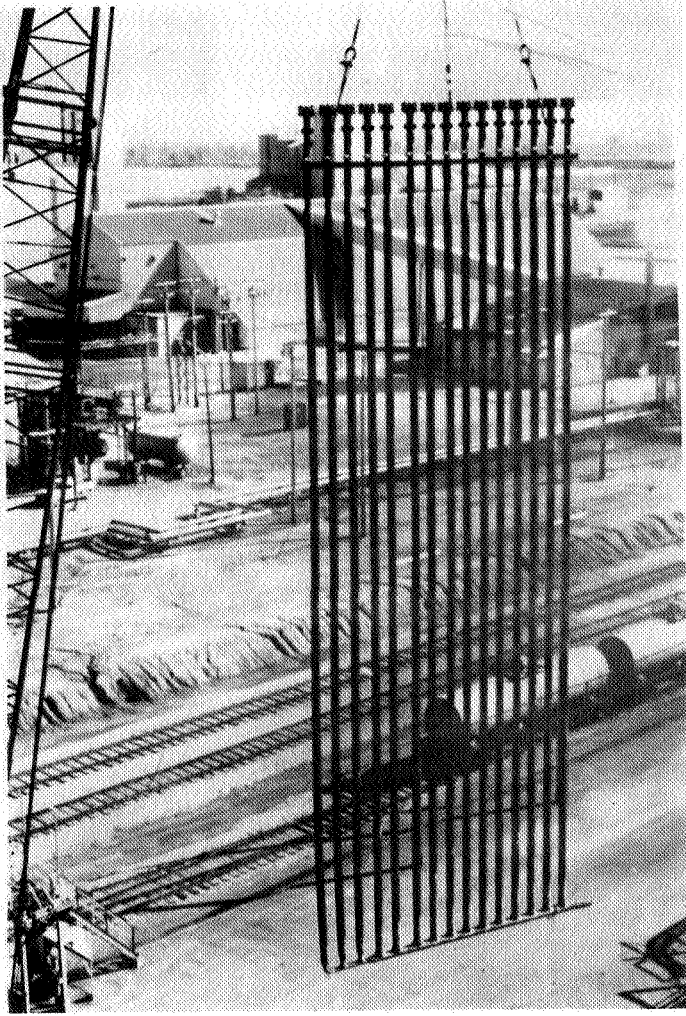
One section of the old harp.

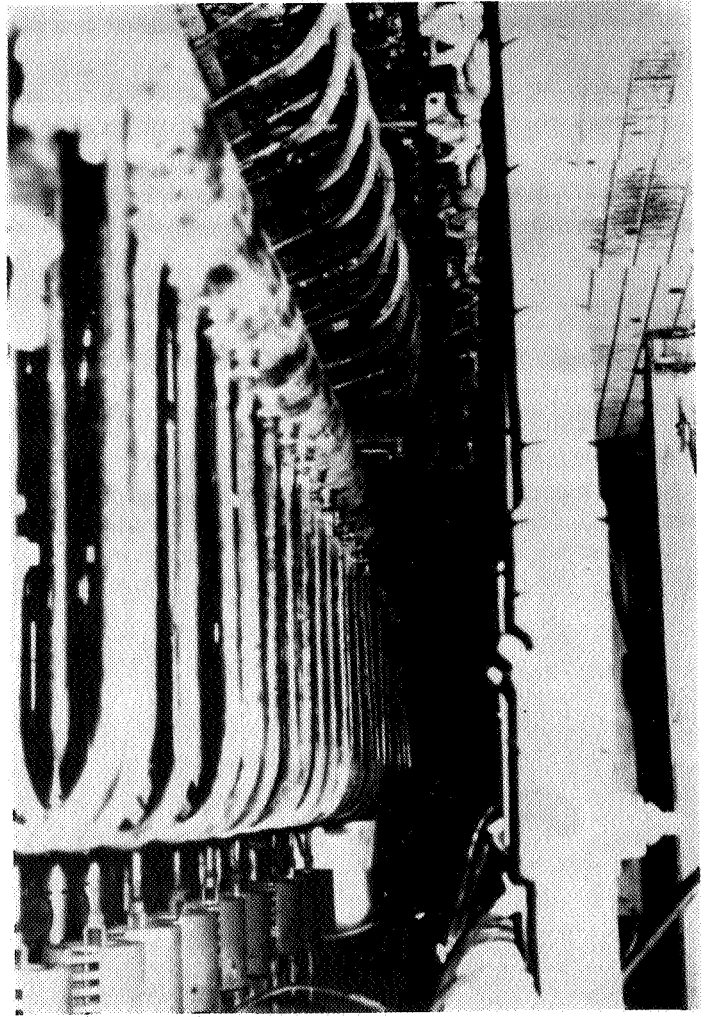
The harp, still supported by chain falls and jacks, was leveled in preparation for making the field joints. At this time, the new pigtails were positioned and welded. Four of the pigtails required re-ramping in the field in order to clear the inlet manifold supports. All of the pigtail welds were dye checked to verify the quality of the welds. Insulating began as soon as inspection had accepted the welds.

New pigtails and spring supports.
