Failure and Repair of an Ammonia Separator

R.W. James
CF Industries, Inc.
Terre Haute, Ind.
and
J.A. Lawrence
CF Industries, Inc.
Olean, N.Y.

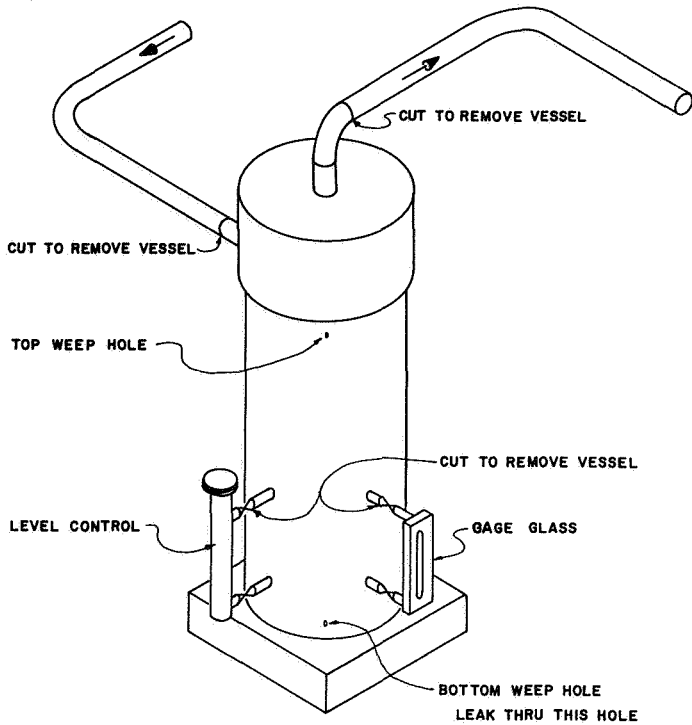
Figure 1. Separator orientation.

multi-layer construction, having an inside diameter of 26 in. and a tangent to tangent length of 10 ft. 1/8 in. with internally machined 2:1 ellipsoidal heads. A tangential inlet nozzle is located on the upper shell and the outlet is centered in the top. Other shell nozzles are two connections for a gauge glass and two connections for a level transmitter. There are two liquid ammonia outlet connections in the sides of the bottom head. Internals consist of a conical section in the top and a set of disengaging baffles in the shape of a cross in the bottom. Two adjacent legs of the baffle are welded to the inner shell with fillet welds. The inner shell is 1/2 in. thick, having a tensile of 85,000- to 105,000 lb./sq. in. and the outer wraps have a tensile of 105,000 lb./sq. in. minimum. Total wall thickness is 3-1/8 in. Both heads are forgings. Four weep holes, two in the top of the shell and two in the bottom of the shell, are drilled through the outer wraps to the inner shell. The leak was discovered at one of these weep holes.

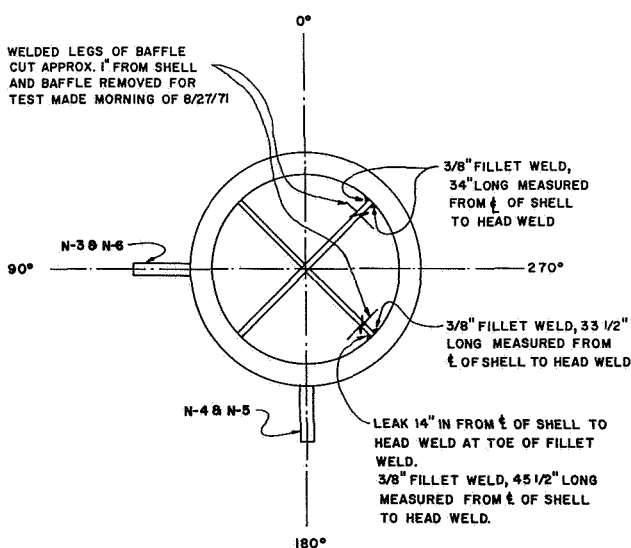
Figure 2. Location of leak on inner shell.

- NOTES:
 1) WELDS SHOWED MUCH POROSITY.
 2) WELDS WERE BADLY UNDERCUT.
 3) MP TEST SHOWED CRACKING ALONG TOE OF BOTH FILLET WELDS.

BOTTOM VIEW OF
 SECONDARY SEPARATOR

Air was put into the hole where the leak had shown up in operation and pressure gauges were installed in the other holes to show where the layers had been pressured. Pin hole leaks were found 14 in. in from the shell bottom and at the toe of one of the fillet welds. Another magnetic particle test along these welds showed cracks along the toes of all four fillets.

Most failures of multi-layer vessels having the same shell material as ours and internals of high tensile material, have occurred at a shell attachment and along the heat effected zone of the weld. This is due to the relative brittleness of these high strength materials. Our failure followed this pattern. For these reasons, it was decided to use a more ductile repair material and E 7018 electrode was chosen. E 7018 consistently shows a tensile of 83,000- to 85,000 lb./sq. in. gauge in the as-welded condition, and this compared favorably with the lower tensile of 85,000 lb./sq. in. gauge of the shell and provided the ductility desired. A procedure was written using 150°F preheat, repairs made, and welds were ground flush with the inner shell.

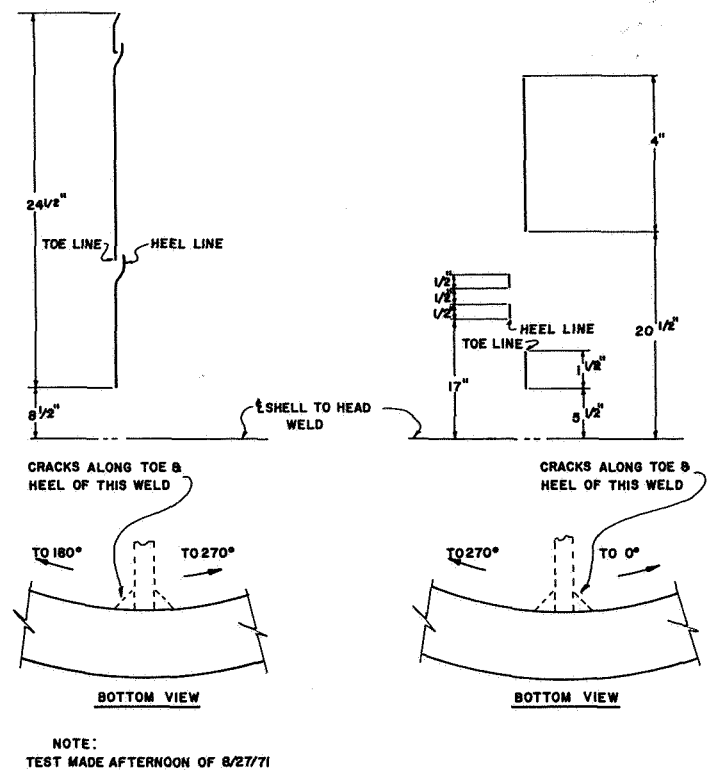
Figure 3. Cracks on inner shell.

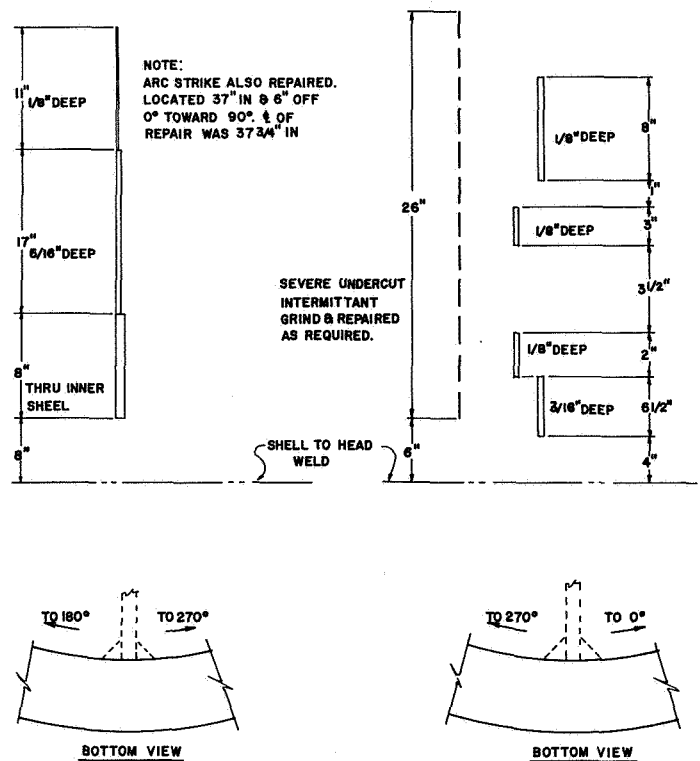
The old welds were ground flush and another magnetic particle test run to layout the shell grinding. We had to grind 36 in. of shell along one baffle weld and 19-1/2 in. along the other in order to remove the cracks. Of this, 8 in.

on one weld was completely through the inner shell thickness.

Figure 4. Grinding to remove cracks.

A magnetic particle test, followed by using air to pressure the layers and Leak-Tec were run and no defects were found. The weld groove was then machined on the shell and bottom head. Baffles were repaired by welding strips of A 516-70 on the two legs cut off during removal.

The baffle was rotated 180° so the new material added to the baffles would be welded to the shell where no weld existed before. We did not want to weld to the shell repair. Baffles were welded in place with 3/8 in. fillet using E 7018 electrode and 150°F preheat. The length of these welds was 32 in. along both sides of each leg and was the limit a welder could reach comfortably and make a good weld. I feel the poor quality of the original welds was partially due to an attempt to weld the entire length of the baffle leg, which was 46-1/2 in. Due to the tight space in this small shell and with the baffle, the angle of the electrode in the holder necessary to reach that far in, caused metal to be blown out and contributed to the severe undercutting.
