# Ammonia Converter Repair That Succeeded

Here's a case history of an installation in a Saudi Arabian fertilizer plant that worked and will provide useful suggestions in the handling of similar problems.

R.M. Gundzik and G.R. Short  
Garrett Research and Development Co.  
La Verne, Calif.

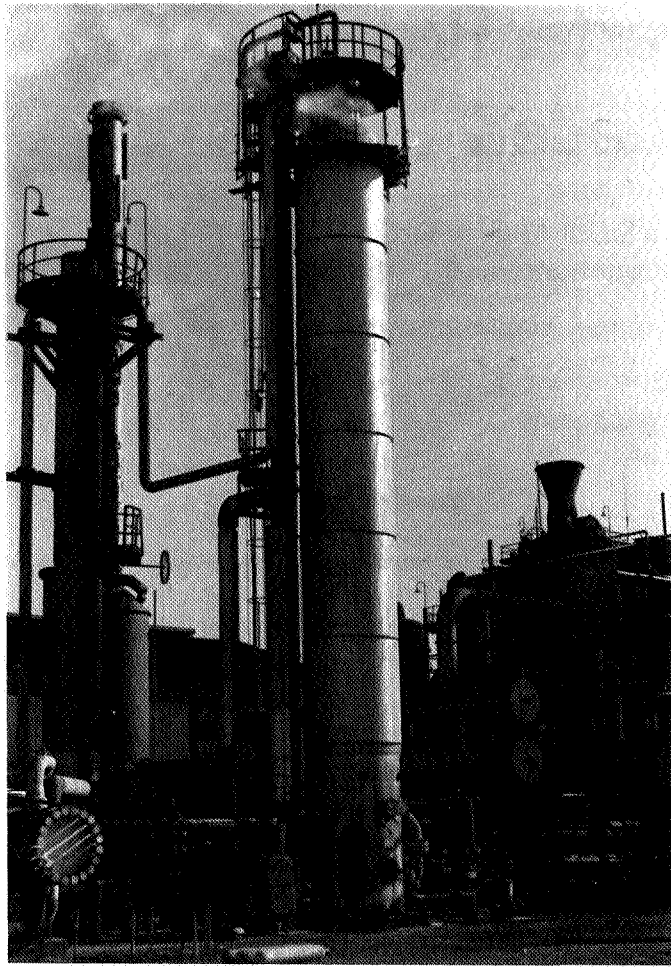
Figure 1. Ammonia converter at SAFCO plant in Dammam.

SAFCO ammonia converter, a number of factors combined to produce excessive metal temperatures at high hydrogen partial pressure. In late 1971, the bottom of the converter, Figure 1, was opened and the canisters removed to investigate the propagation of cracks which had appeared on the inside surface of the forging above the outlet nozzle in the lower forging.

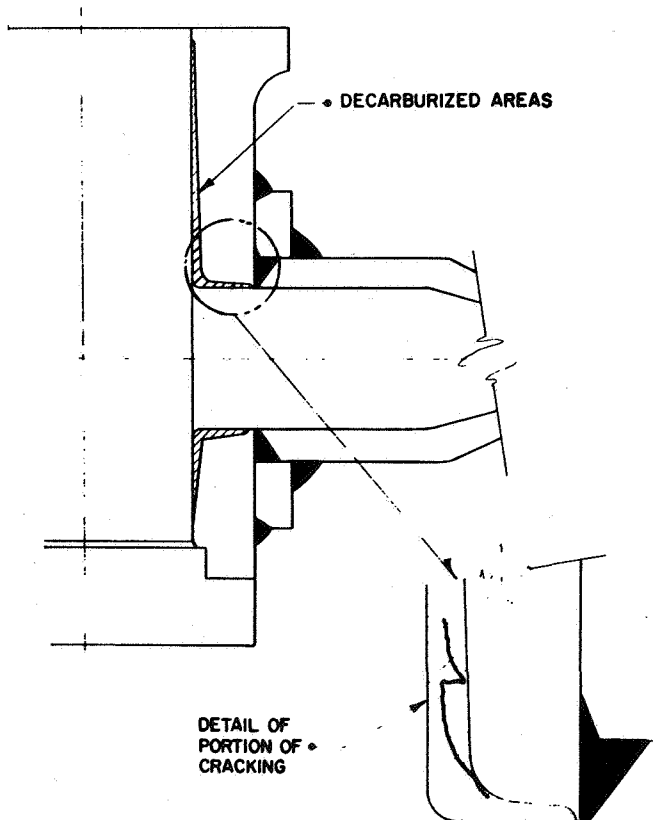
Figure 2 shows the general location of the decarburization and cracking. It was so extensive and widespread that further operation of the converter was inadvisable without bottom forging replacement or extensive repairs including nozzle replacement.

The inspection of the weld between the forging and the nozzle revealed that the cracks in the weld had propagated to a depth of 67 mm. in the 71 mm. thick nozzle. This propagation occurred despite the addition of reinforcement. The outlet nozzle was removed and the 13 in. opening in the forging was bored out to 16-1/8 in. Decarburized and cracked material was removed by on-site machining. The tool used to accomplish this job was a field-type boring machine which removed material in the vicinity of the outlet nozzle by eccentric boring.

Figure 2. Lower forging with original nozzle.

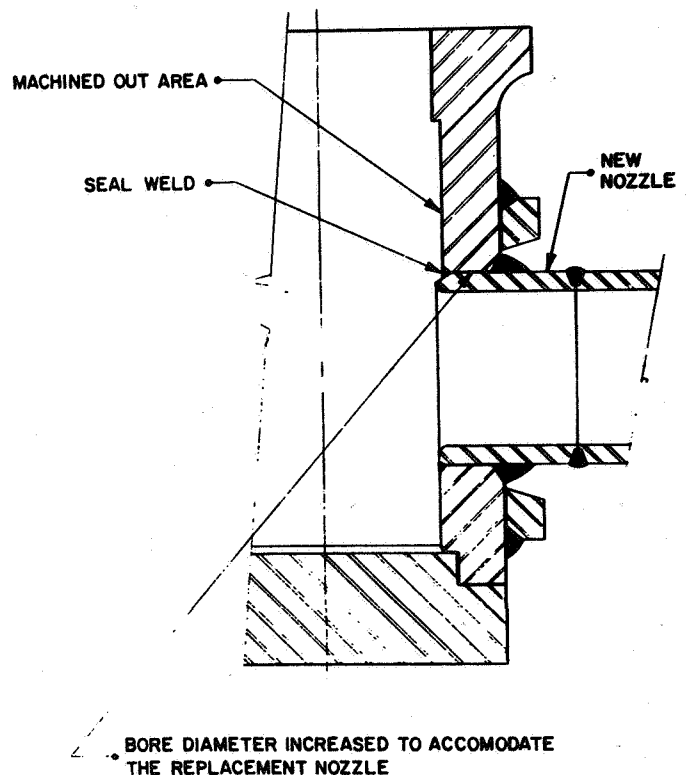
Figure 3. Lower forging with replacement nozzle.

within acceptable limits. At the same time a new nozzle as shown in Figure 3 was installed and the outside weld fillet size was increased over and above the original dimensions to 3 in. on the horizontal leg.

The new nozzle is 2-1/4% chrome, 1/2% molybdenum steel, which is not subject to hydrogen attack at normal operating conditions. The chrome and molybdenum stabilize the carbon; hence no methane is produced. The Nelson diagram (1) is a series of curves defining operating limits for steels in hydrogen service and is used as a guide for material selection. The experience at SAFCO generally confirms the validity of these curves. The Nelson diagram has been updated recently by the American Petroleum Institute (2).

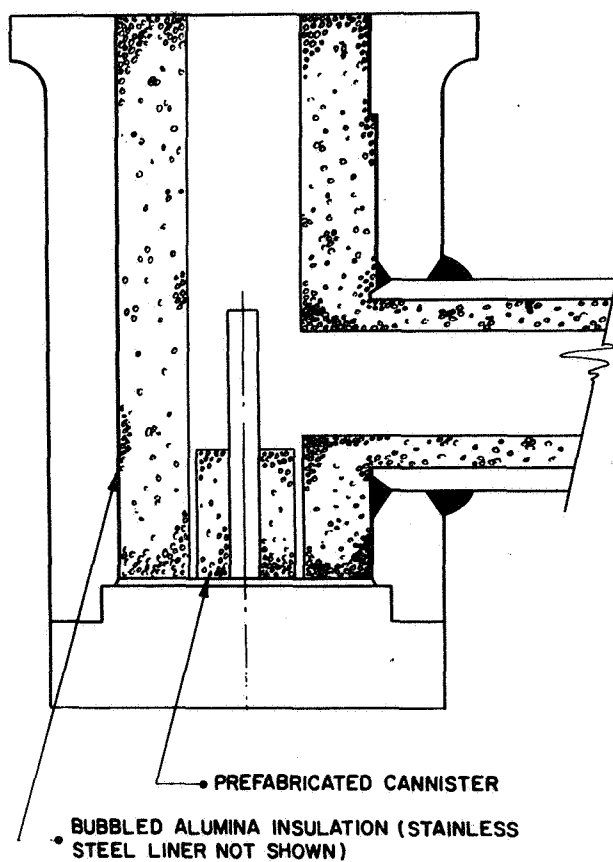
Figure 4. Lower forging with bubbled alumina insulation.

The canister was removed and the lower forging was insulated with bubbled alumina insulation in the form of a castable refractory, as shown in Figure 4. Harbison-Walker "Lightweight Castable 33" was used. Its thermal conductivity is 5.4 Btu./hr./sq. ft./°F/in. at 1000°F, and this value in fact was borne out in actual service. The value is 50%

lower than that of the previous insulation, castable refractory and firebrick.

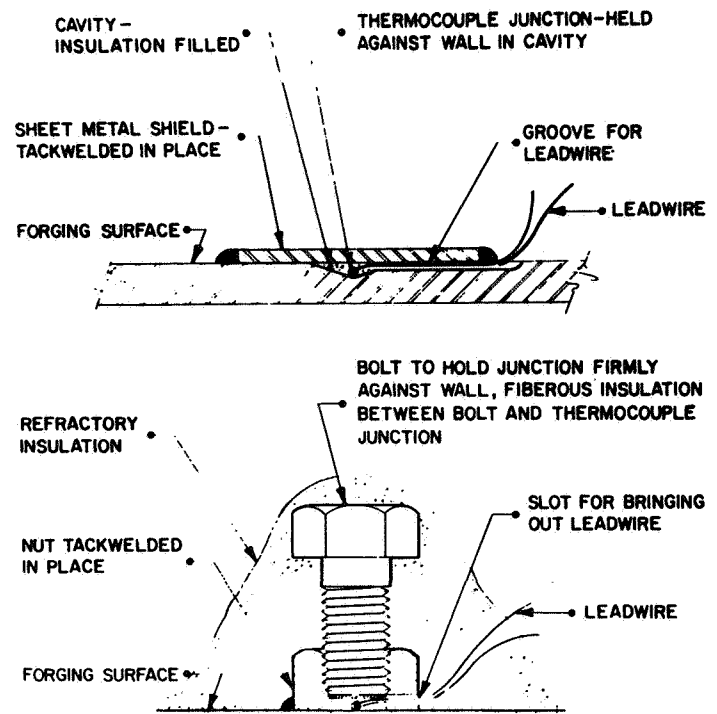
Figure 5. Typical surface thermocouple installations.

The thermocouple installation method was improved. Twenty-two points are now monitored. Figure 5 shows the two thermocouple installation configurations used for measuring surface temperatures. Insulation was added over the top to insure that the junction would be at the metal temperature. The forging is sufficiently thick so that the

metal is locally insulated from the cooling air which does not affect the junction temperature significantly.
