# Solving a Steam Generating Tube Failure

A case history of a tube failure in the primary reformer furnace of a 600-ton/day ammonia unit, telling how the problem was analyzed, repairs were made, and steps taken to prevent a recurrence.

C.C. Song  
and  
W. Unruh,  
Esso Chemical Canada  
Redwater, Alberta

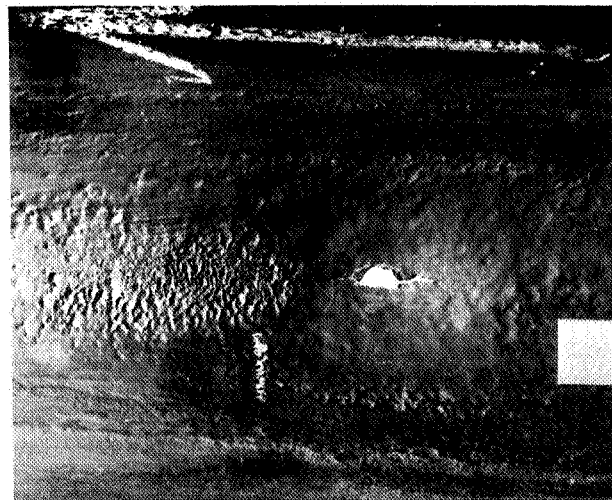
Figure 4. Inside surface of failed tube.

The unit was shut down on December 6, cooled and inspected on December 7. Tube failure had occurred on the fifth tube of the first pass. A hole approximately 0.9 in. long and 0.2 in. wide was found at the 12 o'clock position directly inside the south tube support. The inside of the failed tube was generally thinned for a radius of approximately 1 in. around the rupture point (see Figure 4).

The close visual and metallographic observations of the failed tube section indicated that failure occurred due to concentrated caustic attack where vapor phase existed. The tube was cut cross-sectionally through the pitted area and the type of pitting shown in Figure 8 was found. This pitting, characterized by severe undercutting and general roundness is believed to be typical of that produced by concentrated (up to 40%) caustic solutions.

The parallel grooves near the top of the inside of the pipe indicated that at this position in the tube, the water and steam existed as separate layers, with water filling most of the pipe and a small steam layer existing at the top. Turbulence in the stream could periodically cause some of the liquid to splash and contact the hotter metal in the steam zone. The water-caustic solution could then concentrate and cause corrosion of the type shown in Figure 8. The cycle of splashing, concentration and corrosion was repeated until failure occurred. Expert's\* opinion about overheating was that it may have localized the corrosion to some extent but was not an actual cause of the failure.

The most attractive and promising solution to postpone failure was in the treatment of boiler feed water. As the primary cause of the steam generating tube failure was caustic attack, it became evident to reduce caustic concentration to a minimum. Co-ordinated phosphate treatment of boiler feed water was initiated. Controls were set up to maintain the pH of the boiler feed water between 9.8 to 10.3, and the Na/PO<sub>4</sub> ratio between 2.4 to 2.8.

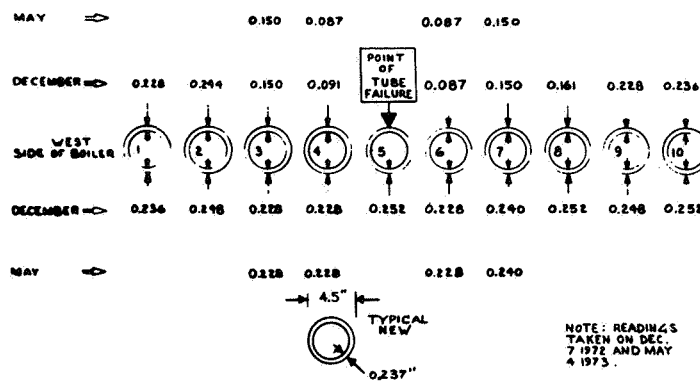
Figure 5. Wall thickness measurements of steam generating tubes.

Ultrasonic wall thickness readings of all 10 branches were taken. It was revealed that the tubes located in the center of the firebox (Nos. 4, 5 and 6 from the west) were extremely thinned at the top. In the case of No. 6 tube, the upper wall thickness was only 0.087 in. which was 37% of the original 0.237 in. thickness. The bottom side of the tubes showed no wear at all. Tube Nos. 3, 7 and 8 had 63% of the original wall thickness (Figure 5).

On May 4, 1973, after five months' operation with the uneasy feeling that the steam generation tube which had only 0.087 in. thickness may fail at any moment, an inspection was made utilizing a shutdown occasion caused by some other reason. It was found that practically no further

deterioration happened as indicated by the second set of numbers on Figure 5. The bypassed tubes left in the firebox without flow were, of course, burnt out. These dead tubes were removed, the insulation sheet at the tube support holes was readjusted and the furnace went back into operation. During the September turnaround, all 30 steam generating tubes were to be replaced with original specified carbon steel material.
