# Corrosion in CO<sub>2</sub> Removal Plant Towers

K.T.G. Atkins  
D. Fyfe  
J.D. Rankin  
Imperial Chemical Industries, Ltd.  
Billingham, England

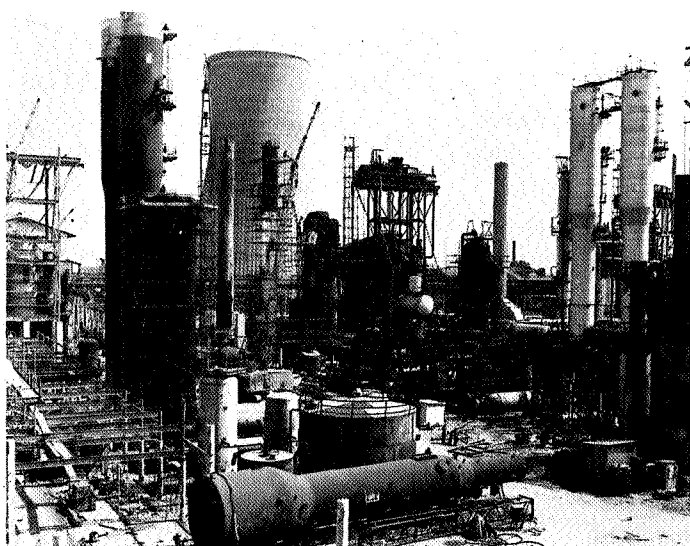
Billingham LP Ammonia unit in construction, ca 1966 showing top half of absorber lying in foreground. Weld to bottom half stress relieved on site. Stress corrosion cracking found in this weld, 1972.

In May last year, a process operator saw a small plume of steam coming from an otherwise featureless area of lagging half way up the CO<sub>2</sub> Absorber of the second of our three plants. Closer inspection revealed a lot of solid material around the point where the steam was coming out, with stalactite-type growths characteristic of leaks from potassium carbonate scrubbing systems. When the lagging was removed, we found an apparently small vertical crack in the vessel shell. From this, issued a mixture of steam, synthesis gas and Vetrocoke liquor. The vessel had been delivered on site in two pieces, and the crack was on the weld made on site between them.

The area around the crack was cleaned up, and the entire site weld examined with ultrasonic crack detecting equipment. This showed a long circumferential crack on the inside surface, some 5 ft. 8 in. long, and about an inch deep—the vessel wall is about 1.65 in. thick. There were also several vertical cracks across this, and these did penetrate the vessel wall. In order to reduce the hazard from the leak, a pad was clamped over it with a chain around the vessel to hold it in place.

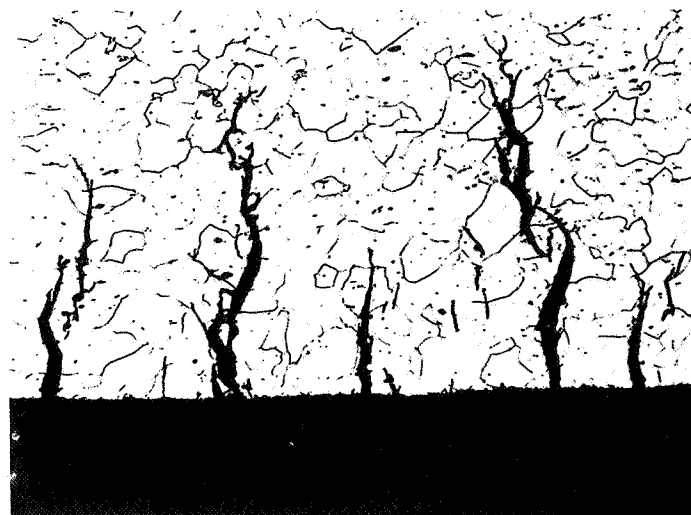
Figure 2. Transcrystalline cracking produced in Vetrocoke solution at 130°C.

In all cases cracking is transcrystalline, Figure 2, and we are now of the opinion that cracking in Vetrocoke liquor is not a form of carbonate SCC but hydrogen embrittlement due to the arsenite.

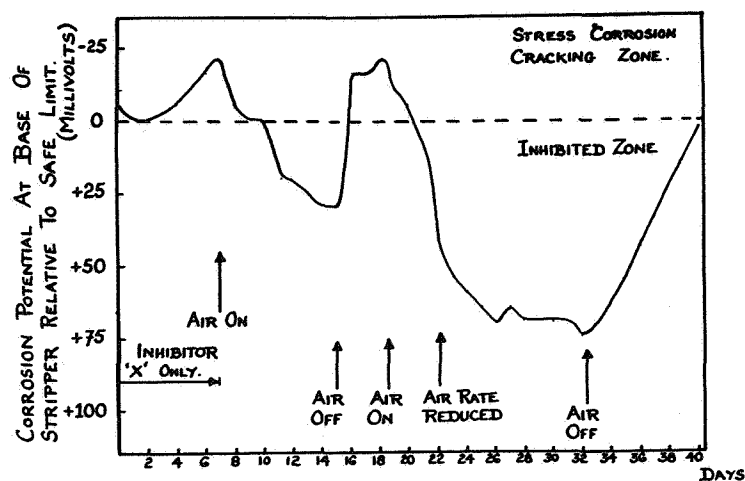
Figure 3. Effect of air addition on corrosion potential of Severnside 1A stripper base.

shows the influence of varying air addition rate, in the presence of the other inhibitor, on the potential of the regenerator base on the ICI plant which first experienced SCC. The correlation is striking.

Our practice is now to maintain the second inhibitor above a defined minimum level in the plant liquor. By varying the rate of air injection in response to a signal from a monitor continuously measuring the potential of the plant in several locations, the liquor is kept in a state that inhibits SCC. The control loop is thus established. Figure 3

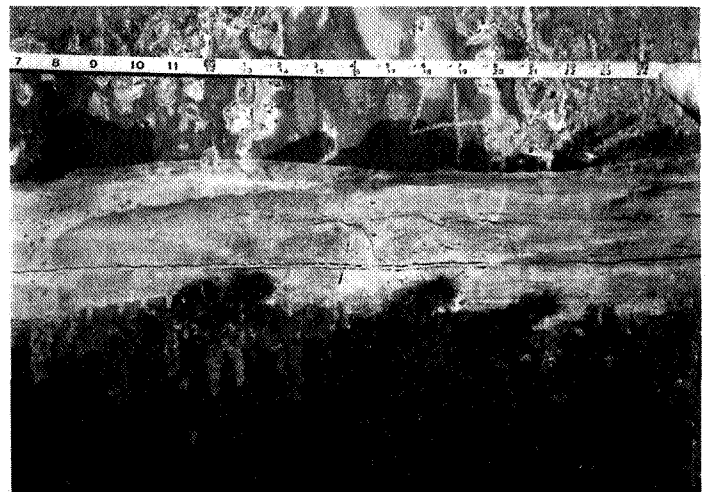
Figure 4. Cracking of site weld on Billingham No. 1 Vetrocoke unit.

*No. 1 Plant:* The surface was lightly ground to prepare it for Magnaflux crack detection. Numerous circumferential and angled cracks were found, together with areas crazed by fine cracks, Figure 4. All the damage was local to the weld made on site to assemble the two halves of the

vessel, between strakes 6 & 7. A full width radial crack was also found on the weld between the semilean liquor inlet nozzle and the vessel shell. This had not leaked. It is still subject to close inspection, and a decision on the repair method is still to be taken.

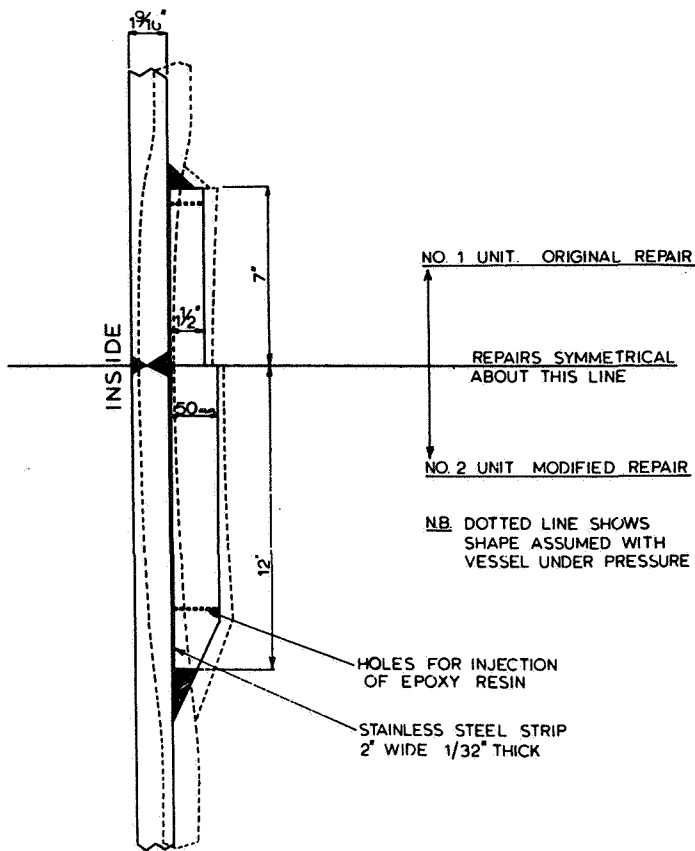
Figure 5. Methods of repair and stress distribution.

One disadvantage of the external band method of repair is that local discontinuity stresses are produced in the shell at the top and bottom of the reinforcing band again, Figure 5. An opportunity arose of measuring the change in stresses at various points during the pressurizing of No. 1 Plant in

February, 1973, which indicated a change in bending stresses in the main shell plate in the vicinity of the fillet weld of some 24,000/lb./sq. in. because of the discontinuity between the shell and strap. Although the UTS of the material from which the towers were made is specified at 45,000/lb./sq. in. and is actually about 10-15% higher than this it is felt that the stresses under working conditions might be in a range to render the material vulnerable to stress corrosion cracking.

On both No. 1 and No. 2 Plants the repair has been carried out by welding an external band of steel plate over the defective weld around the full circumference of the tower. Alternative methods of repair considered involved either cutting out the original weld and re-welding, or cutting out a section of the tower including the defective weld and welding in a new section.

It was decided that the steel band should be capable of taking the hoop and the longitudinal stresses, so that although the cracked weld might get worse, the strength of the tower was unimpaired. The details of the system in the two plants differed as can be seen from the sketches, Figure 5. On No. 1, which was the first to be tackled, a band made from 1½ in. thick plate to BS 1501-151 28A in nine pieces 14 inches deep, was welded to the shell with 1 inch fillet welds using Fortrex 31 electrodes. ¼ inch BSP tapped holes were provided in each piece to enable epoxy resin to be pumped into the interspace to prevent leakage from the crack which penetrates the shell coming into contact with the fillet and butt welds attaching the strap to the shell. In the event of complete failure of the vessel's circumferential weld the stresses in the strap and in the attaching 1 inch fillet welds are well within the acceptable figures for the materials involved.

For the subsequent repair on No. 2 Plant, the reinforcing band and upper and lower fillet welds were tapered off at 30°. This has the effect of reducing the maximum stress in the shell arising from the discontinuity to a lower value than the hoop stress which has already been shown to be acceptable in the Vetrocoke environment. The steel band was made 24-in. wide. The change of thickness to 50 mm was determined by availability of suitable material and for no other reason. All the stresses involved are obviously less than those in No. 1 Plant.
