Repairing Ammonia Tank Insulation

A case history of a successful repair following a major failure of the sidewall insulation; about 85% of the material was replaced with a new type material.

K.E. Vidalin, and D.W. Bertram
Simplot Chemical Co., Ltd.
Brandon, Manitoba, Canada

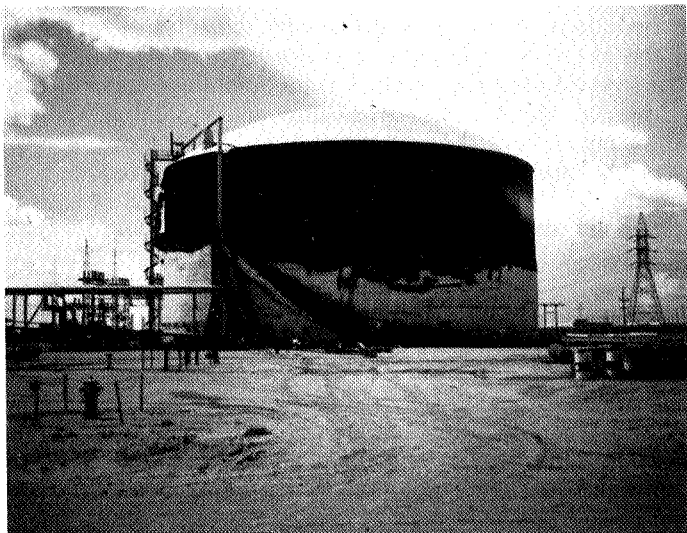
The foamglass insulation began to sag and buckle on June 11, 1971. On June 18, 1971, before anything could be built to support the sagging section, the entire top half of the insulation fell from the tank. The failure initiated at the bulged section and progressed around the tank in a clockwise direction as viewed from above. The remaining insulation was pulled down to the 8-ft. level, where solid ice was encountered. See Figure 1.

The tank level at this time was 1 ft. 6 in., and we had not experienced any high winds prior to the insulation failure. The ultimate failure was the direct result of the moisture permeating the vapor barrier. This caused the insulation cell structure to be broken down by the freeze-thaw cycle, and as we lowered the ammonia level inside the tank, the ice, which was the only structurally sound element in the system, melted, resulting in the system's collapse.

Samples retrieved from the rubble clearly indicated that poor workmanship had prevailed throughout the project. Numerous samples indicated no asphalt and no adhesion between adjacent blocks. Core samples taken from the blocks showed complete breakdown of the cell structure and most cores were saturated with water. Core densities of the foamglass were as high as 21.00 lb./ft.³ as compared to a published density of 8.50 lb./ft.³.

Figure 1. Condition of tank on Monday, June 21, 1971, immediately after the failure but before repairs. Photo of west side of tank.

The remaining foamglass on the tank was removed and squared off at the 8-ft. level, where a structural steel support ring was installed to support the new insulation system. This ring was necessary because the storage tank could

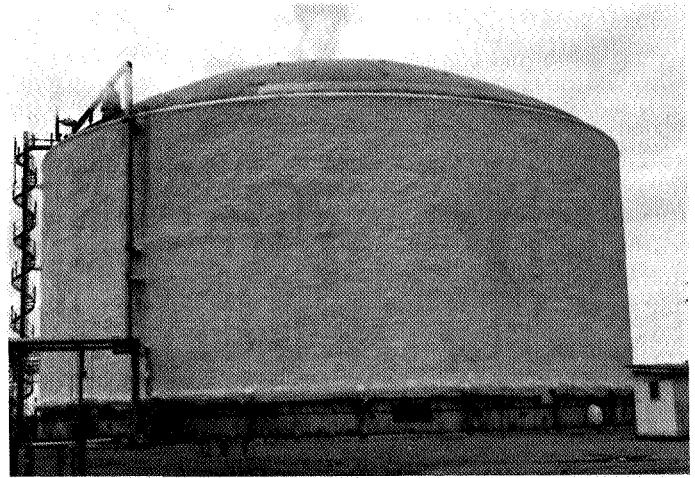
Figure 2. Tank in April, 1972, after repairs were completed.

The tank was first sandblasted and then prime-coated with an epoxy paint to insure excellent bonding of the urethane. Around the roof insulation support, lugs were spot-welded from which rows of wire mesh were hung which were then tied together to form a continuous mat around the tank.

As the urethane is applied, gaps are left between each section to allow the urethane to expand and cure fully, reducing any unnecessary stresses. The urethane was then coated with a 26-mil. vapor barrier and a 10-mil. white Hypalon weather coat. See Figure 2.
