Solving a Steam Reformer Tube Failure

Here's a case history of stress corrosion cracking in tubes in an Israeli ammonia plant reforming furnace and how the failures were detected and prevented.

J. Fuchs
Chemicals and Phosphates Ltd.
Haifa, Israel

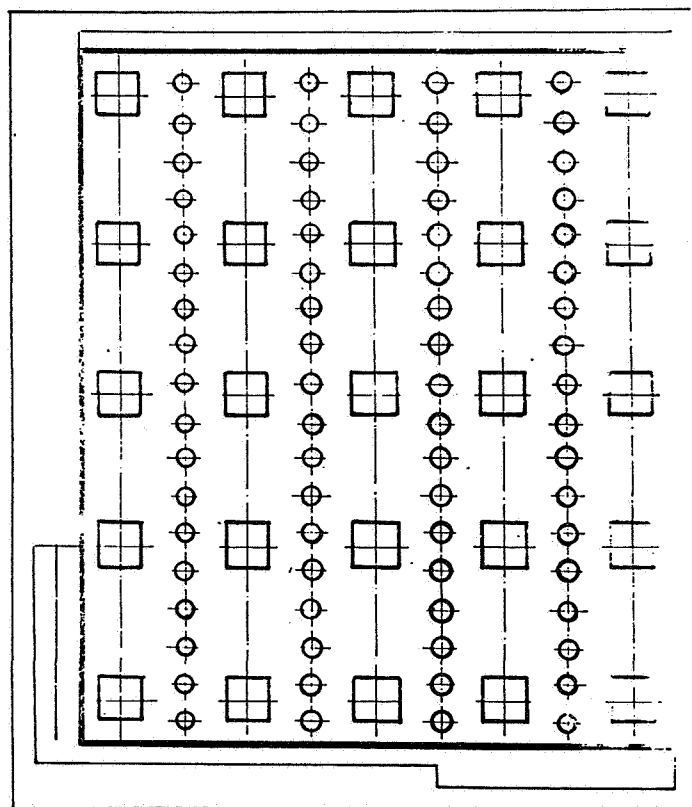
Figure 1. Primary reformer furnace cross section. Circles denote tubes and squares denote burner locations.

The primary reformer consists of 72 tubes, divided into four rows of 18. The tubes in each row are fed from one of the four top headers through inlet pigtails, and the gas leaves through two bottom headers. These headers are connected to the secondary reformer by a transfer line. The reformer is top fired by 25 Air Oil naphtha burners, arranged in 5 rows of 5 each, as shown in the cross section view in Figure 1.

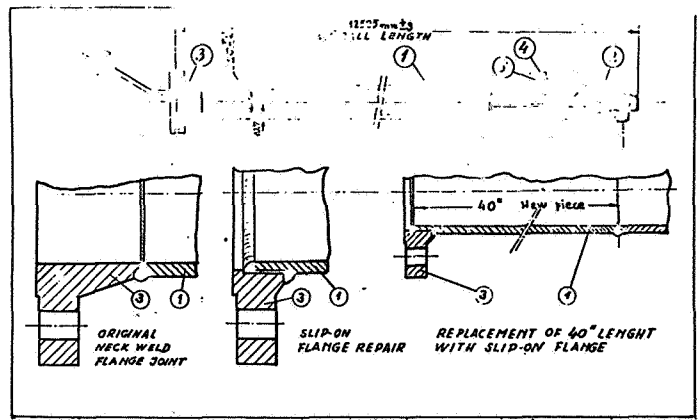
Figure 2. Primary reformer tube repairs: types A and B.

1. Nineteen tubes were cracked from ½-in. above and below the top flange weld, which is about 3-ins. beneath the flange. Most of the cracks were vertical but some were circumferential.

2. Fifty-three tubes had cracks at the top weld, and the cracks extended further down.

One badly leaking tube was removed from the furnace and sectioned for its entire length. The cracking was found to extend about 40-ins. down from the top flange. This corresponds to the upper level of the catalyst in the tubes, and is above the fired zone.

The appearance of the cracks suggested stress corrosion. Sections from the cut tube were taken to the Metallurgical Department of the Israel Institute of Technology and the cracks positively identified as resulting from stress corrosion. As a matter of interest the C&P stock of spare brand-new reformer tubes were all checked with dye penetrant, and minor cracks were found around the same top flange weld.

The cracking in the region of the flange weld was so severe that no attempt was made to gouge out the cracks and reweld. Instead the tops of all the cracked tubes were cut off and replaced, as follows:

1. Forty-three tubes with cracks below the top weld, had the entire 44-in. cracked length cut out and sections of tube welded in. (see Figure 2, type A repair.)

2. Nineteen tubes were repaired by cutting off the cracked section and moving the flange down about ¼-in. (See Figure 2, type B repair.)

All 62 repaired tubes had their flanges machined to a slip-on type and were then rewelded. The tube sections

used for the repair were taken from the bottom part of the 10 replaced tubes. It should be explained that the plant is at some distance from tube suppliers, thus repairs had to be made with material available on site. Inconel 82 argon-root welding and Inco-weld "A" arc weld was used for welding. All welds were inspected by dye penetration and radiography.

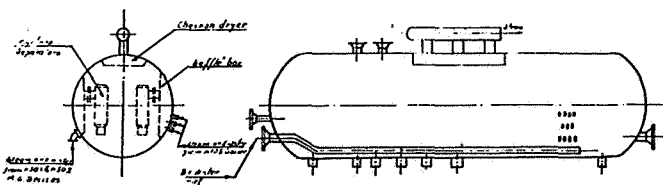
Figure 3. The steam drum as per contractors design.

There is a single steam drum with three water circuits: one to the convection section (flue gas) and two to two waste heat boilers (make gas) between the secondary reformer and the high temperature shift converter. Design evaporation rate is 30 ton/hr. In the contractors design (Figure 3), the steam-water mixture from the flue gas and make gas boilers enters the drum via a baffle box and from there into cyclones, where steam and water are separated. A chevron dryer was to be provided to reduce TDS in exit steam to 1 ppm when boiler TDS was 2500, regardless of the action of the cyclones.
